TECHNICAL NOTE SERIES NO. 80-3

BEACH CHANGES AT THE LONG POINT LIGHTSTATION, LAKE ERIE

A Progress Report on the Monitoring
 of a Shore Protection System

April 1980

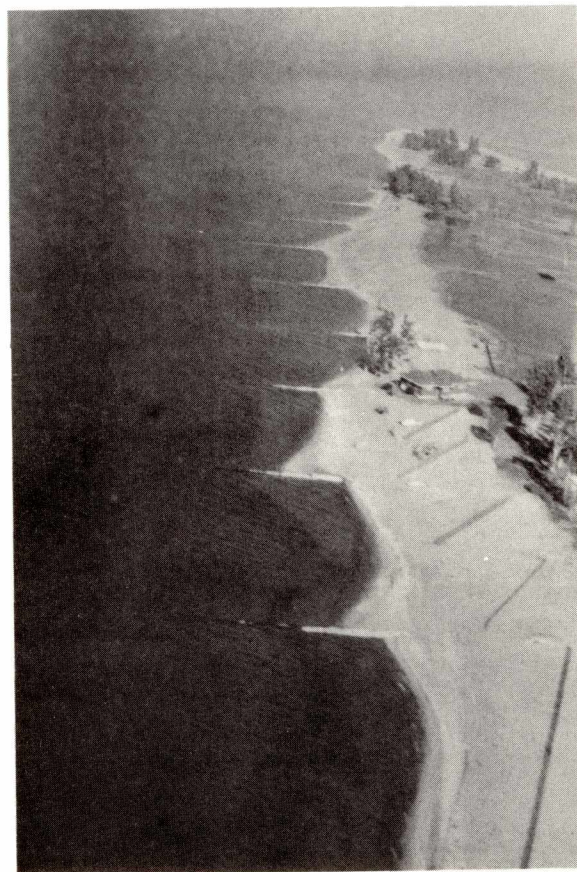
Figure 2.

Aerial Photograph of Fabricast Molded Block Groynes and Snow Fencing at Long Point. (August 3, 1978.)

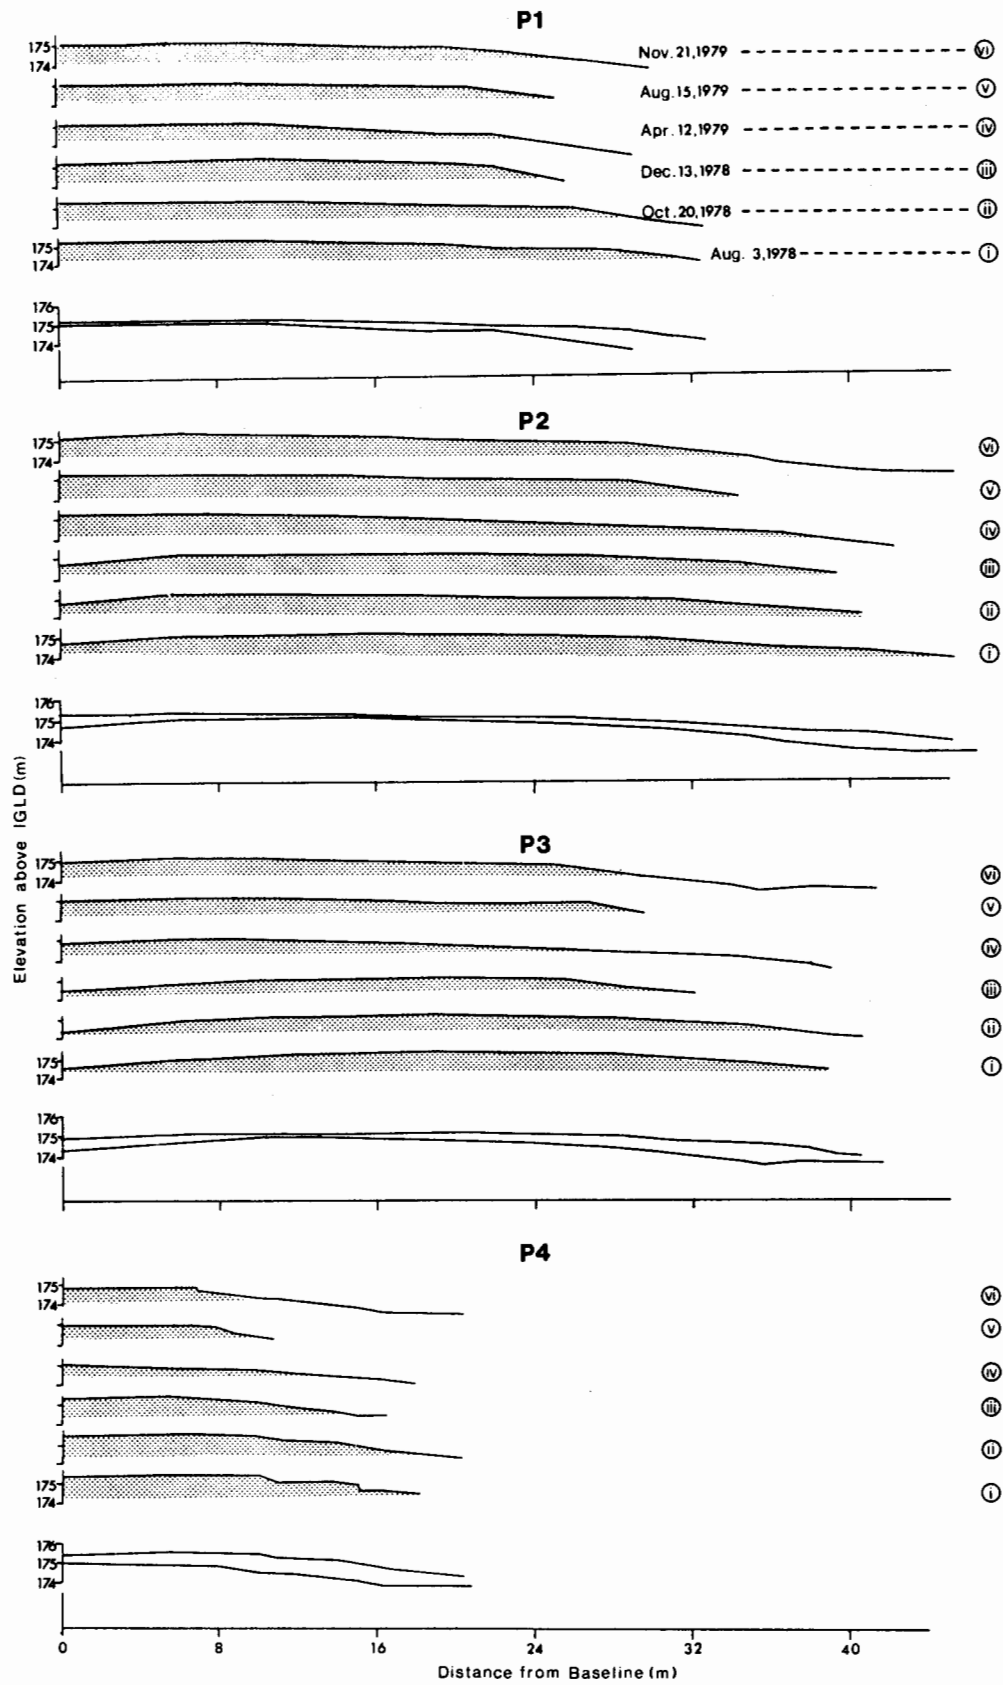
Figure 5. Beach Profiles After Construction of Groynes

The four monitoring sites shown in Figure 4 have been surveyed six times since shore protection was installed in July 1978. Individual beach profiles and the dates are shown for each survey in Figure 5 as well as a composite plot or sweep zone indicating the overall magnitude of change in profile for the entire survey period.

All cross-sections show recession in spite of shore protection and a drop in lake level of 22 cm. The net change for the August 1978 to November 1979 survey interval indicates an average loss of 7.1 m when referenced to a fixed elevation of 174.25 m (IGLD). Ironically, one of the stations within the groyne system (P2) had the highest recession with an 8.3 m* loss. This may be explained by the fact that adjustments in sediment accumulation continue to take place in response to reversals in longshore current. East of the groyne system, the beach at P4 retreated 7.2 m while the west beach (P1) had the least loss (5.5 m). Although maximum beach retreat did not occur simultaneously for the four sections of beach, Table A.1 (Appendix) shows that the protected reach and east beach sustained the highest recessional loss ranging between 9.0 and 9.7* m.

Sweep zones show profiles of maximum deposition and scour conditions. These do not vary significantly, suggesting that reaches (P2 and P3) within the groyne field remain as dynamic as reaches (P1 and P4) at each end of the groyne system.

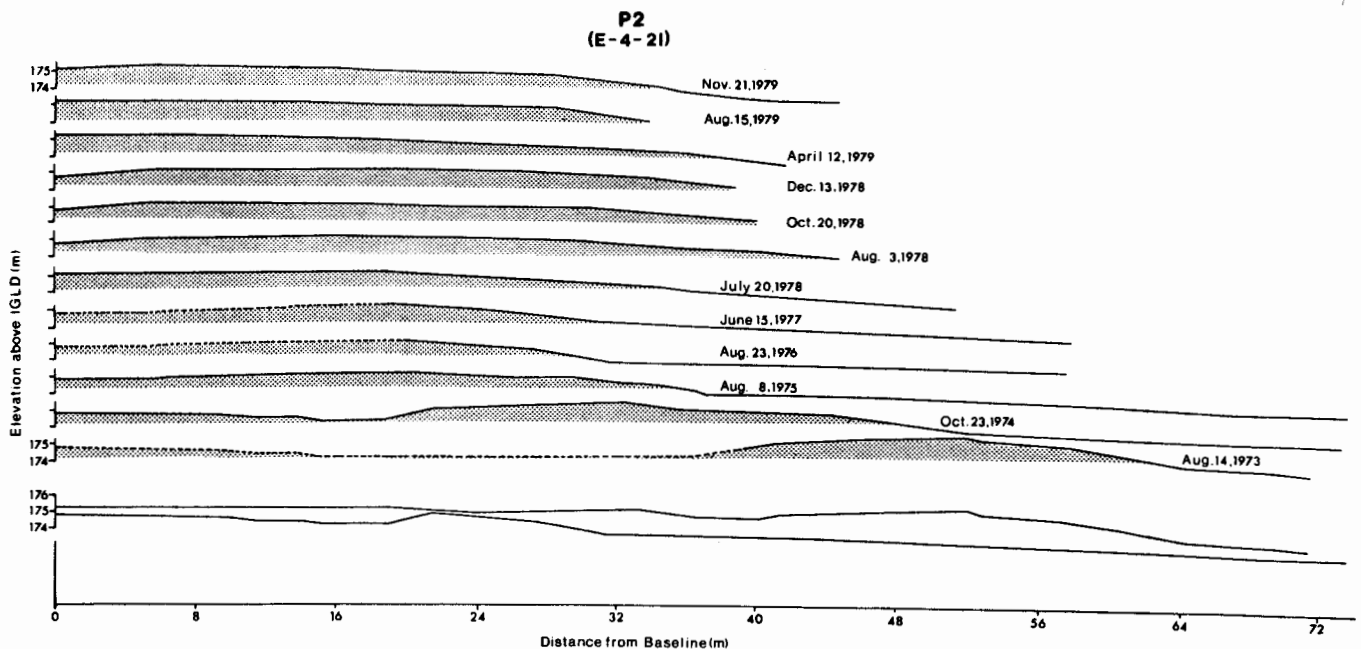
Figure 6. Long-term Observations of Beach Changes

The highest recession rates during the survey period occurred during the early years of the monitoring program beginning in 1973. Both profile plots (Figure 6) and recession figures show continuous retreat of the beach, especially during the high water years of 1973 and 1974 when recession rates averaged about 10 m/yr. Since 1976, the beach at this location has receded about two metres.

Again, volumetric data (Table A.2) show that the actual amount of beach has changed insignificantly at P2. Since 1973, the beach has lost $4.1 \text{ m}^3/\text{m}$. Maximum erosion occurred in June 1977 when losses reached $15.0 \text{ m}^3/\text{m}$ when compared to 1973 conditions. As of November 1979, conditions are comparable to the amount of beach material present in late 1974. This data appears incongruous to the recession data which indicated losses of up to 10 m/year and a recovery which is 32.9 m short of the 1973 shore position (174.25 m).

At this site, however, the beach is a barrier beach fronting a low-lying hinterland, some of which is submerged. Erosion, therefore, has occurred as a landward migration of the beach whereby much of the eroded material is displaced as overwash inland. Profiles in Figure 6 illustrate this process. The actual amount of beach material above elevation 174.25 m, therefore, may have changed in position but not in volume. Because most of the beach at the groynes is backed by a low-lying hinterland, the authors assume it will continue to migrate inland as there is no obstruction to movement in that direction. At P2, the hinterland has been filled by overwashed sands so migration or recession may actually slow down relative to other reaches where infilling continues.

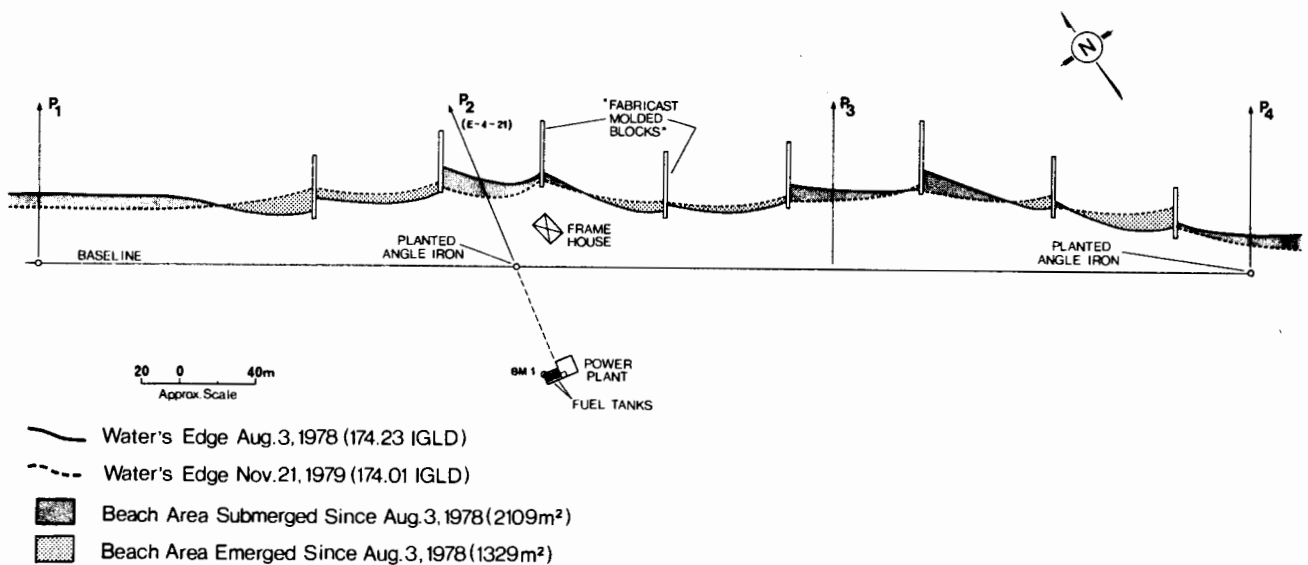
Figure 7. Changes in Beach Area From August 1978 to November 1979

During this period, Lake Erie water level dropped 22 cm, which would normally yield more dry beach area. At all four profiles, however, the area of exposed beach was reduced, which is consistent with the recession data using a common fixed water level of 174.25 m. In total, 2100 m² of dry beach area has been lost since groyne installation. This has been partially compensated for with a build-up of about 1300 m² of new beach material at other locations in the system. This results in a net loss of 800 m² of beach area.

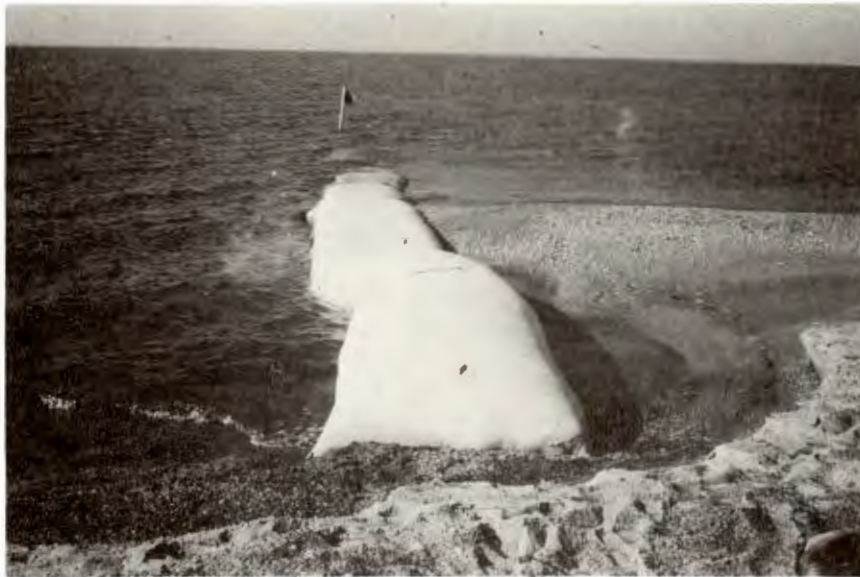
Plate 1. FABRICAST MOLDED BLOCK GROUYNE AS IT APPEARED FIFTEEN DAYS AFTER CONSTRUCTION (PHOTOGRAPHED AUGUST 3, 1978)

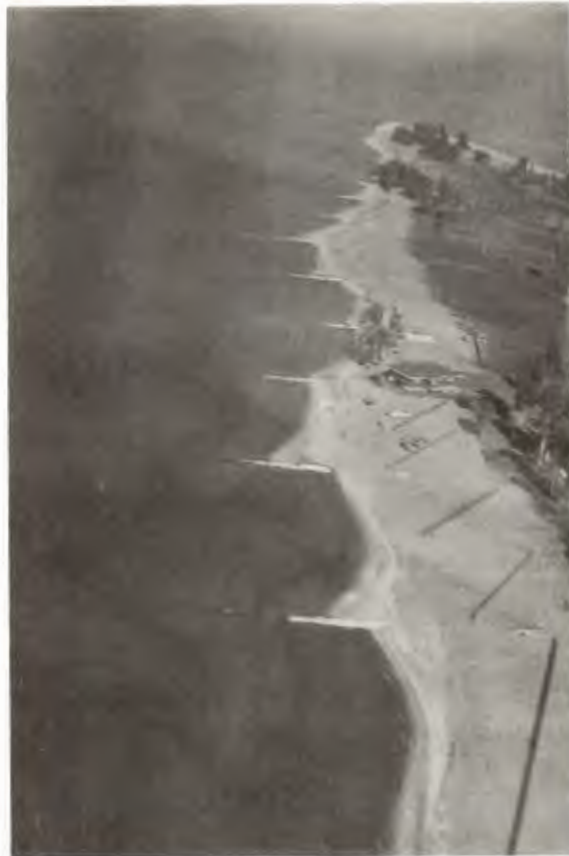
Plate 2. AERIAL PHOTOGRAPH OF GROUYNE SYSTEM SHOWING DRIFT ACCUMULATION ON EAST SIDES OF GROYNES AND SECTIONS OF SNOW FENCING (PHOTOGRAPHED AUGUST 3, 1978)

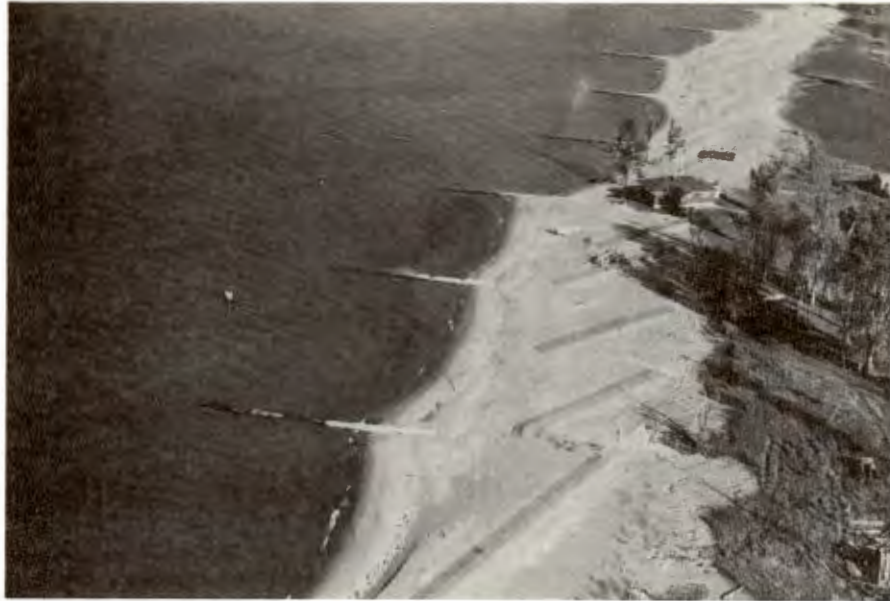
Plate 3. AERIAL PHOTOGRAPH SHOWS DRIFT ACCUMULATION ON WEST SIDE OF GROYNES, INDICATING A REVERSAL IN LITTORAL CURRENT. (PHOTOGRAPHED OCTOBER 20, 1978)

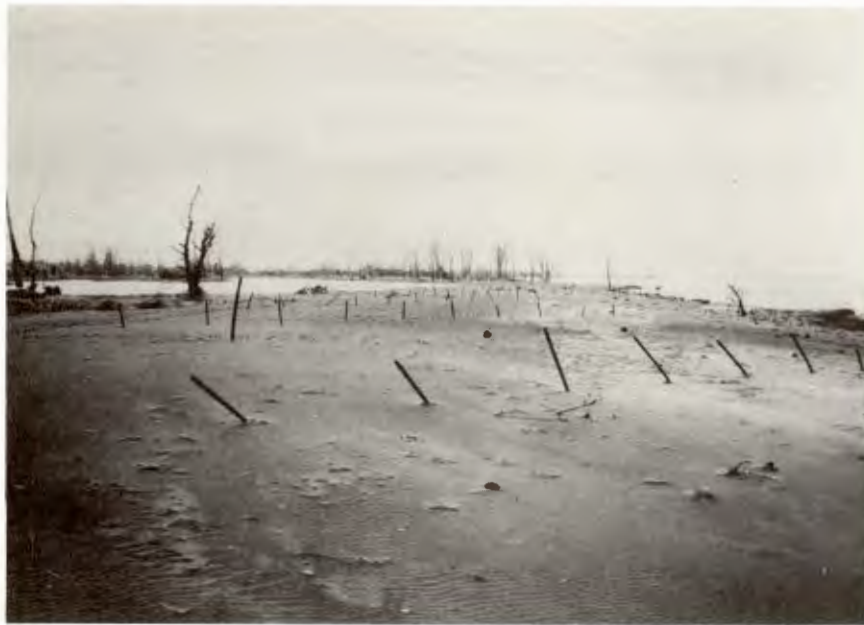
- April 9, 1979 - Long Point lightkeeper reported that a storm of April 6, 1979, caused structural damage to residence - part of concrete block foundation collapsed under wave attack. Also, snow fencing was completely wiped out.

Plate 4. PHOTOGRAPH SHOWS IMPACT OF SPRING STORM IN APRIL 1979. HIGH WINDS AND WAVES COMPLETELY REMOVED SNOW FENCING FROM STEEL SUPPORT RODS. (PHOTOGRAPHED APRIL 12, 1979)
