BABINE RIVER - SLIDE HAZARD ASSESSMENT

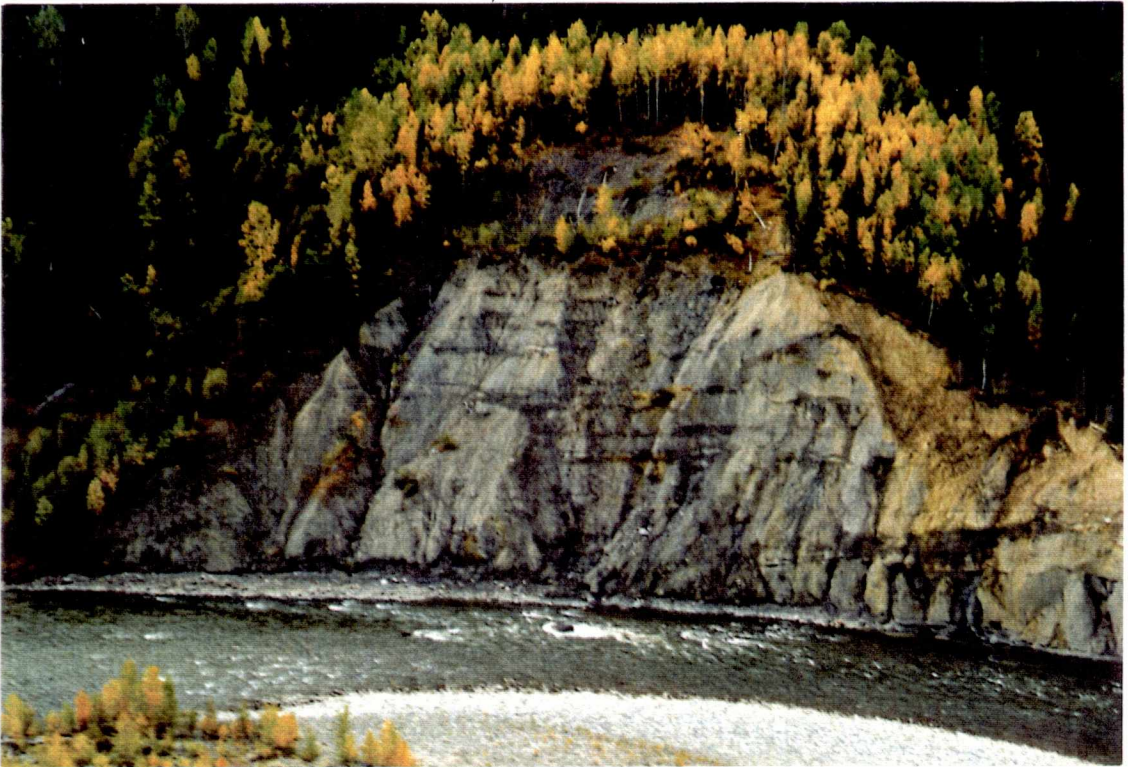
The first 50 km of the Babine River below the Fence flows in a valley that has far less evidence of slope instability than further downstream, as a result of the flatter slopes and less active river erosion. Some soil slopes (Photos 1 and 2) are actively sliding but the river appears to be able to keep pace with the rate of sediment inflow. Even large slides from these soil slopes would not result in prolonged blockages or steep gradients due to the erodible nature of the material, although sediment supply could increase sharply. The rock slopes along this reach generally are not high and there were no apparent rock instabilities of sufficient volume to block the River.

PHOTO 1: Undercutting and slumping of glacial deposits. Slumped material is readily removed by the River.

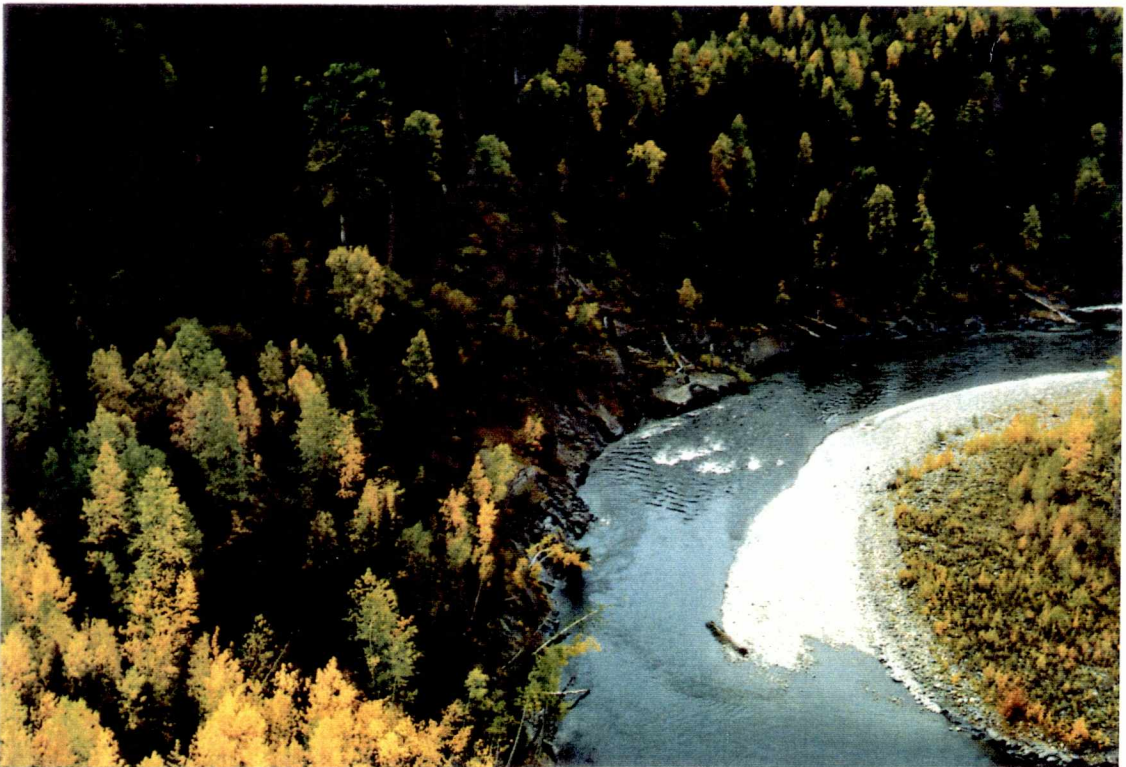
PHOTO 2: Sliding in silty sediments. Recent slide debris protrudes slightly into the River.

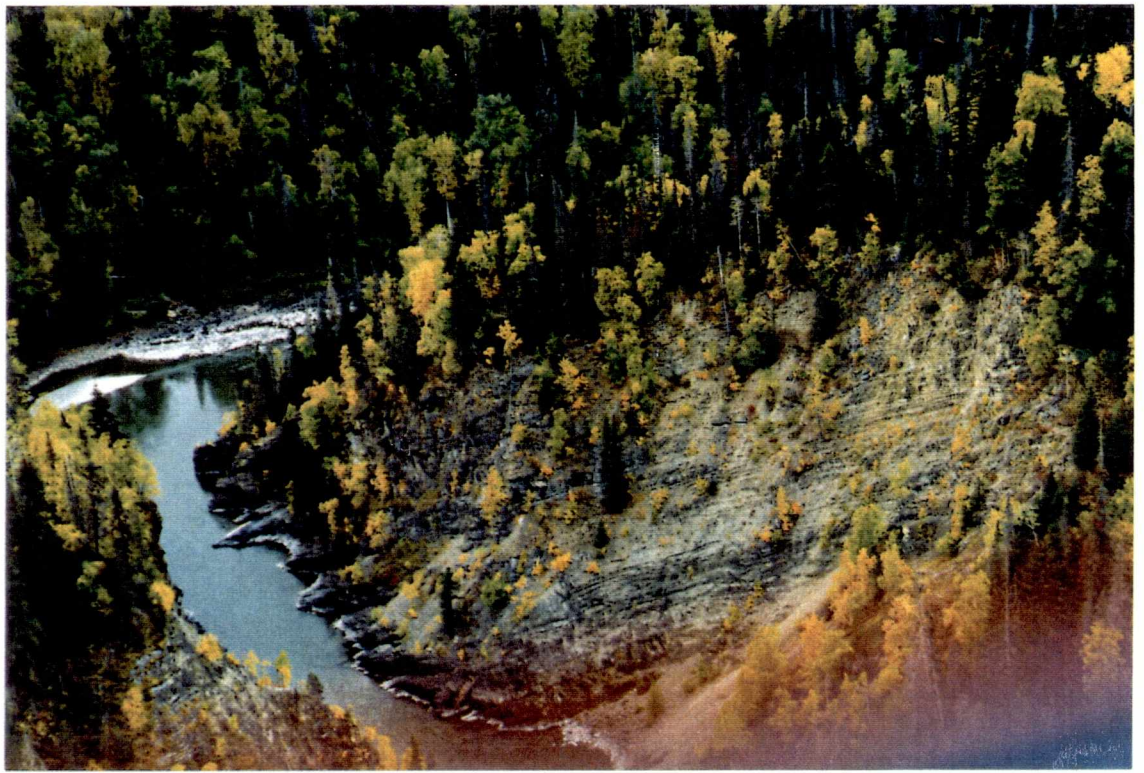
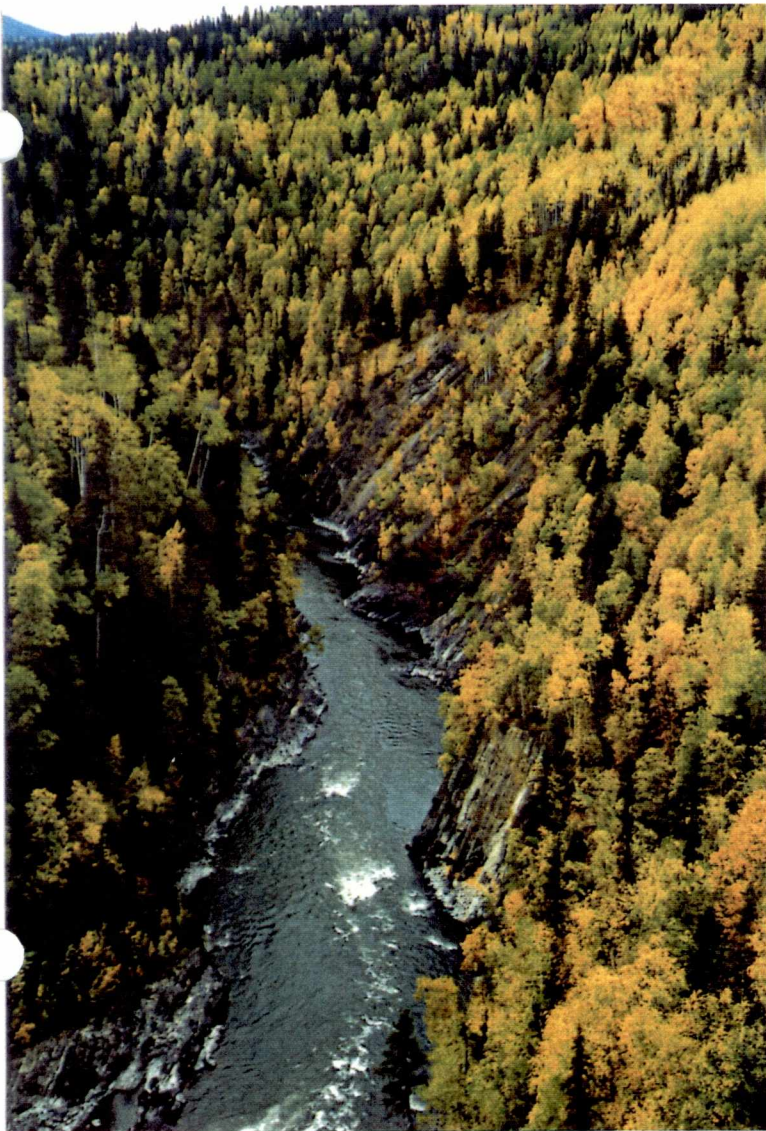
Where the River follows the strike of the bedding and it is tilted greater than about 30 degrees, the topographic profile is asymmetric with one side of the canyon formed along bedding surfaces (dipslopes) and the opposite side formed along steep fracture surfaces (Photos 3 and 4). The Dipslope area discussed below is the best example of this situation. As the River erodes the toes of the dipslopes, successive layers of rock slide down the bedding surfaces. The nature of these slides depends on the steepness of the bedding, the stratigraphy, the geologic structure (faults etc.) and the rate and location of the river erosion. The canyon walls that are opposite from the dipslopes are often very steep. They appear to erode as a series of small rockfalls isolated by steep joints. Larger slides appear to have occurred where throughgoing joints or faults have been undercut.

the River (Photo 3). However, a few wedge-shaped hollows indicate larger slides also could have occurred (Photo 5). It is not known if these occurred as large, single-events which could block the river or as a series of small rockfalls.

PHOTOS 3 AND 4: Typical bedrock canyon. Steep ravelling slopes in the upper photo occur where the river cuts across the strike of the bedding. In the lower photo, resistant beds protrude into the river and form rapids.

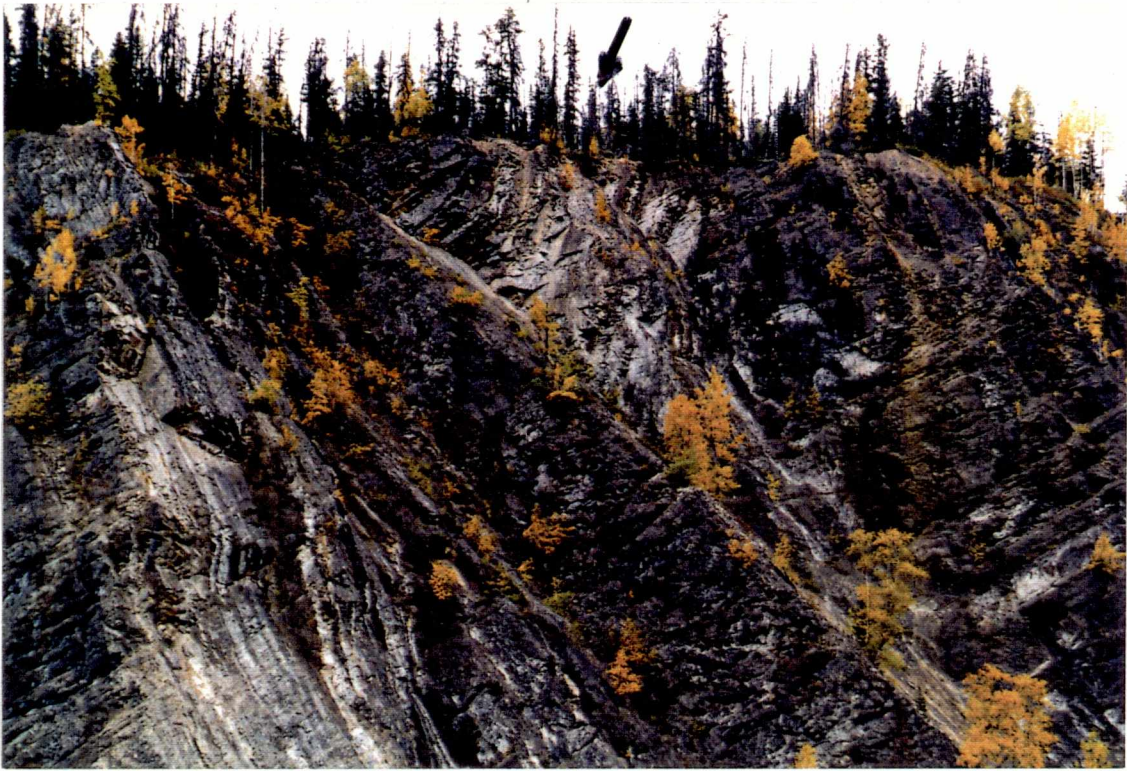
Nevertheless, the adjacent high, steep slopes provide opportunity for single event slides of similar magnitude. For example, a wedge of rock directly across from the 1951 slide which has a volume in the order of 50,000 cubic metres appears capable of sliding as a single event (Photo 5). This particular wedge would likely break up as it fell resulting in an erodible deposit but similar wedges lower on the slope or formed from more massive rocks could cause serious obstructions.

PHOTO 5: A potential wedge failure opposite from the 1951 Slide. Scars of previous failures are apparent adjacent to the wedge.

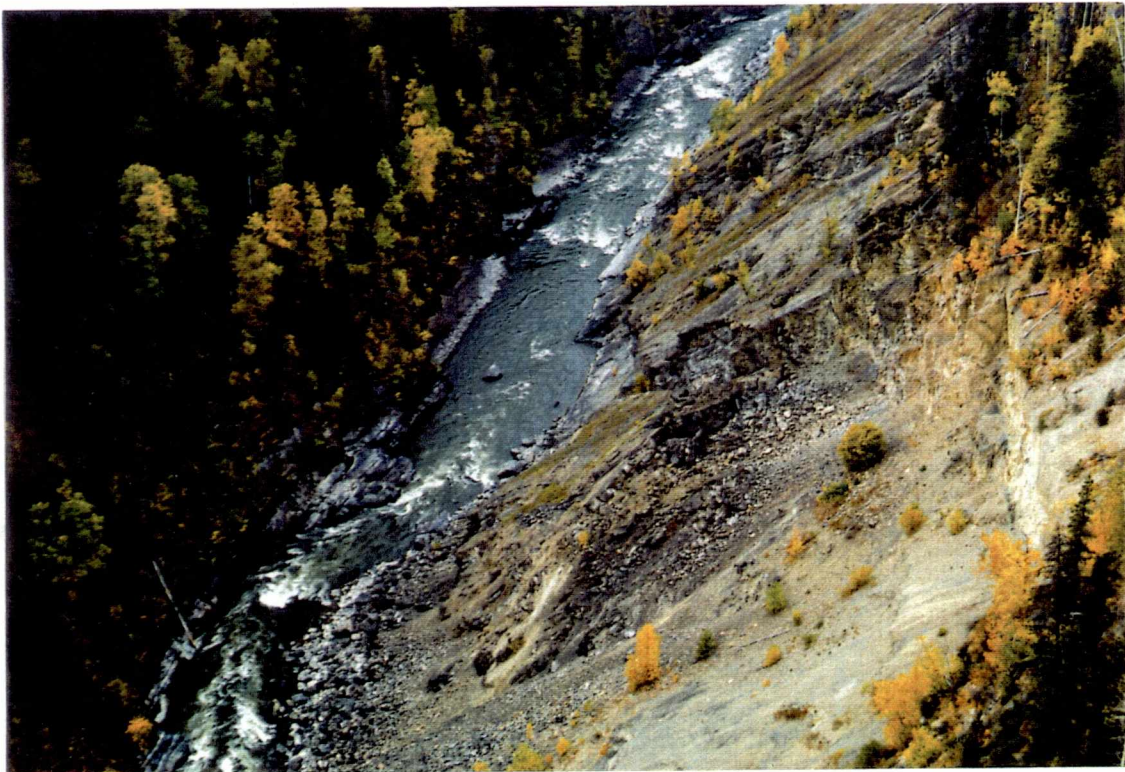
The active slide described by Dr. White in 1964 and shown on the 1990 photos (Photos 6 and 7) is the most active slide along a 1 km section of the canyon about 1 km upstream from the 1951 Slide. At this location, the River flows parallel to the strike of bedding in the sedimentary rocks. The bedding dips 40-45 degrees southwest resulting in a dipslope on the right bank and a steep cliff on the left bank (Photo 7).

According to Dr. White, the active slide was about 8 m thick, 90 m long and 75 m along the river, corresponding to a volume of 54,000 cubic metres. Some of this material (6000 cubic metres+-)

has since been eroded away by the river. The crack at the top of the slide described as being about 5 m wide by Dr. White, now appears to be about 15 m wide, indicating about 10 m of downslope movement in the intervening 29 years.

PHOTO 6: The active slide along the Dipslope area. Crack at top of slide was described as 15 feet wide in 1964.

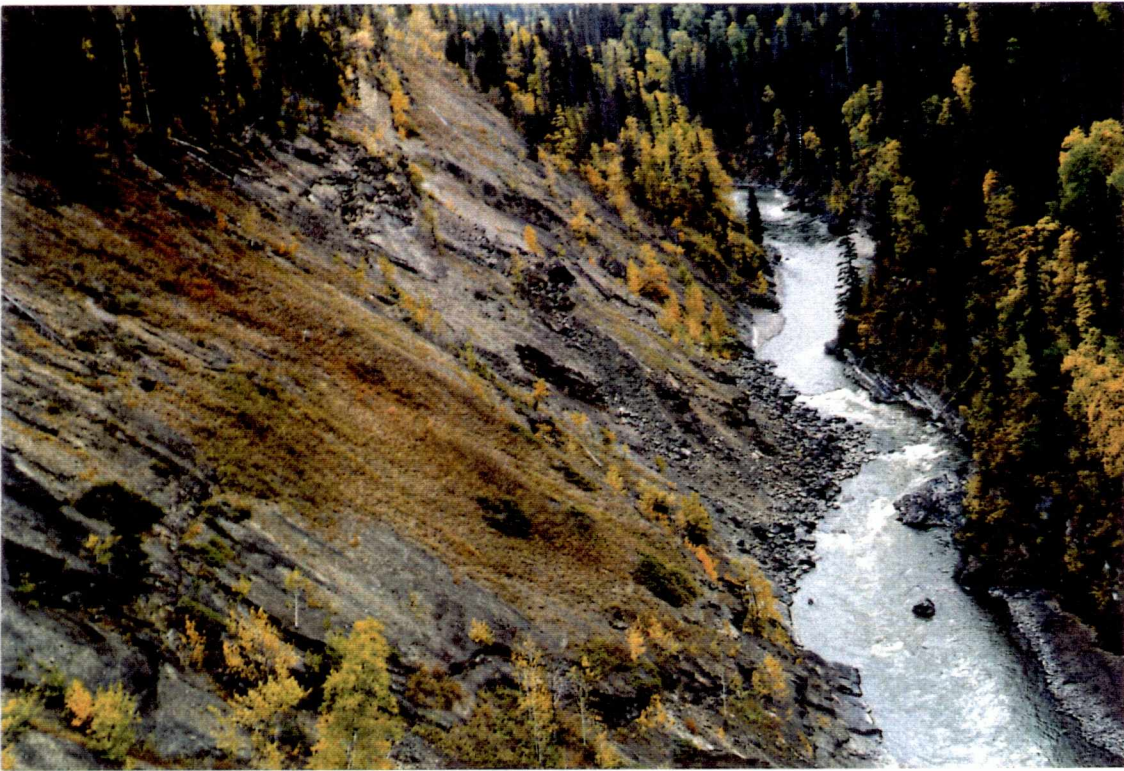
Of more concern are the undercut slopes which have not yet slid significantly. Remnant scarps and slip surfaces along this section of the river clearly indicate a long history of sliding similar to that which is presently occurring. The two scarps shown on Photo 7 indicate previous slides of similar thickness but about twice the area of the current slide. Both slip surfaces appear to have been on a dark shale layer. It appears that the river undercuts the slope until a weak layer is daylighted and sliding follows. Large, single event slides would tend to occur where the spacing between weak layers is large.

PHOTO 7: The Dipslope area with active slide and river constriction in centre of photo. Scars of previous slides further upstream.

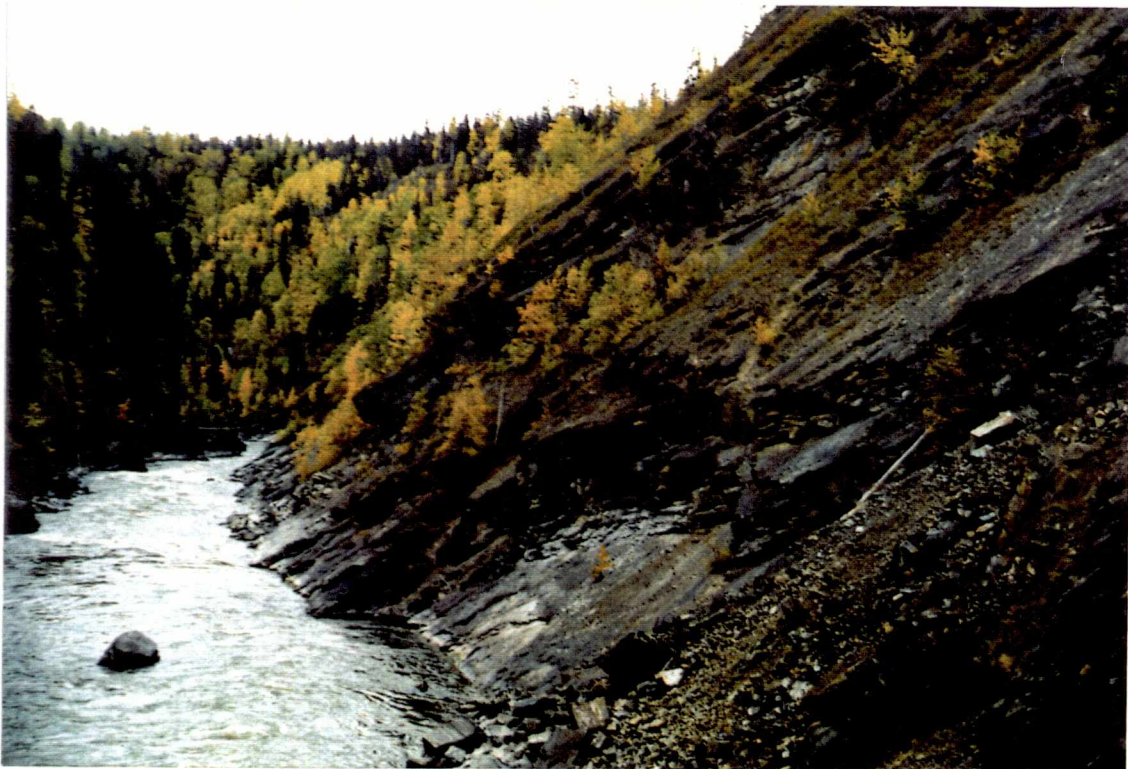
Presently, the greatest apparent slide hazard exists just downstream from the existing slide (Photo 8). At this location the river has already undercut the bedding 5 or 10 metres and rock is actively sliding from the toe (Photo 9). Whether this slide develops as a series of small rockfalls which can be removed by the river or as a single large slide that creates an obstruction remains to be seen.

PHOTO 8: Undercut slopes just downstream from the active slide and scarps from earlier slides.

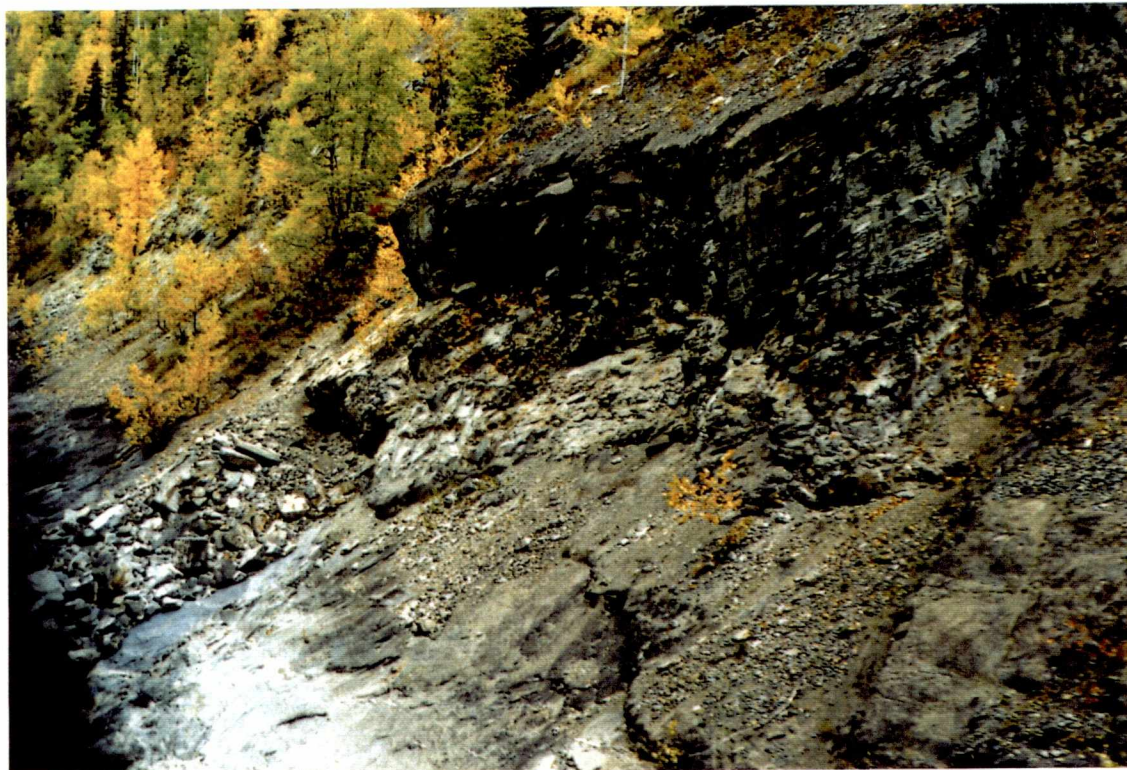
PHOTO 9: Small slides from the toe of the slope seen in Photo 8. Scarp is 5-10 m high.

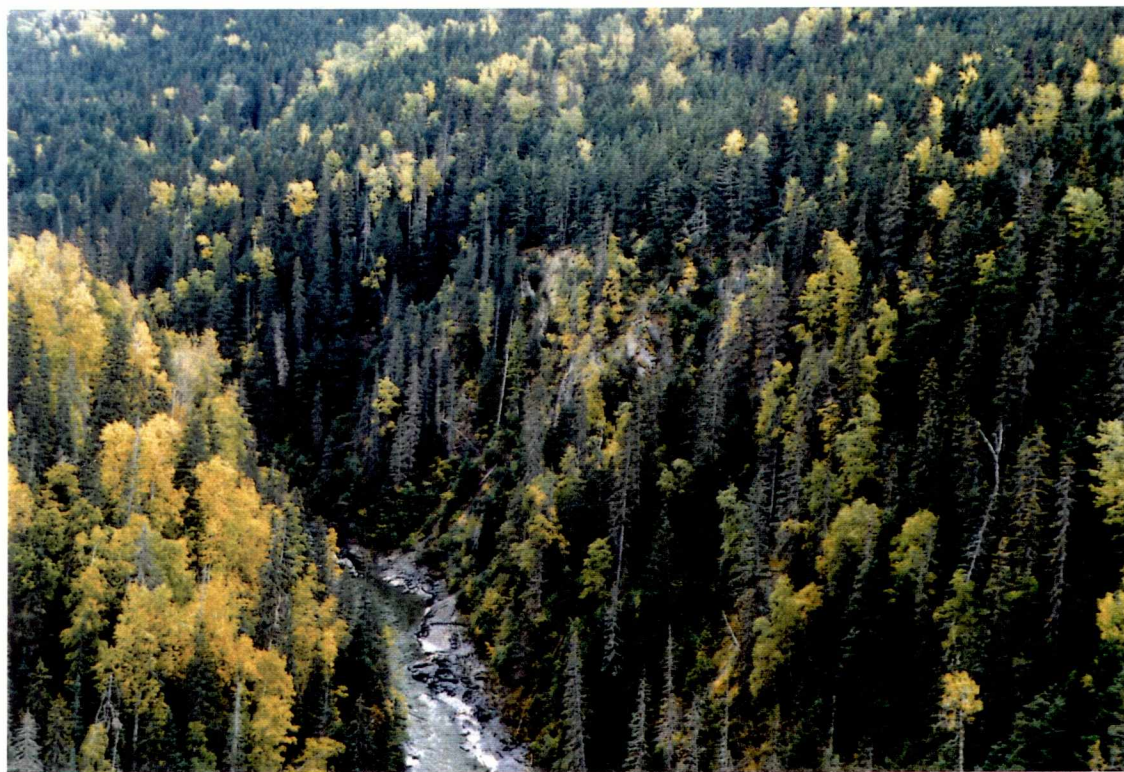
Rock slides are a serious potential problem. At this level of investigation few if any of the high, steep, rock slopes can be considered completely free of the possibility of sliding. Minor recent activity could indicate more deep-seated problems and should be viewed with caution (Photo 10). Nevertheless, it is readily apparent from the current activity that most of the risk lies within the 3 km stretch from the 1951 Slide upstream, as previously identified by Fisheries personnel. Within this section of the canyon it is almost certain that additional rock slides will take place sometime during the next few decades. The risk of these slides seriously obstructing the river is more difficult to predict. Geological mapping would help to determine the likely modes of failure and risk of blockage.

PHOTO 10: A recent small rock and soil slide just upstream from Kisgegas could indicate larger instabilities.
