MANUSCRIPT REPORT

No. 73-1

RECOMMENDATIONS CONCERNING THE RETENTION
OR REMOVAL OF WATER CONTROL STRUCTURES
ON THE WEST RIVER, SHEET HARBOUR, NOVA SCOTIA.

January, 1973

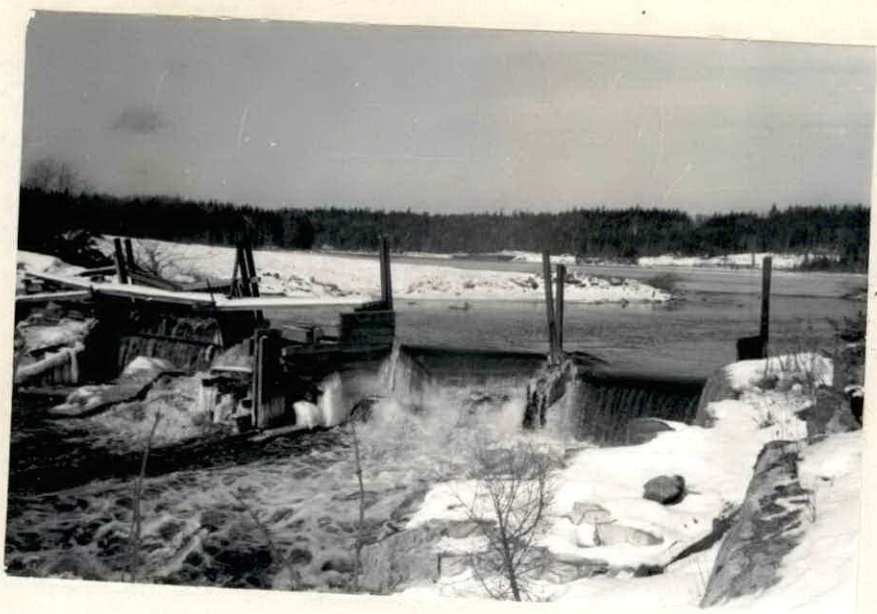
The dam is in very poor condition as a result of damage during Hurricane Beth. It is considered to be beyond repair and will probably deteriorate further in the near future.

1 - Slasher Dam (1) partially
breached

The removal of Slasher Dam (1) is recommended. Most of the flow would then pass through that channel (except at very high water) which has a more gradual slope. This work would facilitate Atlantic salmon passage into the Sheet Harbour Lakes. Gaspereau would also gain access to the lakes.

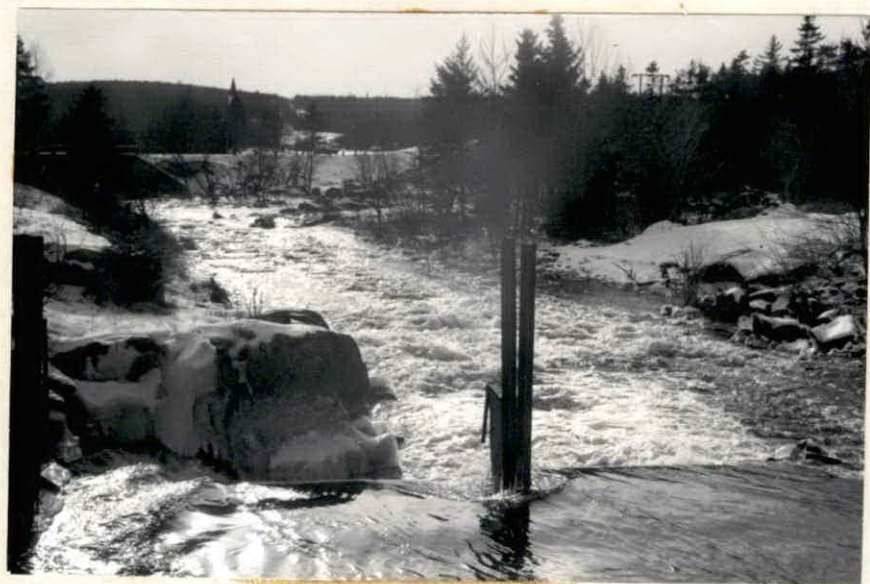
At present, the dam is a barrier to fish passage, however, fish passage is provided for in the Lower or Mill Dam (2) which is located to the west of the island at this location. If the Slasher Dam (1) is to be reconstructed, fish passage would continue at the Lower or Mill Dam (2). If the Slasher Dam (1) were to be removed, most of the river flow would be through the channel on this side of the island. The stream bed elevation on this side of the island is several feet lower than the concrete sill elevation of the Lower or Mill Dam (2). Contours of the river bottom above the Slasher Dam (1) are required to determine if a barrier for fish passage would be created by removing the dam. The probability of creating a barrier by removal of this dam is not too likely, however, the possibility does exist.

2 - Slasher Dam (1) looking
downstream

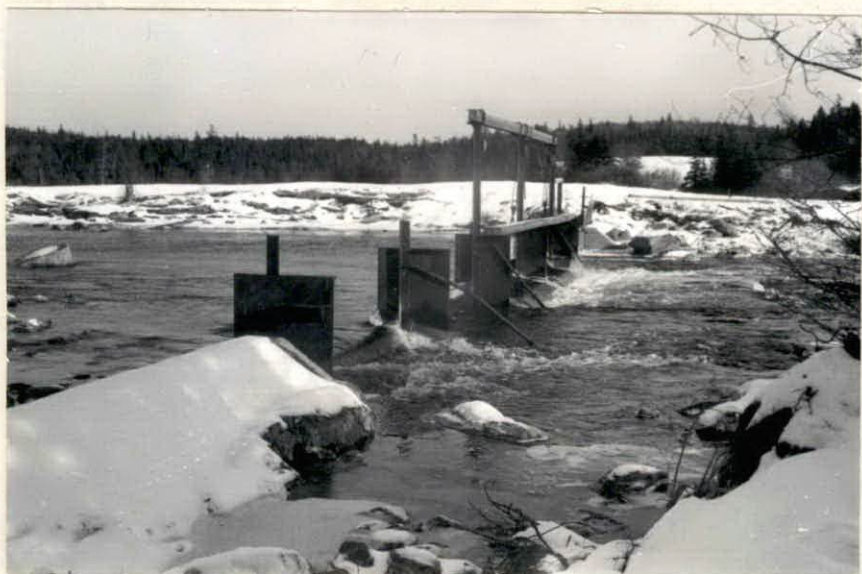
3 - Lower or Mill Dam

The dam was reconstructed in 1971 for about \$4,000 to replace a 40-year-old dam that was in bad condition. It is constructed of steel uprights and supports embedded or bolted to a concrete base to hold timber stoplogs. Two stoplog-controlled openings in the center of the structure control the water level to a maximum of four feet. The dam has a length of about 170 feet and a maximum height of 5 feet. Access to the center section for removal or installation of stoplogs would be difficult, in particular, during high flows. The dam is generally in very good condition.

Adequate fish passage is provided by a 5 foot wide clear opening that extends to stream bed level.

At the time of visit, this dam was holding very little water. The removal of the stoplogs and the stoplog retainers (steel I beams) is recommended as the steel retainers could lead to serious debris accumulation during flood periods.

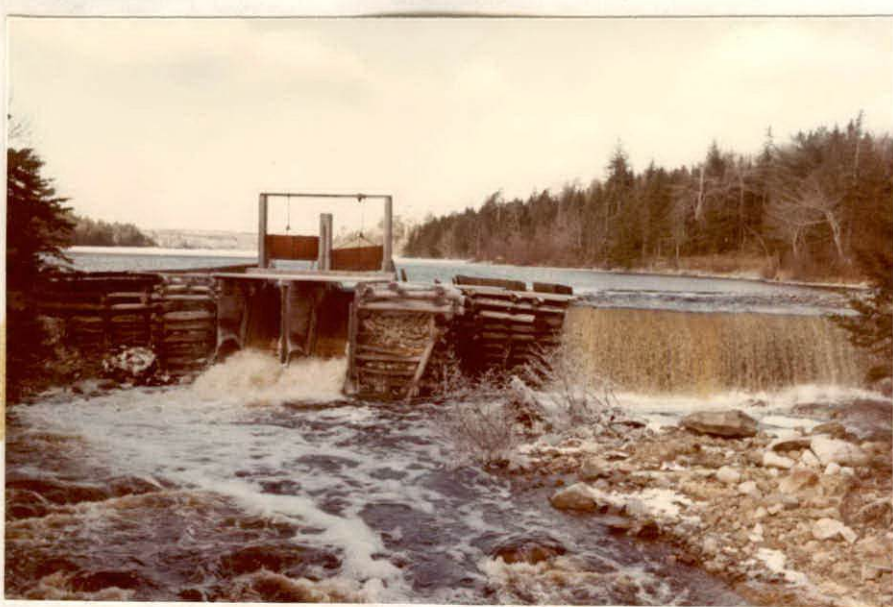
4 - Main River Dam (3)

The structure is in fairly good condition. Some of the flash boards are missing, however, and it appears that a section of the dam has settled. The life of this structure could perhaps be extended by carrying out repairs of moderate cost. This timber dam is, however, approximately 20 years old and its life cannot be extended forever. Extensive repairs or complete reconstruction would probably be required within 10 years. Problems in manipulating the steel plate stoplogs would be encountered during high flows with the existing structure.

The dam is a complete barrier for fish passage. An estimated cost of providing fish passage facilities for this site would be roughly \$30,000.

This dam should be removed, as it prevents salmon access to at least 4 miles of good rearing and spawning areas. This represents a 24% increase to existing rearing areas.

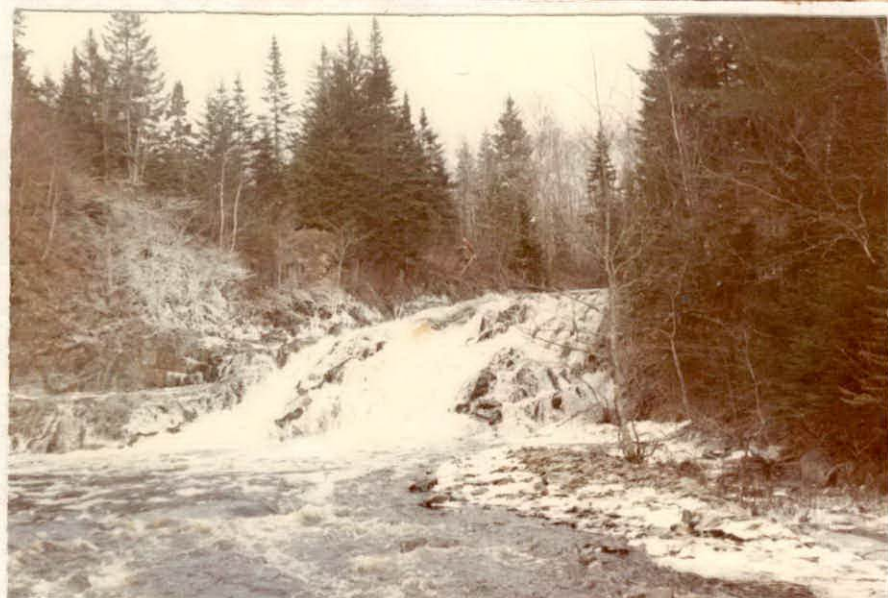
The width of the river at this location is approximately 50 feet. Through the rapids most of the flow is concentrated through a 4-foot-wide gorge. The rapids extend for an overall horizontal distance of approximately 125 feet with a 20-foot drop in the water surface elevation. The greatest drop takes place at the lower portion of the rapids where the water surface drops 11 feet in a horizontal distance of 30 feet. Immediately upstream over a distance of 30 feet is another 6-foot difference in the water surface elevation. The upper portion of the rapids are fairly gentle with a 3-foot drop in approximately 65 feet.

These falls are a natural barrier for fish passage. Due to the nature of the natural configuration of the rock at the site, fish passage cannot be obtained by blasting alone. A conventional-type fishway including extensive blasting would be required to provide fish passage at the barrier. The site is approximately 1/2 mile from the nearest road, which makes it fairly inaccessible for construction. The cost of providing fish passage at this site would be in excess of \$60,000.

5 - Natural falls (31)
impassable to Atlantic
salmon

Approximately 5 miles of stream 10 yards wide are available for salmon production above the falls. This would represent a 15% increase in available salmon rearing area. Because of the low benefit/cost ratio, no recommendation is being made to remove this natural barrier.

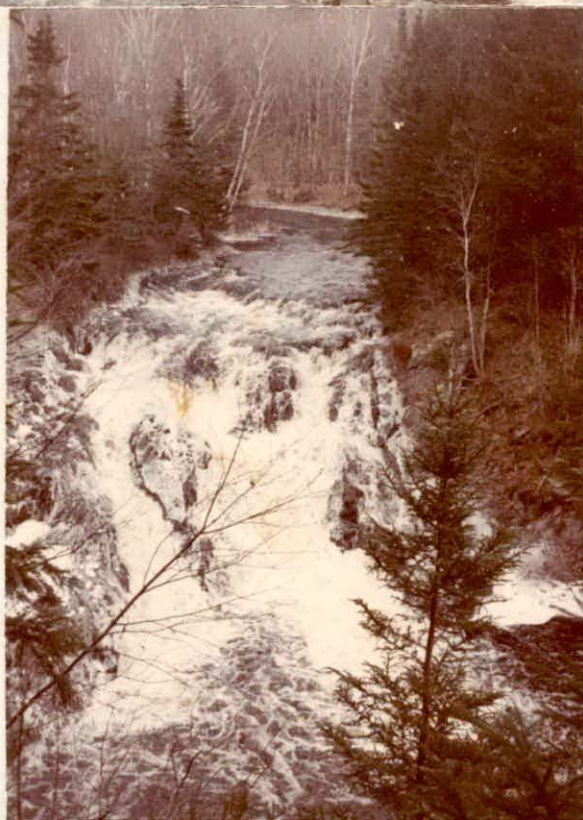
6 - Same as - 5 - View from
the bluff. Note river
section (approx. 50 feet
wide) above.
