REPORT ON THE FISH LADDER AND NATURAL FISHWAYS
AT SKUTZ FALLS, COWICHAN RIVER

August 1937.

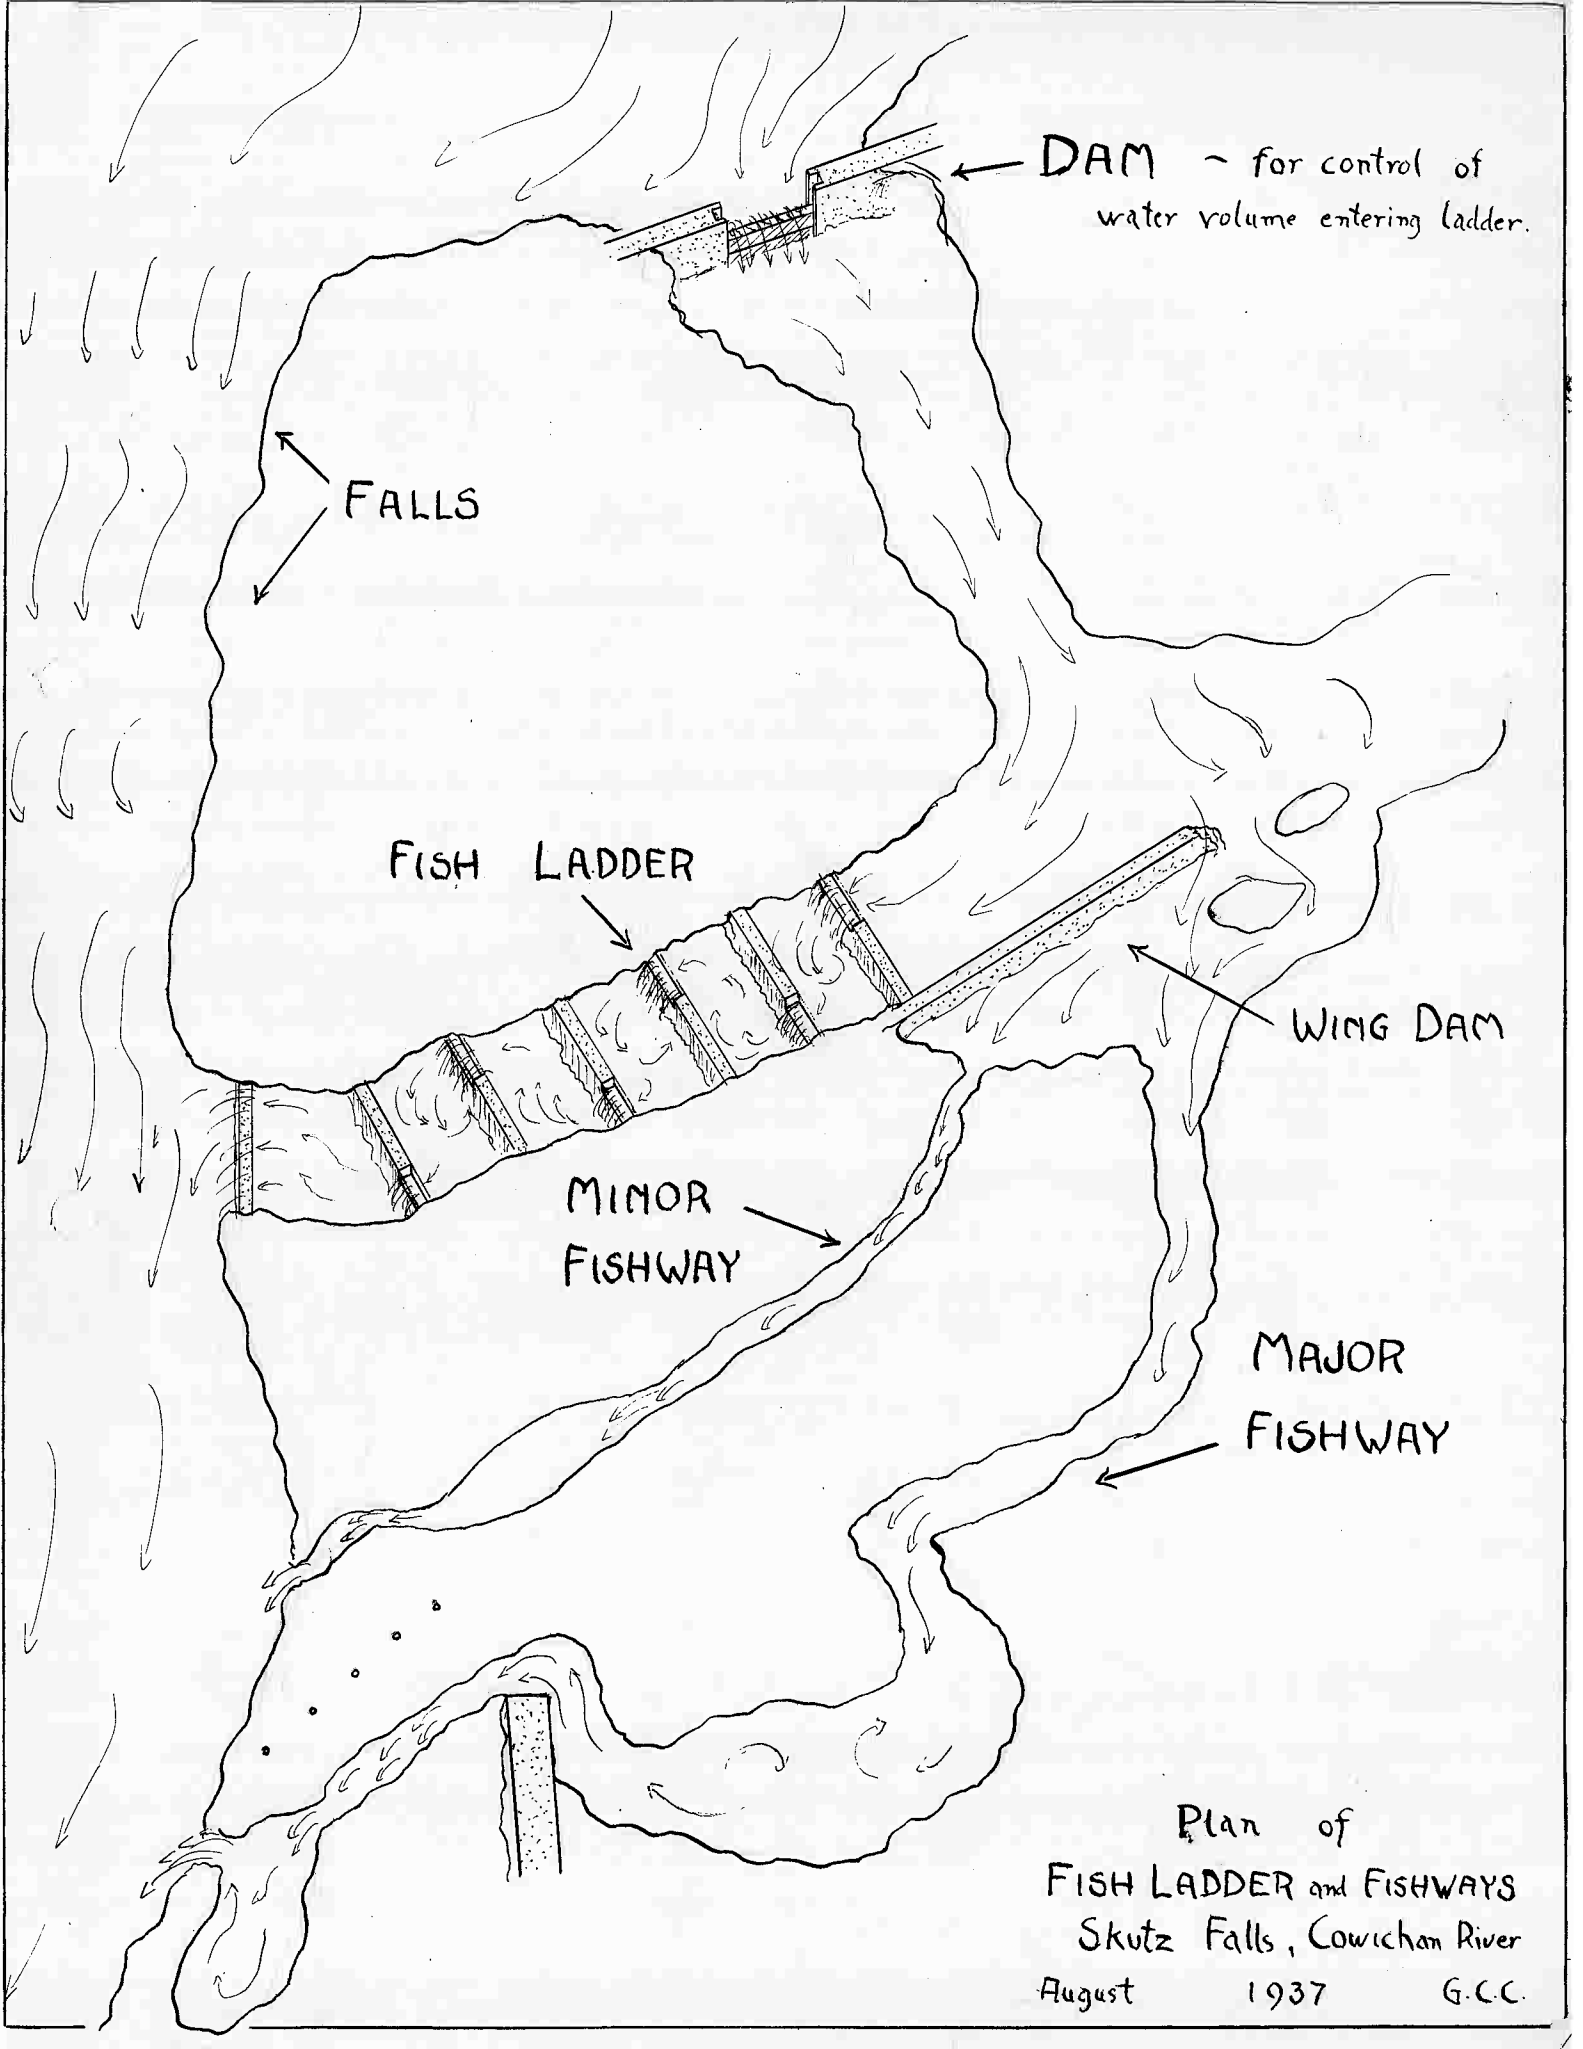
Plan of
FISH LADDER and FISHWAYS
Skutz Falls, Cowichan River
August 1937 G.C.C.

Thus, at the present time, four routes are now open for the ascent of fish :- a) by way of the falls which is passable only at ~~the~~ time of high water (fig. 6), b) by way of the fish ladder which, in its present state, is passable only at time of low water (fig. 7), c) by way of the minor fishway which is passable only during high water, and d) by way of the major fishway which is probably passable at all times. The arrangement of these various passage-ways is shown in the accompanying plan.

Although the fish ladder is in an unfavourable position, its efficiency can be much improved if steps are taken to control the amount of water flowing over it. The following is therefore recommended :-

a) that timbers be provided to fit the slotted gate-way in the dam above the fish ladder.

b) that some person, preferably a Fishery Guardian, be made responsible for the regulation of water flow through the gate-way by the insertion or removal of the timbers.

c) that a timber be inserted in the upper-most step of the ladder to reduce the flow of water over the ladder and at the same time to deflect more water over the adjacent fishways.

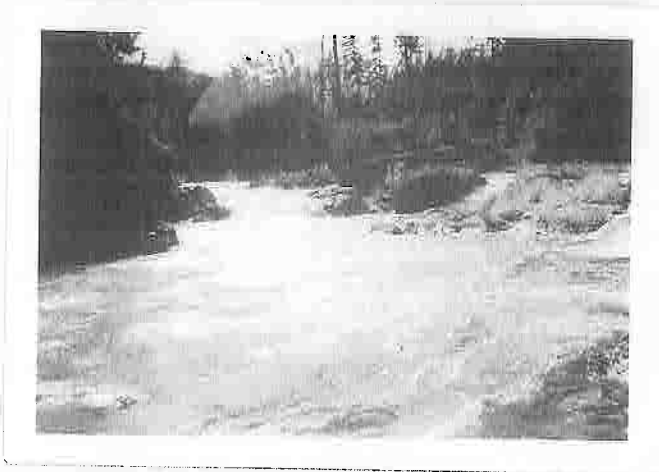
The fish ladder around Skutz Falls, Cowichan river, was constructed in the summer of 1931 but in the opinion of local fishery officers it has never given satisfactory results. The inefficiency of the ladder is mainly due to its location which is such that the water at the entrance of the ladder enters the river at right angles to the swiftest current making it exceedingly difficult for fish to make the first turn. (Figure 1 and plan) Moreover, at all times but extreme low water, the volume of water coming over the ladder is so great that few fish can possibly make the ascent.. As a result, in past seasons it has been observed that large numbers of salmon and other fish have attempted with little success to surmount the falls by struggling up small overflow streams entering the river below the falls and fish ladder, and it was suggested that these natural fishways be improved to allow the easy passage of fish. Accordingly, on July 16/37 arrangements were made with Mr. A. Gordon, Superintendent of the Lake Cowichan Forestry Camp, to make use of the services of a work gang of 5 boys with all necessary tools, during the period of July 19 - 22 inclusive.

Figure 1. Skutz falls and fish ladder at medium water, July 4, 1937.

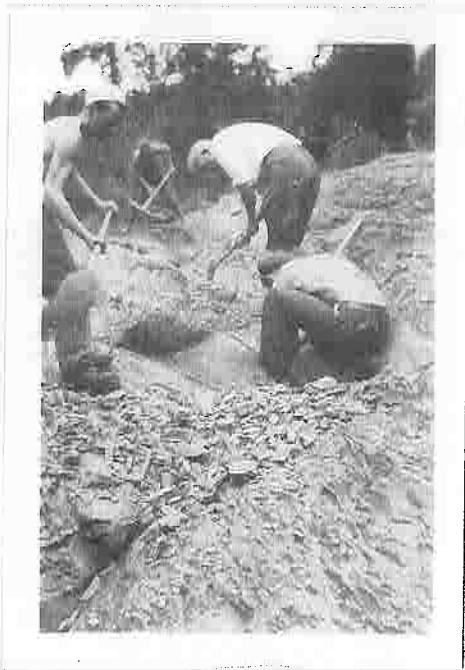
smaller stream was shorter and more precipitous but lacked resting pools and carried water only at flood time. By the use of rock pick-axes and dynamite both passages were cleared and improved, the larger stream, by removal of rock and deepening of the channel to confine the water to one course, the smaller stream by lowering the intake level and providing resting pools at two points along its course. Steps in the construction work are shown in figures 2 and 3 and views of the completed fishways are shown in figures 4 and 5.

Figure 2. Construction work on minor fishway.

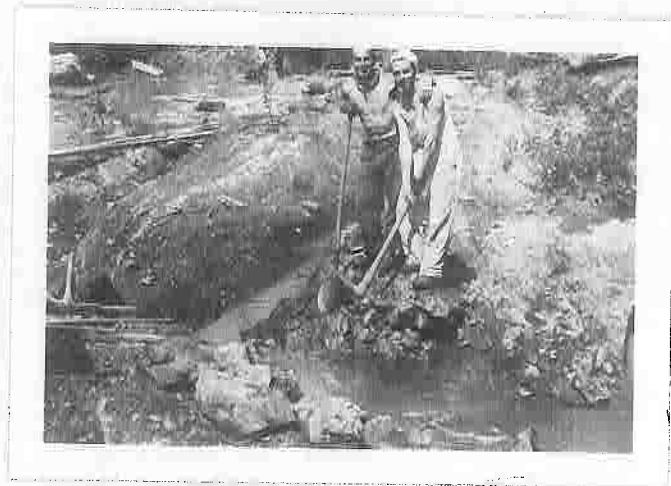
Two natural side streams over the rock were selected for improvement. The larger stream flowed by way of an unobstructed channel through two large rock pools but entered the river in a thin sheet of water which was almost impassable to fish. The

Figure 3. Construction work on major fishway.

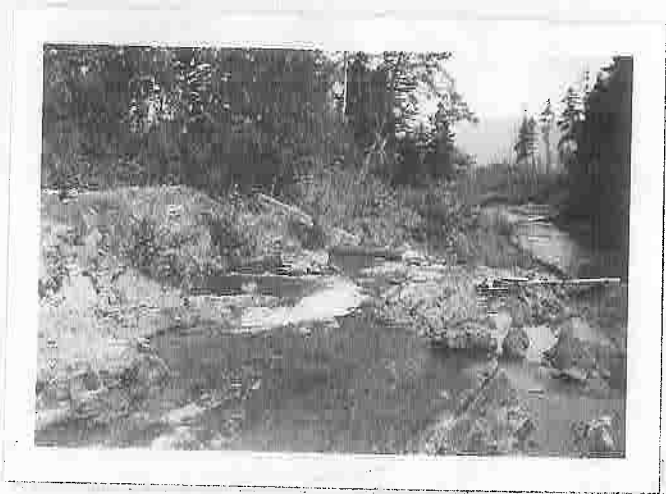
Figure 4. Looking down major fishway .

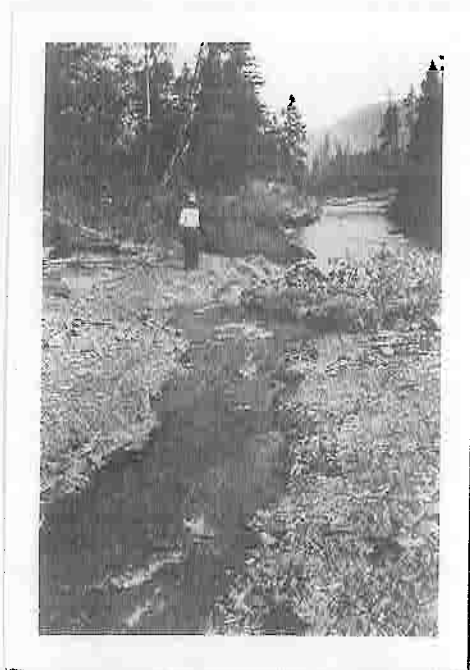
Figure 5. Looking down the minor fishway.

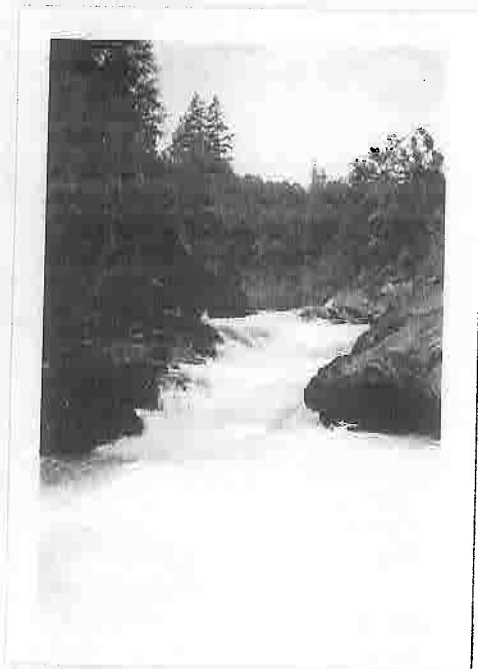
Figure 6. Skutz falls at low water.
July 20, 1937.

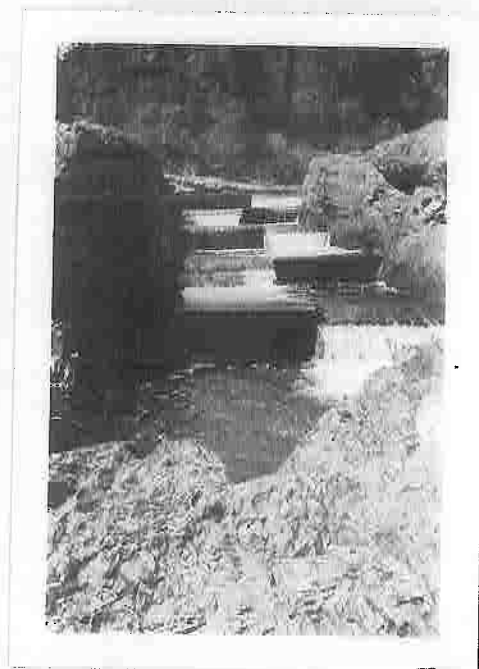
Figure 7. Fish ladder at low water.
July 20, 1937.
