**Fish Habitat and Inventory Project 2000
Prescriptions for Stabilizing Degrading Fish Habitat
Peel Inlet and Rennell Sound Streams
Haida Gwaii**

Submitted to:
**Habitat Restoration and Salmon Enhancement Program
Department of Fisheries and Oceans
Ministry of Environment, Lands and Parks**

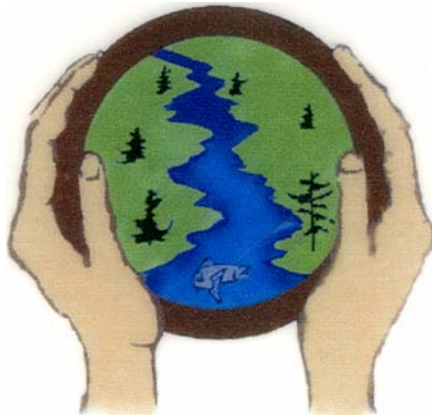
**HECATE STRAIT STREAMKEEPERS SOCIETY
Deborah Pearson, George Farrell, Kevin Koch
Box 1045 Queen Charlotte, BC
V0T 1S0**

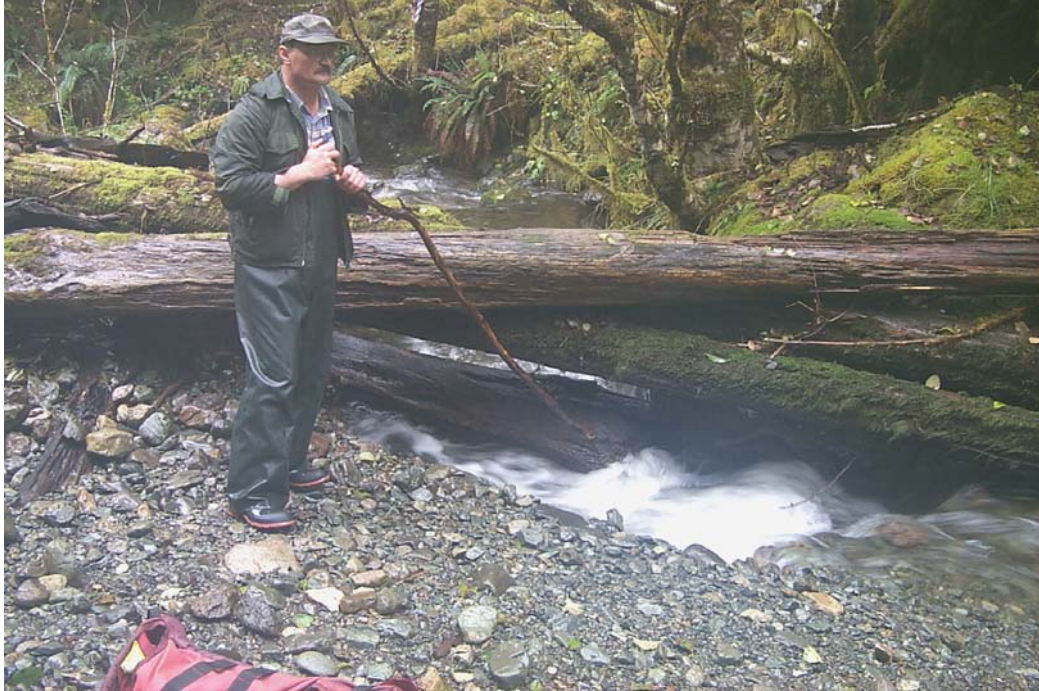
Photo 13: 1+510m – Looking DN at same section as photo 11 close-up. We recommend bucking 2 m of this log. Close inspection showed this is a cut log resulting from past logging in this creek.

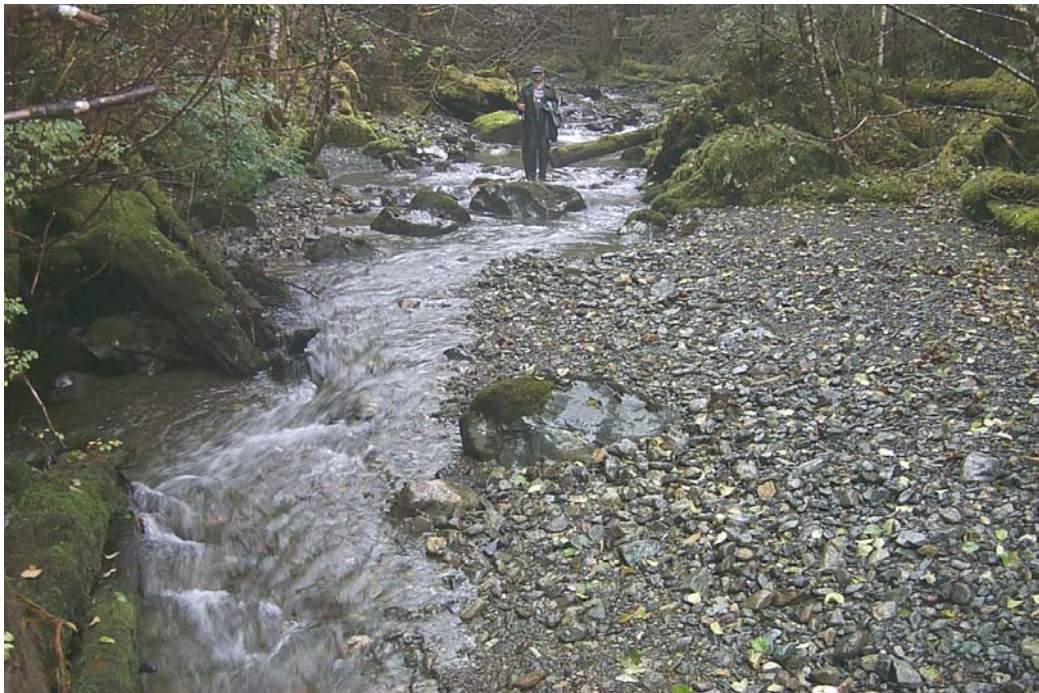
Photo 14: 1+510m – Looking UP from the top end of the logjam. UP from Neil to ~1+600m the substrate is boulder and bedrock dominant, with cobble as subdominant.

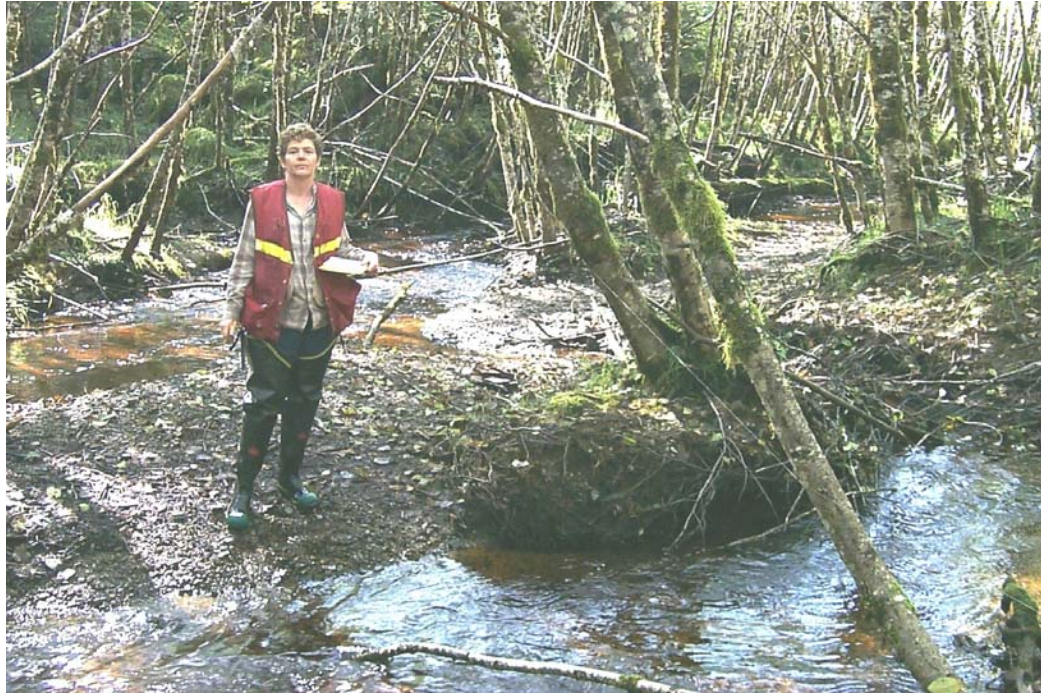
Figure 3: 0+050 m. Looking DN from mid-channel. Braiding has occurred UP from the jam at 0+000 m. Minor manipulation of jam could improve access for salmon through the lower 325 m of this creek. Matters are much worse ~250 m. upstream, where a road awaiting deactivation and beavers cause further habitat degradation. Two adult pinks were observed in the lower section, and no coho fry. We suspect this lower reach dewateres in the summer. We recommend an environmental monitor be on site during the road deactivation and that a further assessment for restoration potential be done after the deactivation is complete.

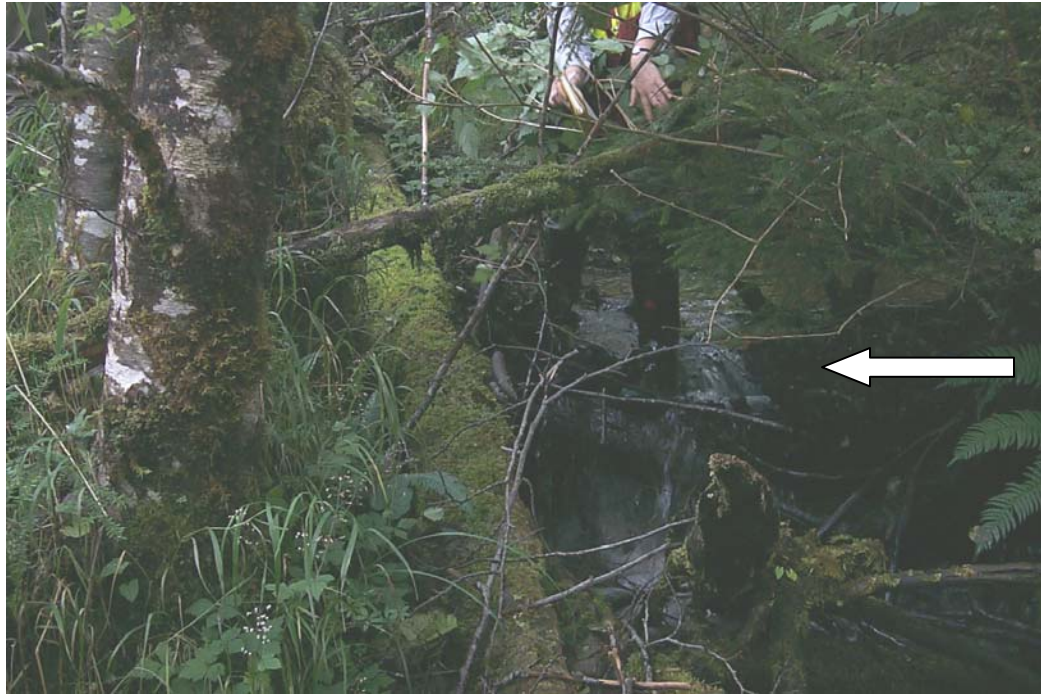
Photo 7: 0+161 m. Looking UP from the RB. Upper limit of observed pink salmon at SWD jam, which appears to be creating a barrier (0.75m high jump at present flow conditions).

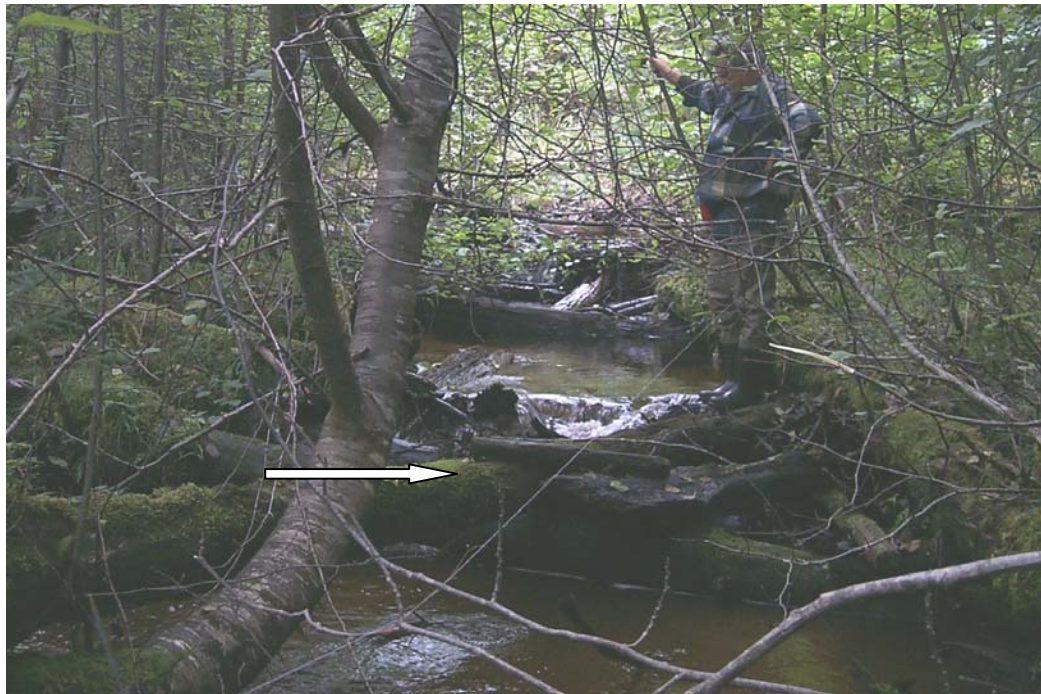
Photo 8: 0+173 m. Looking UP from the RB at LWD jam (arrow). SWD collecting on upstream side of LWD structure. Available LWD could be manipulated for improved cover.
