PROGRESS REPORT NO. 46

PRELIMINARY INVESTIGATIONS OF  
THE HARRY'S RIVER SYSTEM

D.F. DOWNER

May, 1968

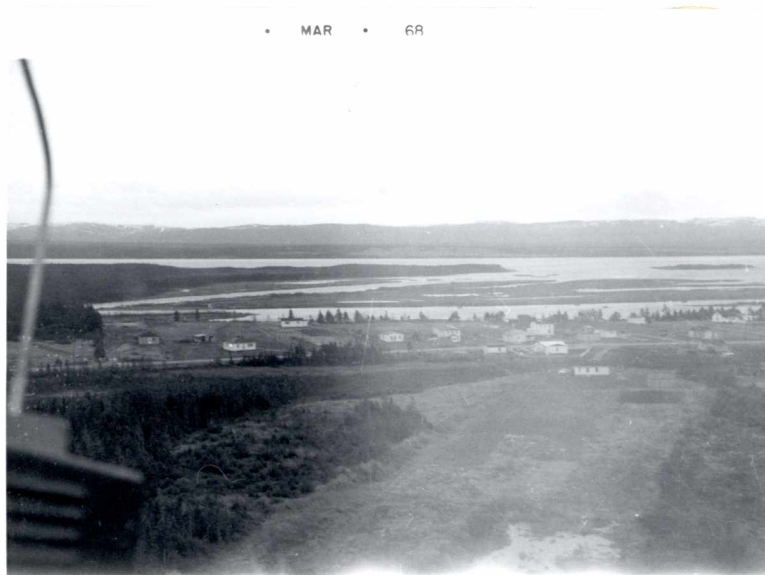
Fig. 3. Estuary of Harry's River.

The estuary of Harry's River extends approximately  $1\frac{1}{2}$  miles from the upstream side of the first island to the southern end of the town of Stephenville Crossing (Fig. 3). It widens from 600 ft. at its inner end

to one mile at its outer extremity. Total area of the estuary is 0.76 square miles. It can be described as a long, shallow delta with depths of 2 - 6 ft. throughout most of its area. Travel in the estuary is difficult except by shallow draft watercraft. Bottom texture consists of mud and sand with a few scattered boulders.

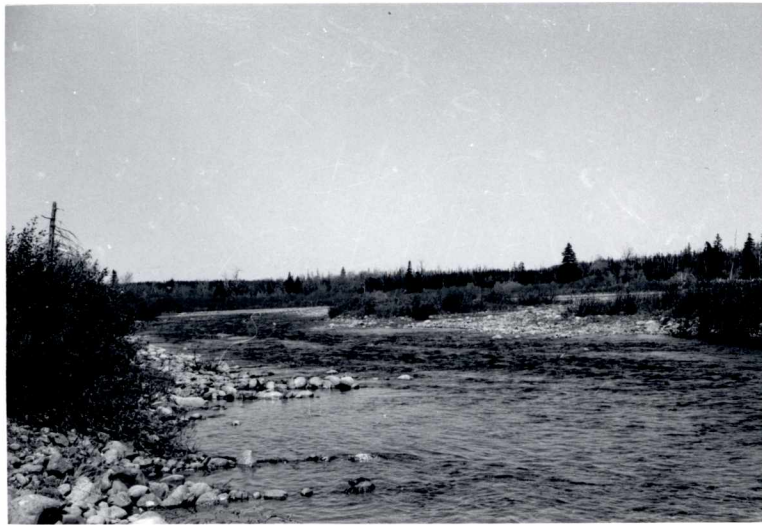
Fig. 4. Typical bottom structure - Main River.

Between Brownmoore Brook and Georges Lake, width range is 60 - 450 ft. The stream drops from elevation 487 ft. to the estuary in a uniform manner so that a few small rapids but no major falls or rapids are present (Fig. 5). Long, straight stretches with a uniform gradient constitute more than 70% of the river in wider parts; mild riffle areas are found in narrower sections where bottom structure consists of large cobbles and boulders. Few steep banks are found along the river.

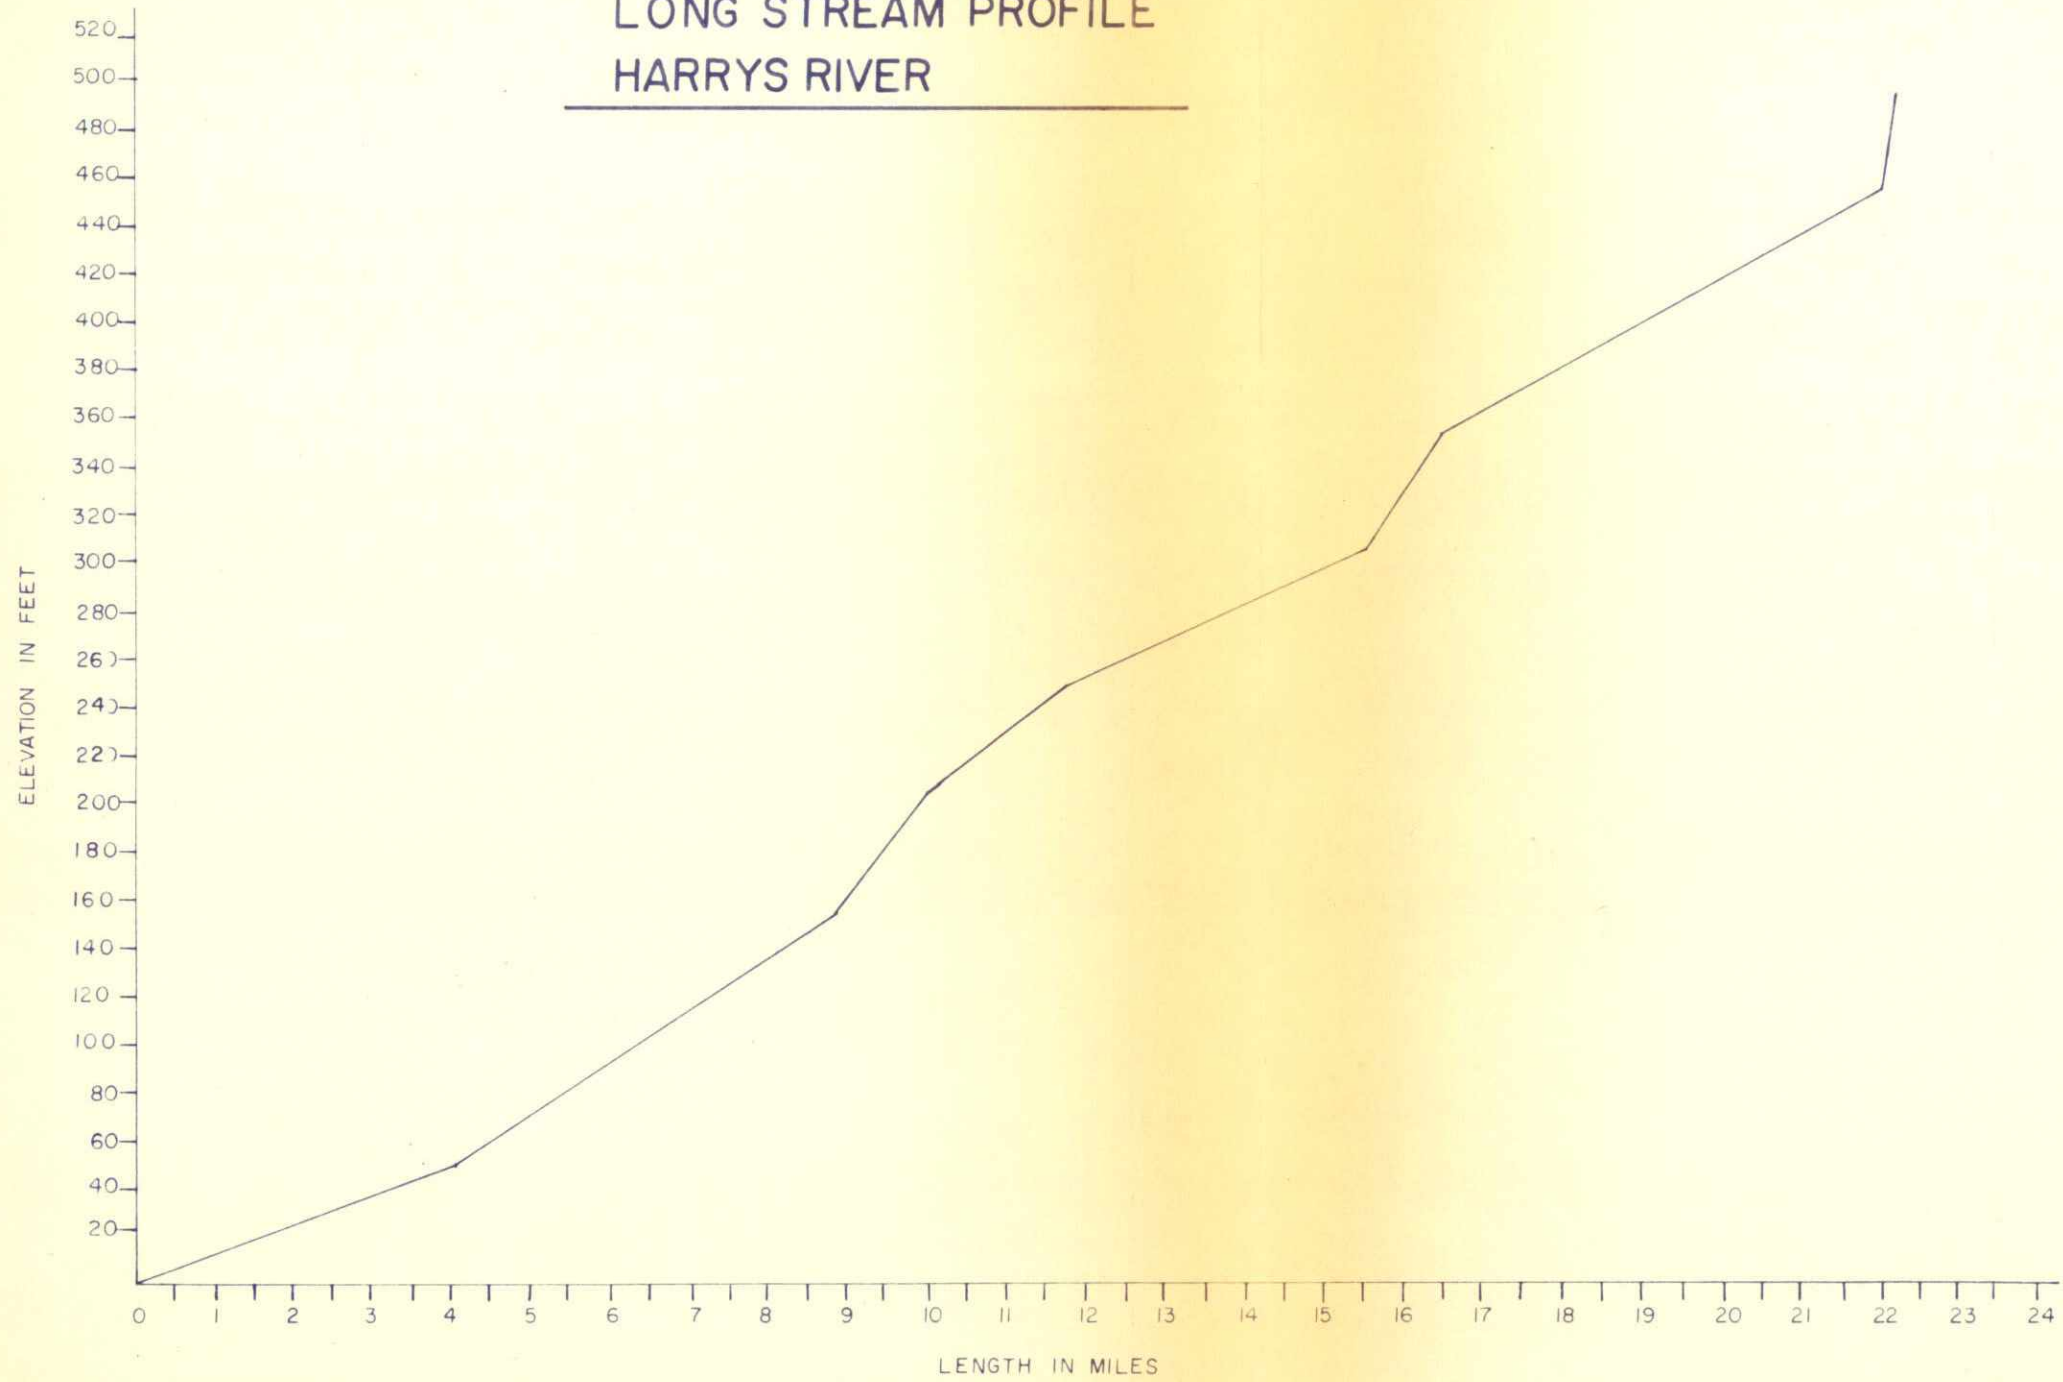
FIG. 5. Long Stream Profile,  
Harry's River.

### LONG STREAM PROFILE HARRYS RIVER

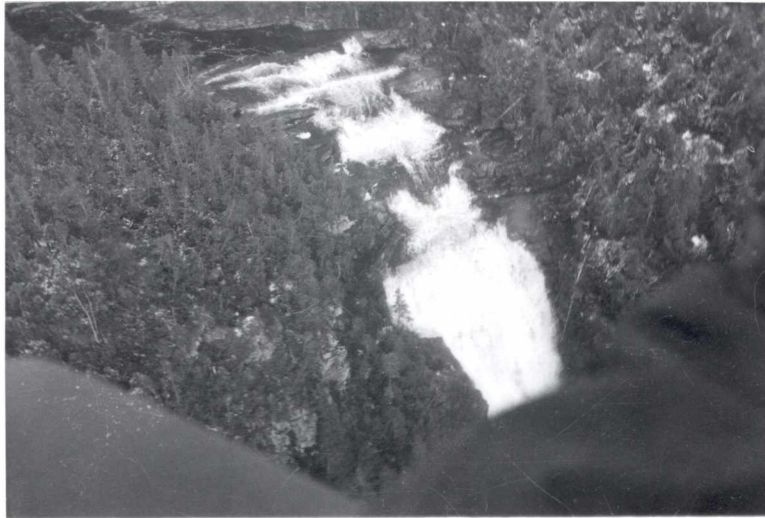
Fig. 6. West North Brook Falls.

Above the falls the stream is very rocky and swift. Even if salmon could get to the upper watershed, they would have difficulty finding spawning ground.

Because of the steep stream gradient, rapids occur throughout, but the only complete obstruction observed is a 40-ft. falls located 1 mile up West North Brook. It is doubtful even if spawners could utilize any of this stream that substantial rearing ground could be found because of very rapid flow and lack of adequate cover.

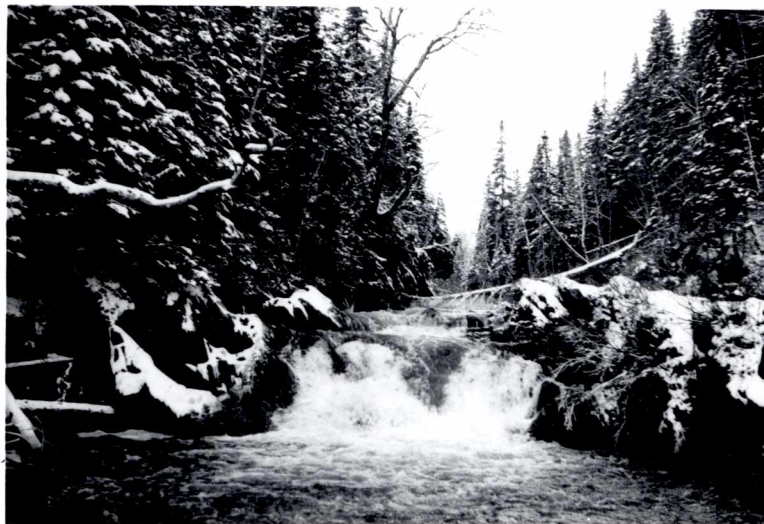
Fig. 7. Spruce Brook Falls.

Spruce Brook has a series of small falls located three miles from the mouth. The upper and largest is a 12-ft. drop over a horizontal distance of 20 ft. (Fig. 7). A run-around near the left bank would allow easy ascent of salmon in high water but it is dry in low water periods. A series of rounded ledges in the main drop could possibly allow ascent during low water. This falls, and smaller drops further downstream, is not regarded as an obstruction to the ascent of migrating salmon and trout.

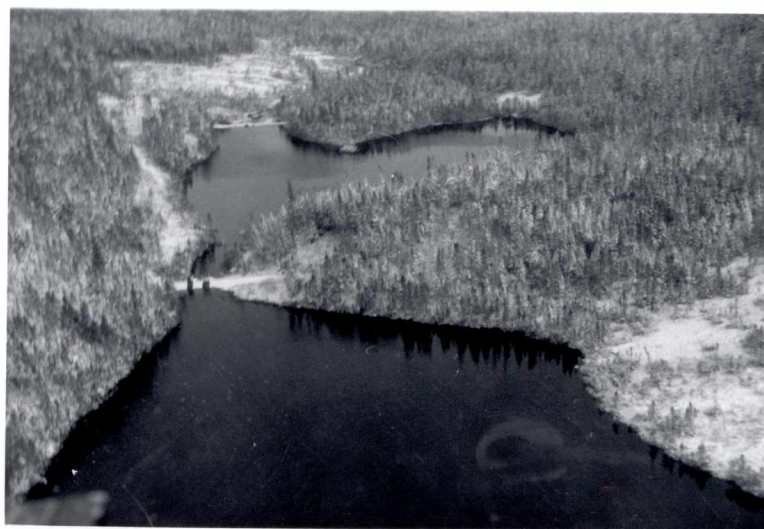
Fig. 8. Wooden dams at Headwaters of Roberts Brook.

The only man-made obstructions observed were old wooden dams erected by Bowater's Pulp and Paper Company at headwater ponds to regulate water supply in log drives (Fig. 8). However, since Harry's River is

no longer utilized for this purpose, most of the dams are in a dilapidated condition and pose no problem to ascending migrants.

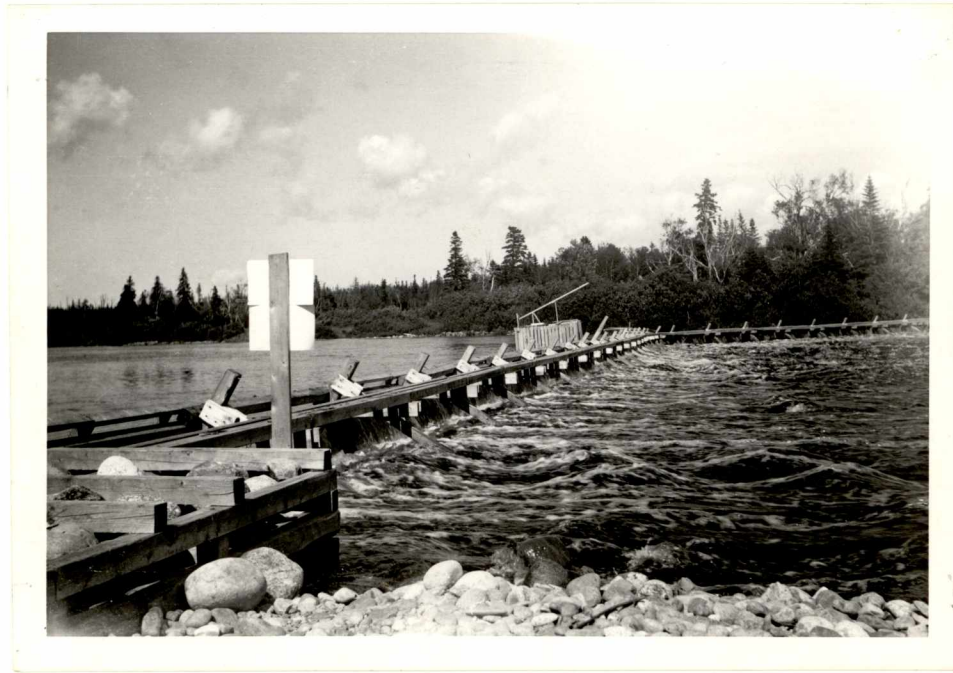
Fig. 9. Counting fence at Harry's River.

A counting fence (Fig. 9) was operated on the main river  $2\frac{3}{4}$  miles from the mouth (Fig. 10) for the period June 22 - September 2 (Table V).

The fence extended a distance of 380 ft. from an island near the centre of the river to the left bank. It was "V"-shaped with one wing approximately 260 ft. and the other 120 ft. in length. One trap was located at the apex of the "V" and another (built later in the season) was placed near the mid-point of the long wing.

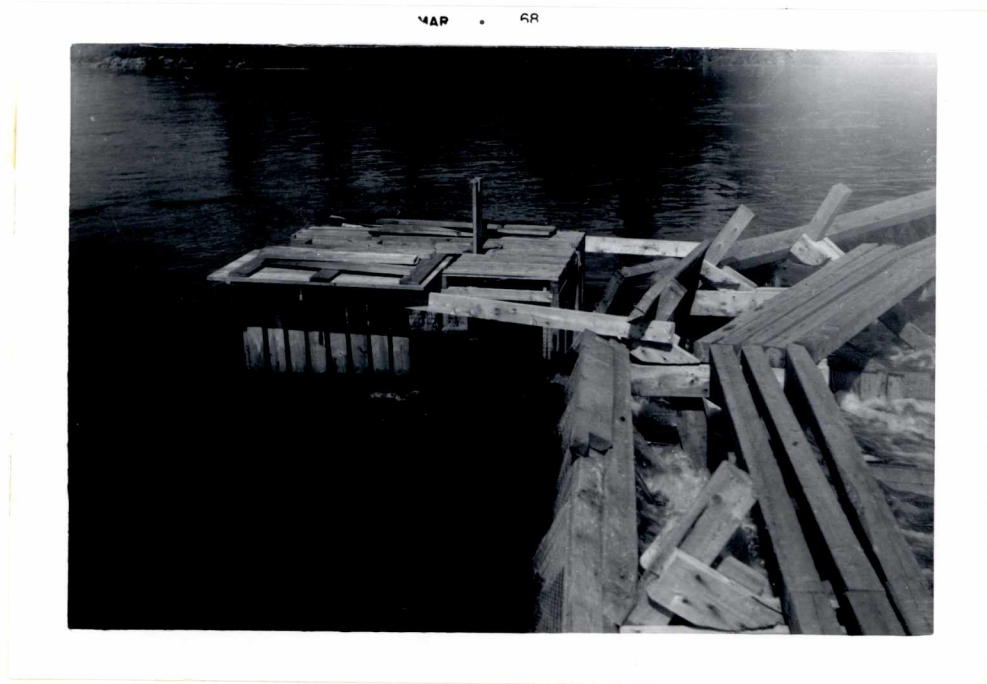
Fig. 11. Counting trap at Harry's River.

One trap was constructed of a wooden framework, 4 x 4 x 6 ft., with 1 in.<sup>2</sup> mesh wire screen forming the sides and bottom (Fig. 11). Boards were placed vertically along the sides to control undue turbulence in the trap. The other trap was built entirely of wood, both for framing and with closely-spaced pickets for screening the water flow through the trap.

Foundation of the fence was made of 8 x 8 ft. wooden cribs, 2 ft. in height, constructed of 6 x 6 in. lumber, set into the river bed to within 6 in. of the top. "A" frames were placed at intervals of 8 ft.

and on them were placed 4 x 8 ft., wooden-frame, wire panels (Fig. 11). Large size of these panels prevented easy removal for debris-cleaning during flood; smaller screen panels would have been more efficient.

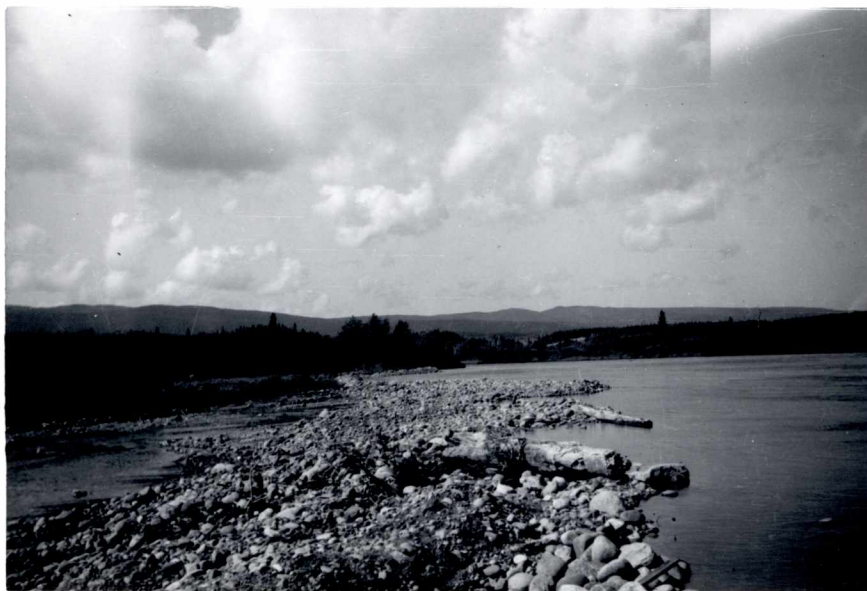
Fig. 12. Rock dyke at Harry's River.

A rock dyke constructed by a bulldozer dammed the right hand channel (Fig. 12). It was 400 ft. in length and extended from the right bank to the island.

High flooding damaged the dyke on two occasions (June 23 and August 7) so that salmon were free to ascend the river undetected for a total of six days. That many did so is unlikely, however, because on other occasions in floods, when the counting fence remained operative, an increase in the run was apparent only during the abatement of flood water. The increased fish movement after the peak flow agrees with Hayes' (1953) studies on the effects of freshets on migrant salmon movement. Our fence was back in operation on each occasion shortly

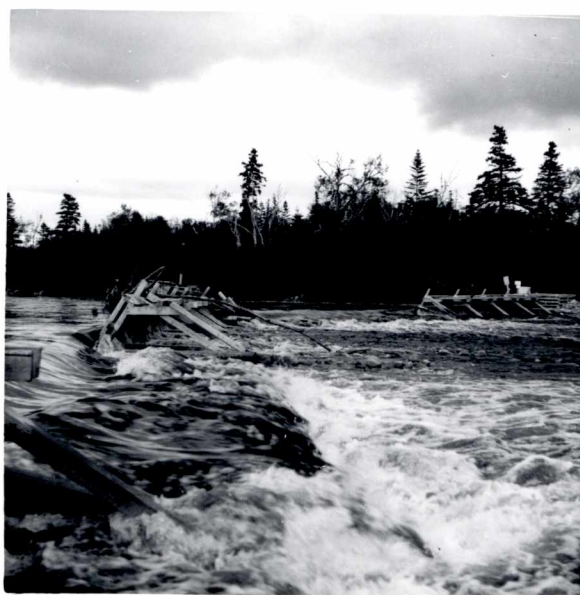
Fig. 13. Fence washout at Harry's River.

A final extremely-high flood on September 2 caused heavy damage to the dyke and counting fence (Fig. 13). The damage forced discontinuance of the operation while fish were still ascending the river.

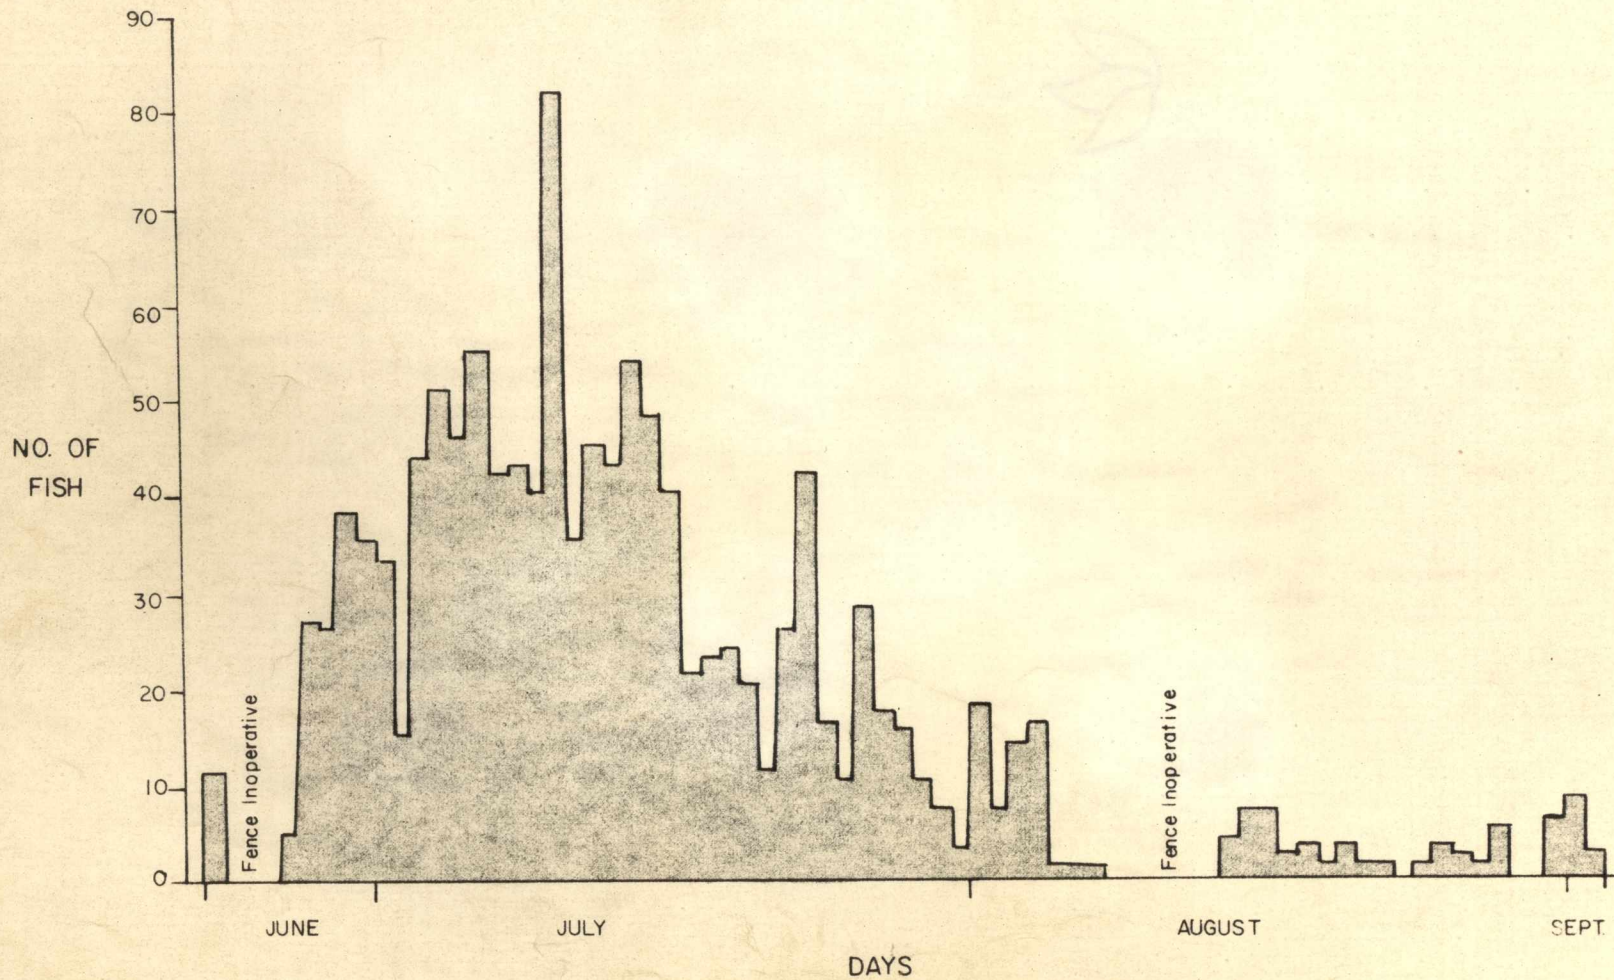
FIG. 14. Graph of daily fish count.

Fluctuations in the daily count occurred but there was a buildup to a peak of 84 fish on July 10 (Fig. 14). A total of 1,252 salmon was counted during the fence operation. Another 350 fish is estimated as untallied escapement during washouts and after cessation of the fence count. A total of 954 fish was angled in Harry's River in 1967; 400, or approximately 42% of this number, were taken below the fence. Estimated total river escapement is, therefore, placed at  $2002 \pm 500$  fish.

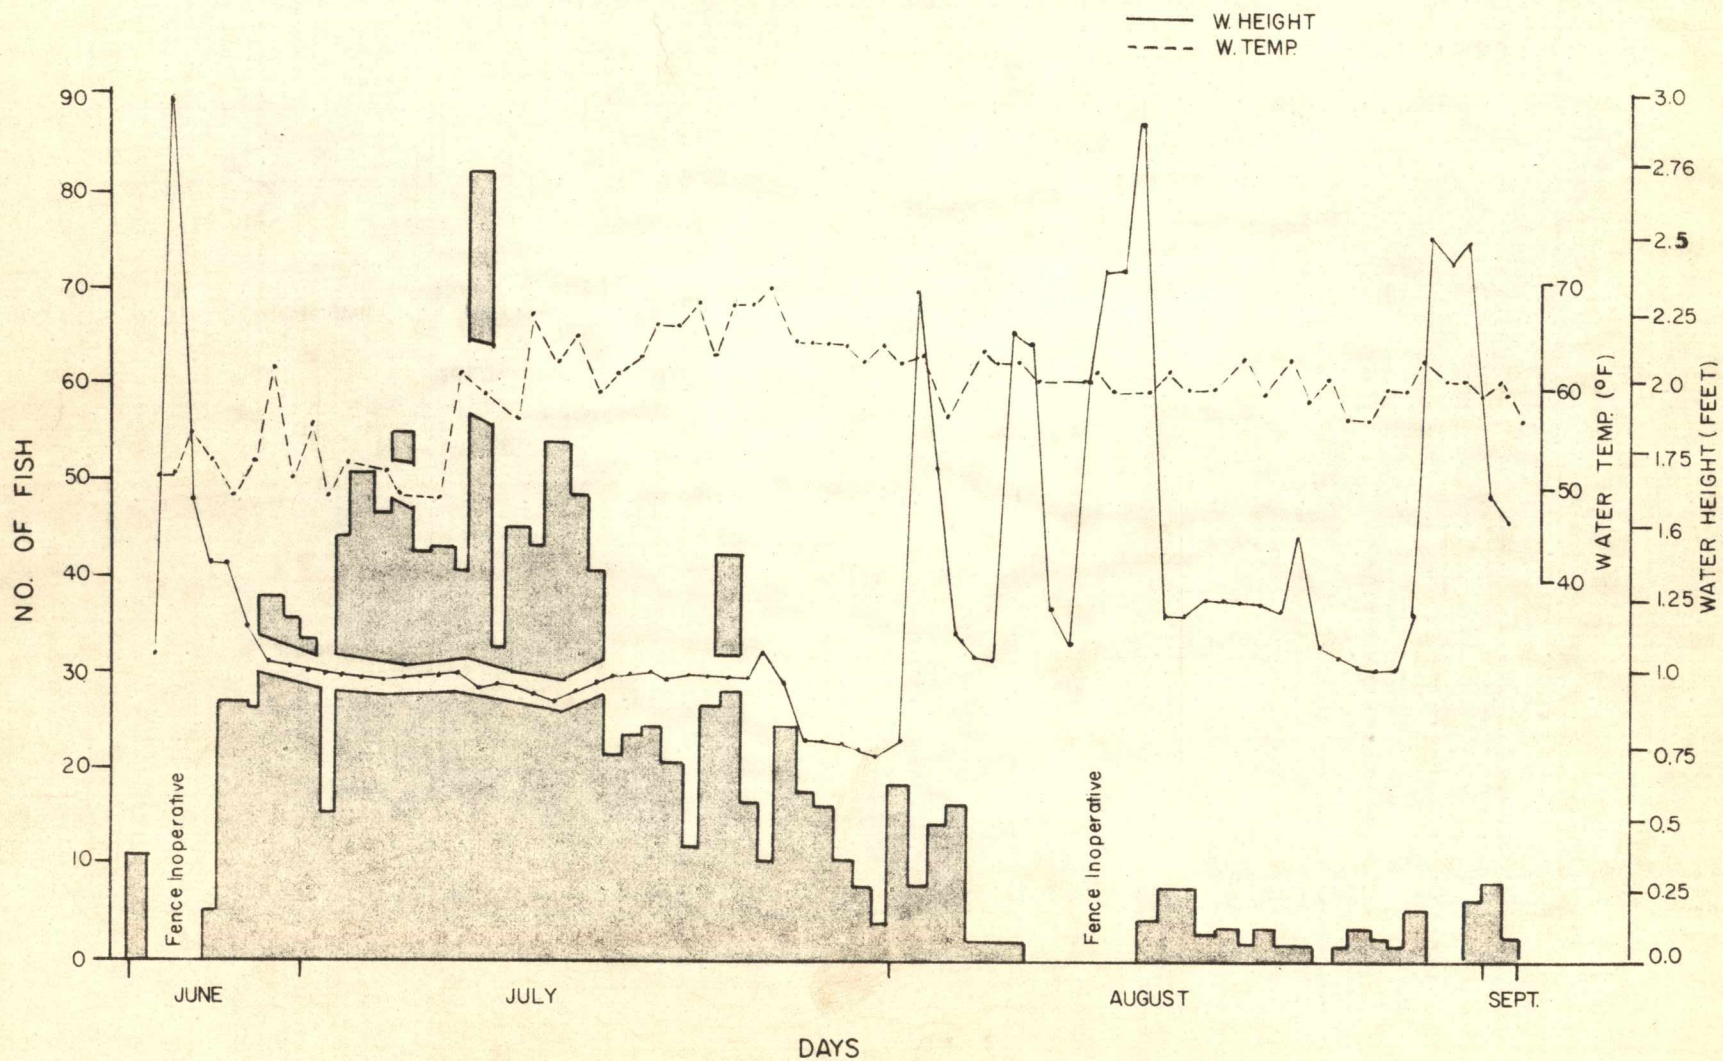
FIG.15. Graph of daily fish count with water levels and temperatures superimposed.

Fig. 15 shows water heights and temperatures superimposed on daily fish counts. Both water heights and temperatures were recorded at 0900 hours daily, so as to minimize variation caused by recording at different time of day. A slight correlation appears to exist between daily fish count and water heights but no such correlation is evident between daily fish count and water temperatures.

Extremely high water, reaching a height of 3.0 ft. in the trap in late June (during which period flooding damaged part of the fence), was followed in the next two weeks by a gradual buildup to a peak fish count of 84 fish on July 10. Daily fluctuations of temperatures during this period seems to have had little if any noticeable effect on this buildup. Relative uniformity of water heights is maintained from the high in late June to the end of July.

While temperature varied little, water-height peaks on August 1, 7, and 14 were followed by a slight increase in the run. A final heavy freshet in late August and early September saw another slight increase in run until the count terminated September 2 with destruction of the fence.

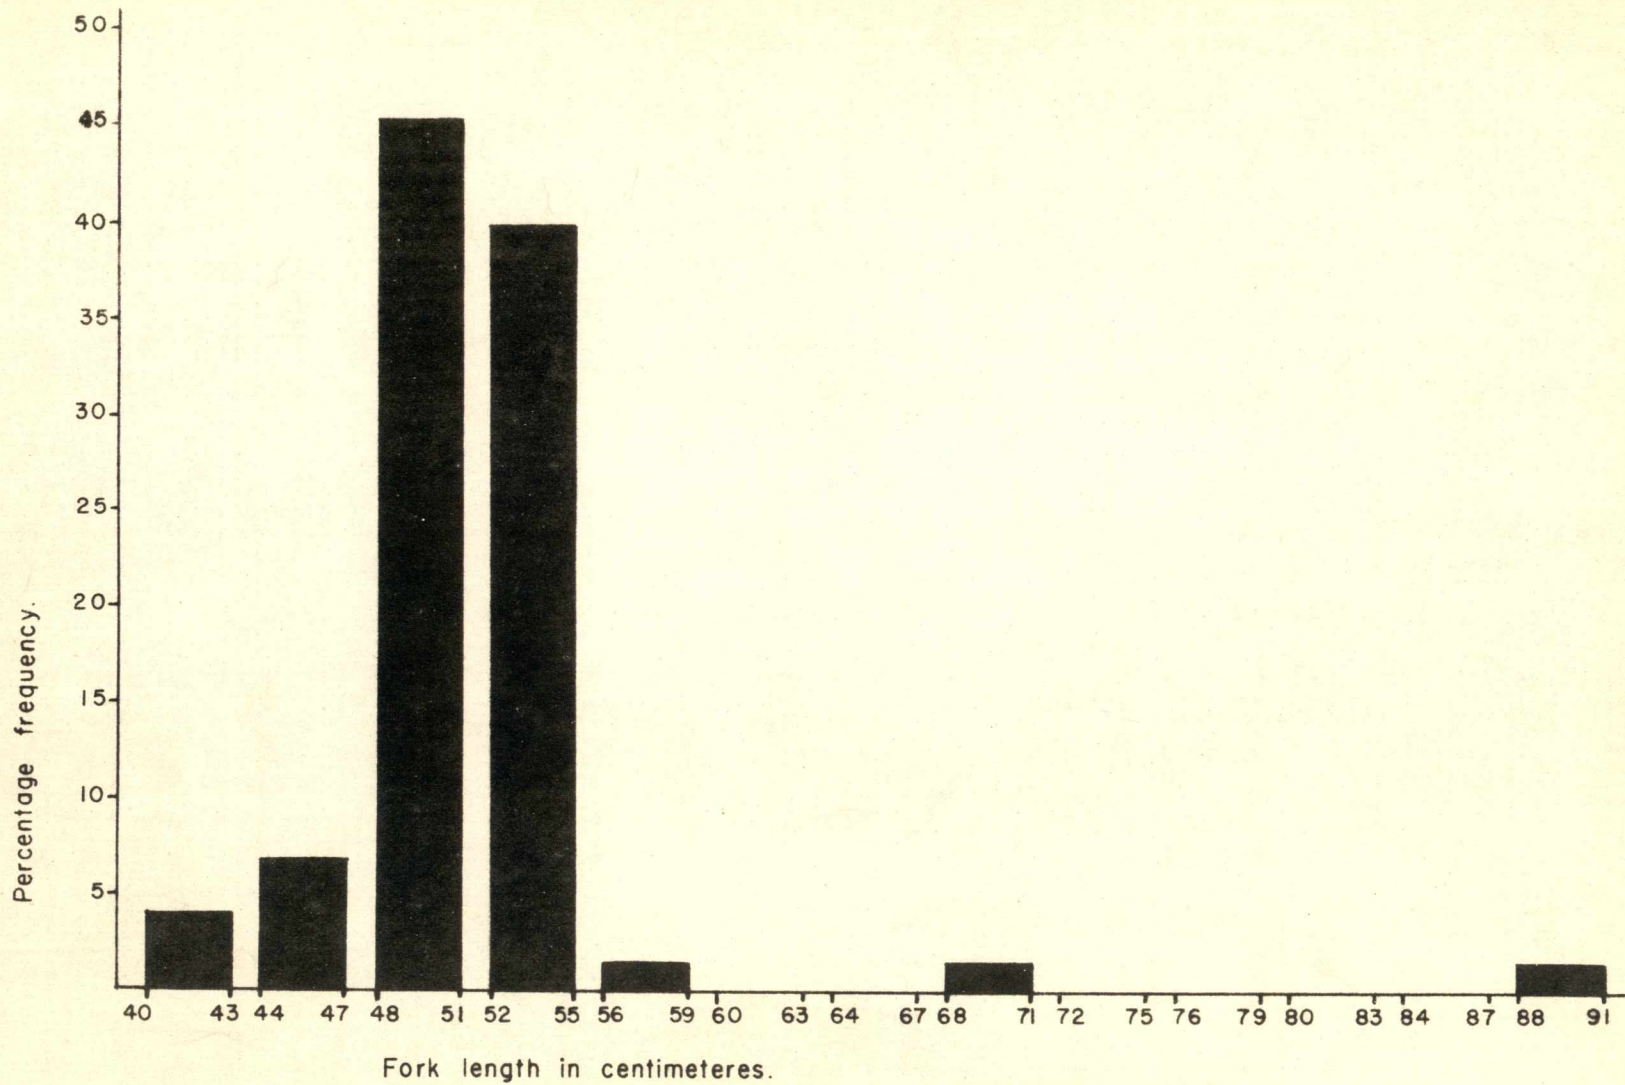
**Fig.16 Length-Frequency distribution for 73 Atlantic Salmon  
Harrys River, 1967**

Fig. 16 shows the fork length distribution for Harry's River escapement sample (N = 73). Length range was 41 - 90 cm. but the bulk of the sample was in the range of 41 - 58 cm. Only two fish were larger than 58 cm. and these were 70 and 90 cm. respectively. Mean length for the sample was 50.5 cm. with a standard deviation of 2.6 cm. No weights were taken.

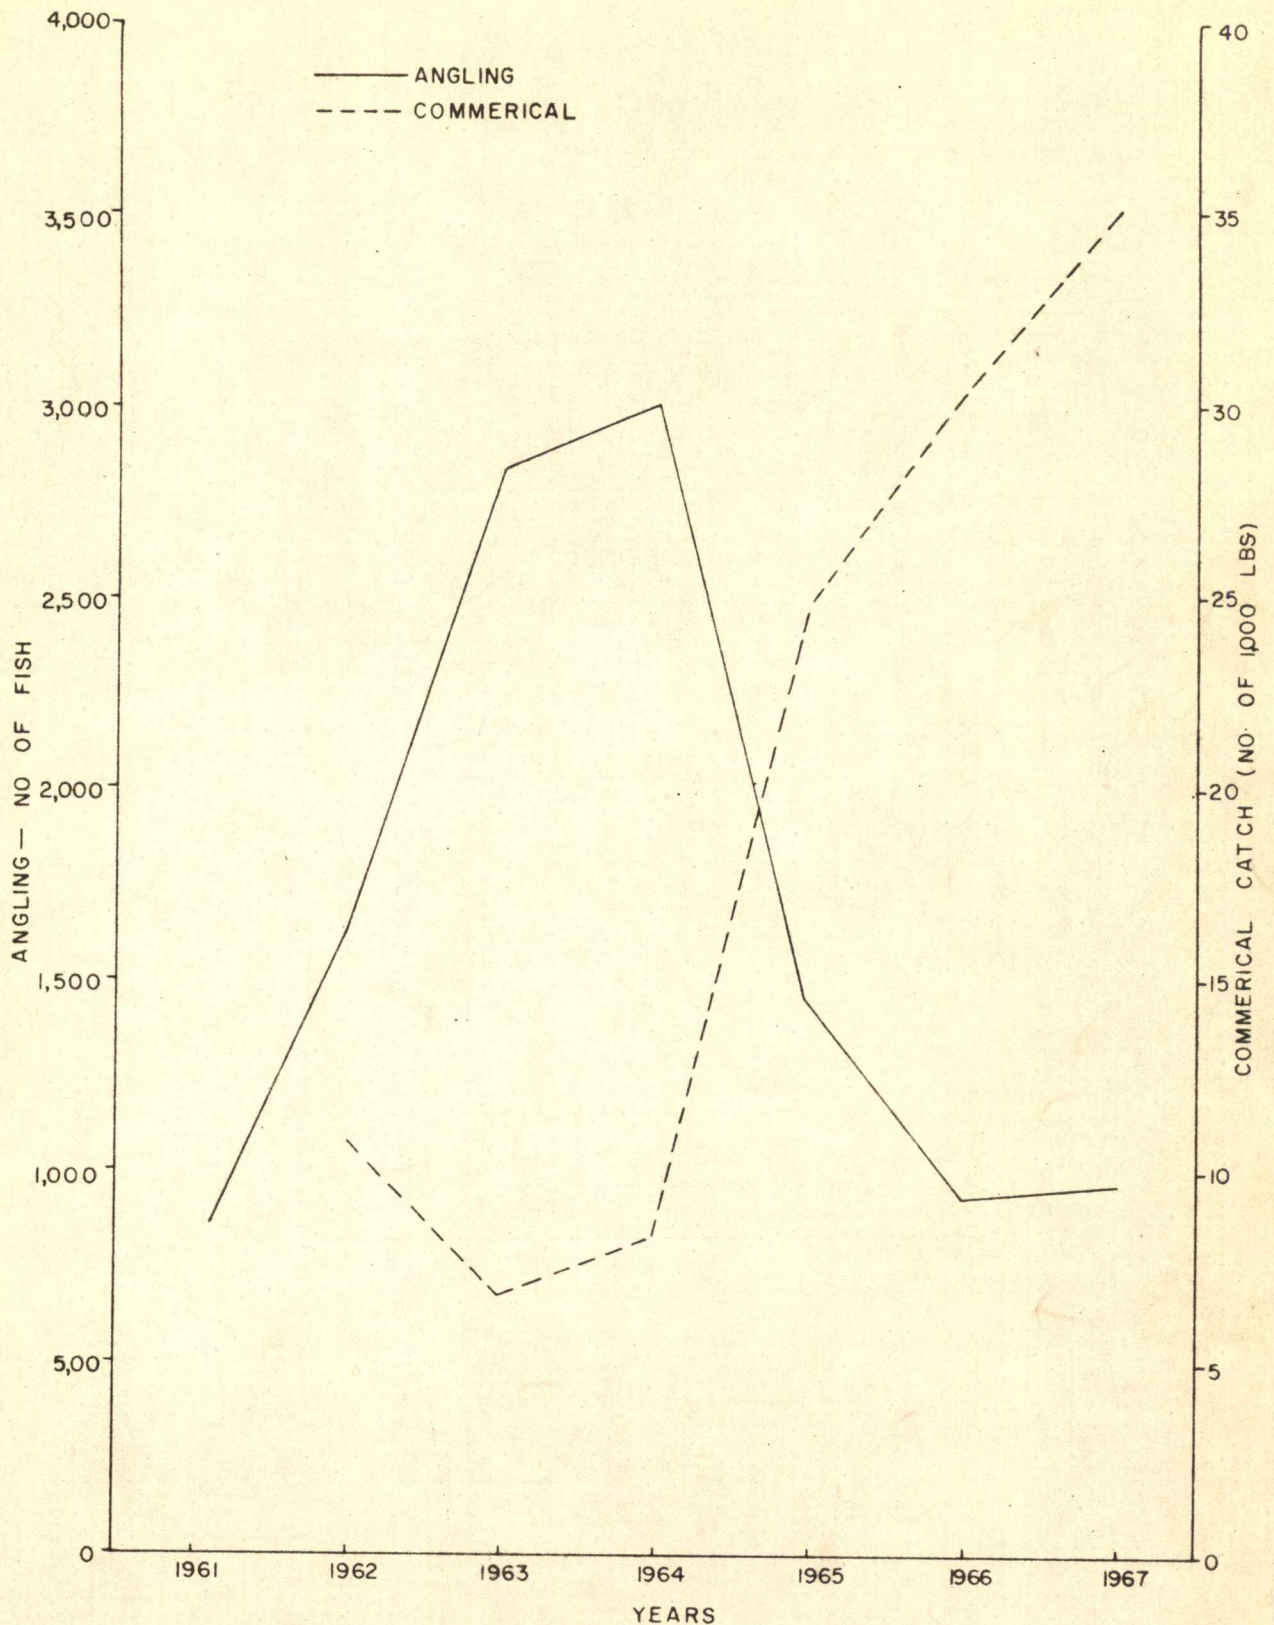
FIG 17. ANGLING / COMMERICAL CATCH

Note the correlation of commercial catch for the four communities with the angling catch for Harry's River in the last six-seven years (Fig. 17). A definite negative correlation exists between the two in that as commercial catch increased the angling catch decreased. Between 1961 and 1964 the angling catch in Harry's River showed an increase while the commercial catch remained essentially the same. After 1964, a sharp rise in commercial catch matches almost a mirror-image decrease in the angling catch.

The rapid annual increase in commercial returns seems to have a serious effect on salmon escapement to Harry's River. Although a slight increase was evident in the number angled in 1967 compared to 1966, this trend toward reduced angling catches can be expected to continue as long as the amount of commercial gear in use in St. Georges Bay remains at high levels.
