# A Review Of Suction Dredge Monitoring In The Lower Fraser River 1971 – 1975

by  
L.K. Dutta  
P. Sookachoff

Technical Report Series No. PAC/T-75-27

Southern Operations Branch  
Pacific Region

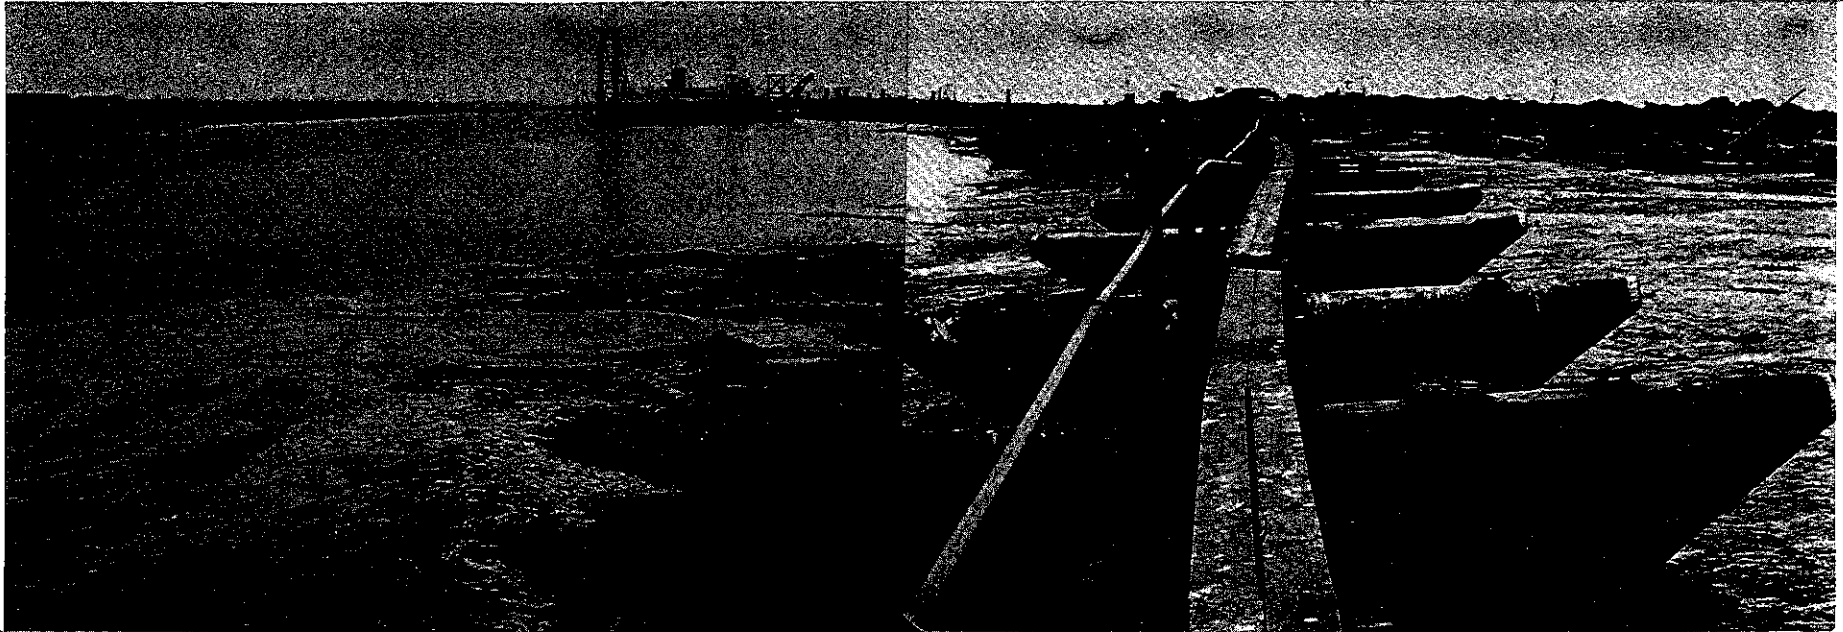
FIGURE 12

DREDGE DPW "322" IN OPERATION, PERIMETER DYKE  
IN PLACE, AND EROSION OF THE DYKE IN PROGRESS  
(Photographed at 13:00 hr, April 16, 1975)

The following illustration (Figure 12) shows the construction and subsequent erosion of the dyke at the settling basin at the North Arm Jetty site. Problems created by the breaching of the containment dyke and spoil discharge onto the beach focused attention on the need for regular departmental review of spoil site and discharge line location in conjunction with the basic review of the borrow site.

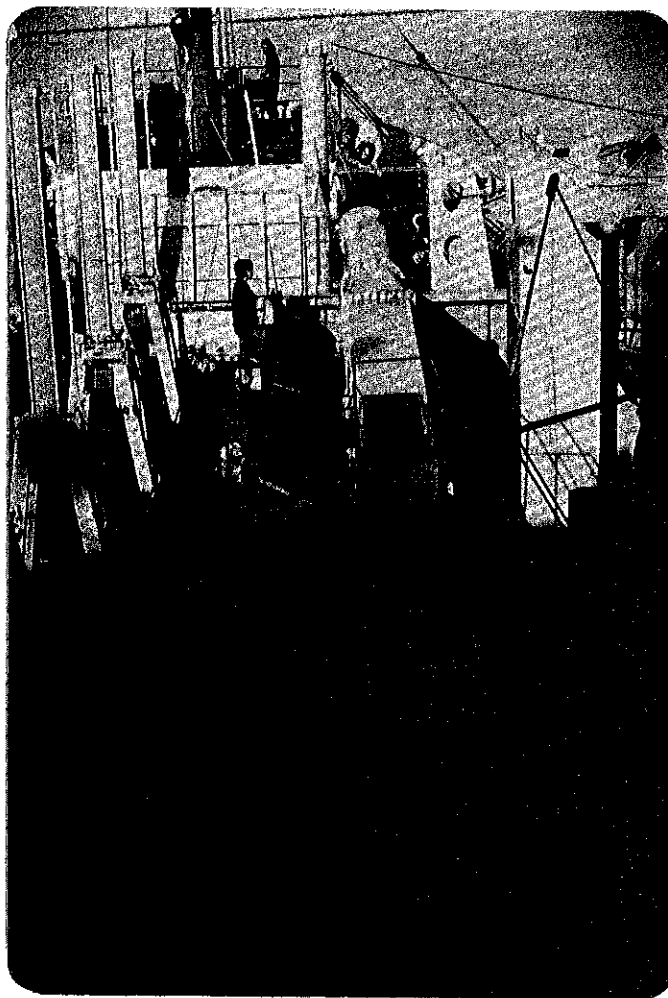
FIGURE 16

MONITORING IN PROGRESS IN  
THE HOPPER DURING DPW ("312")  
"FORT LANGLEY" OPERATIONS.

Photograph taken at the Steveston Cut  
site on May 13, 1975.

Figures 16, 17, 18 and 19 on the following three pages illustrate some of the on-site monitoring procedures used during the DPW "Fort Langley" ("312") dredging operations.

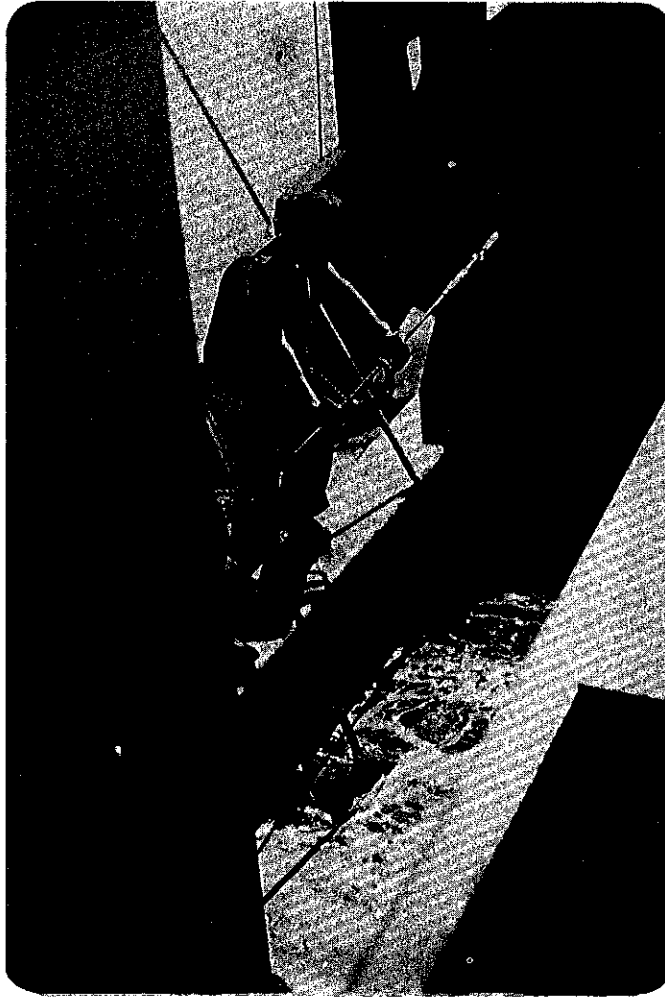
FIGURE 17

MONITORING IN PROGRESS IMMEDIATELY  
UPSTREAM OF THE SPILLWAY, DURING DPW  
"FORT LANGLEY" DREDGING OPERATIONS.

Photograph taken at the Steveston Cut  
site on May 22, 1975.

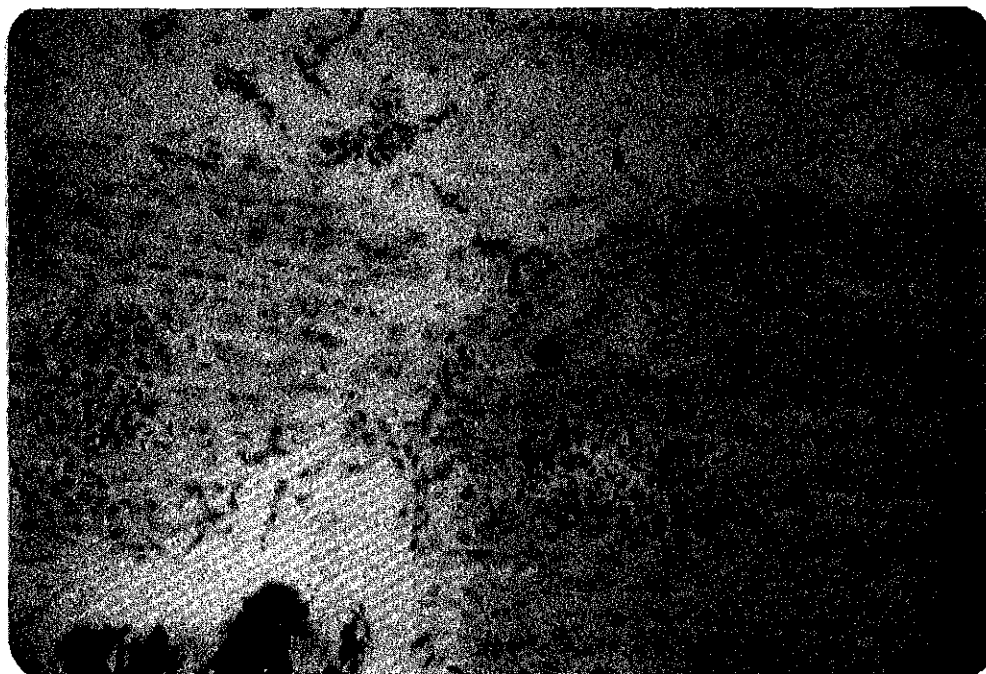
FIGURE B-5

Haemorrhagic Lesions Located in Lateral Muscle.  
Haematoxylin & Eosin. X40.

In Tables B-1 and B-2, I have compiled the results of the histopathological survey for the salmon supplied by your group. A total of 94 salmon fry and 16 sockeye smolts were examined during the course of this study. Figures B-1 to B-8 show the most frequently noted pathological conditions.
