Deadman River Channel Stability Analysis

Fraser River Action Plan
Department of Fisheries & Oceans
555 West Hastings Street
Vancouver, B.C. V6B 5G3

**Canadian Manuscript Report of
Fisheries and Aquatic Sciences No. 2310**

DEADMAN RIVER
CHANNEL STABILITY ANALYSIS

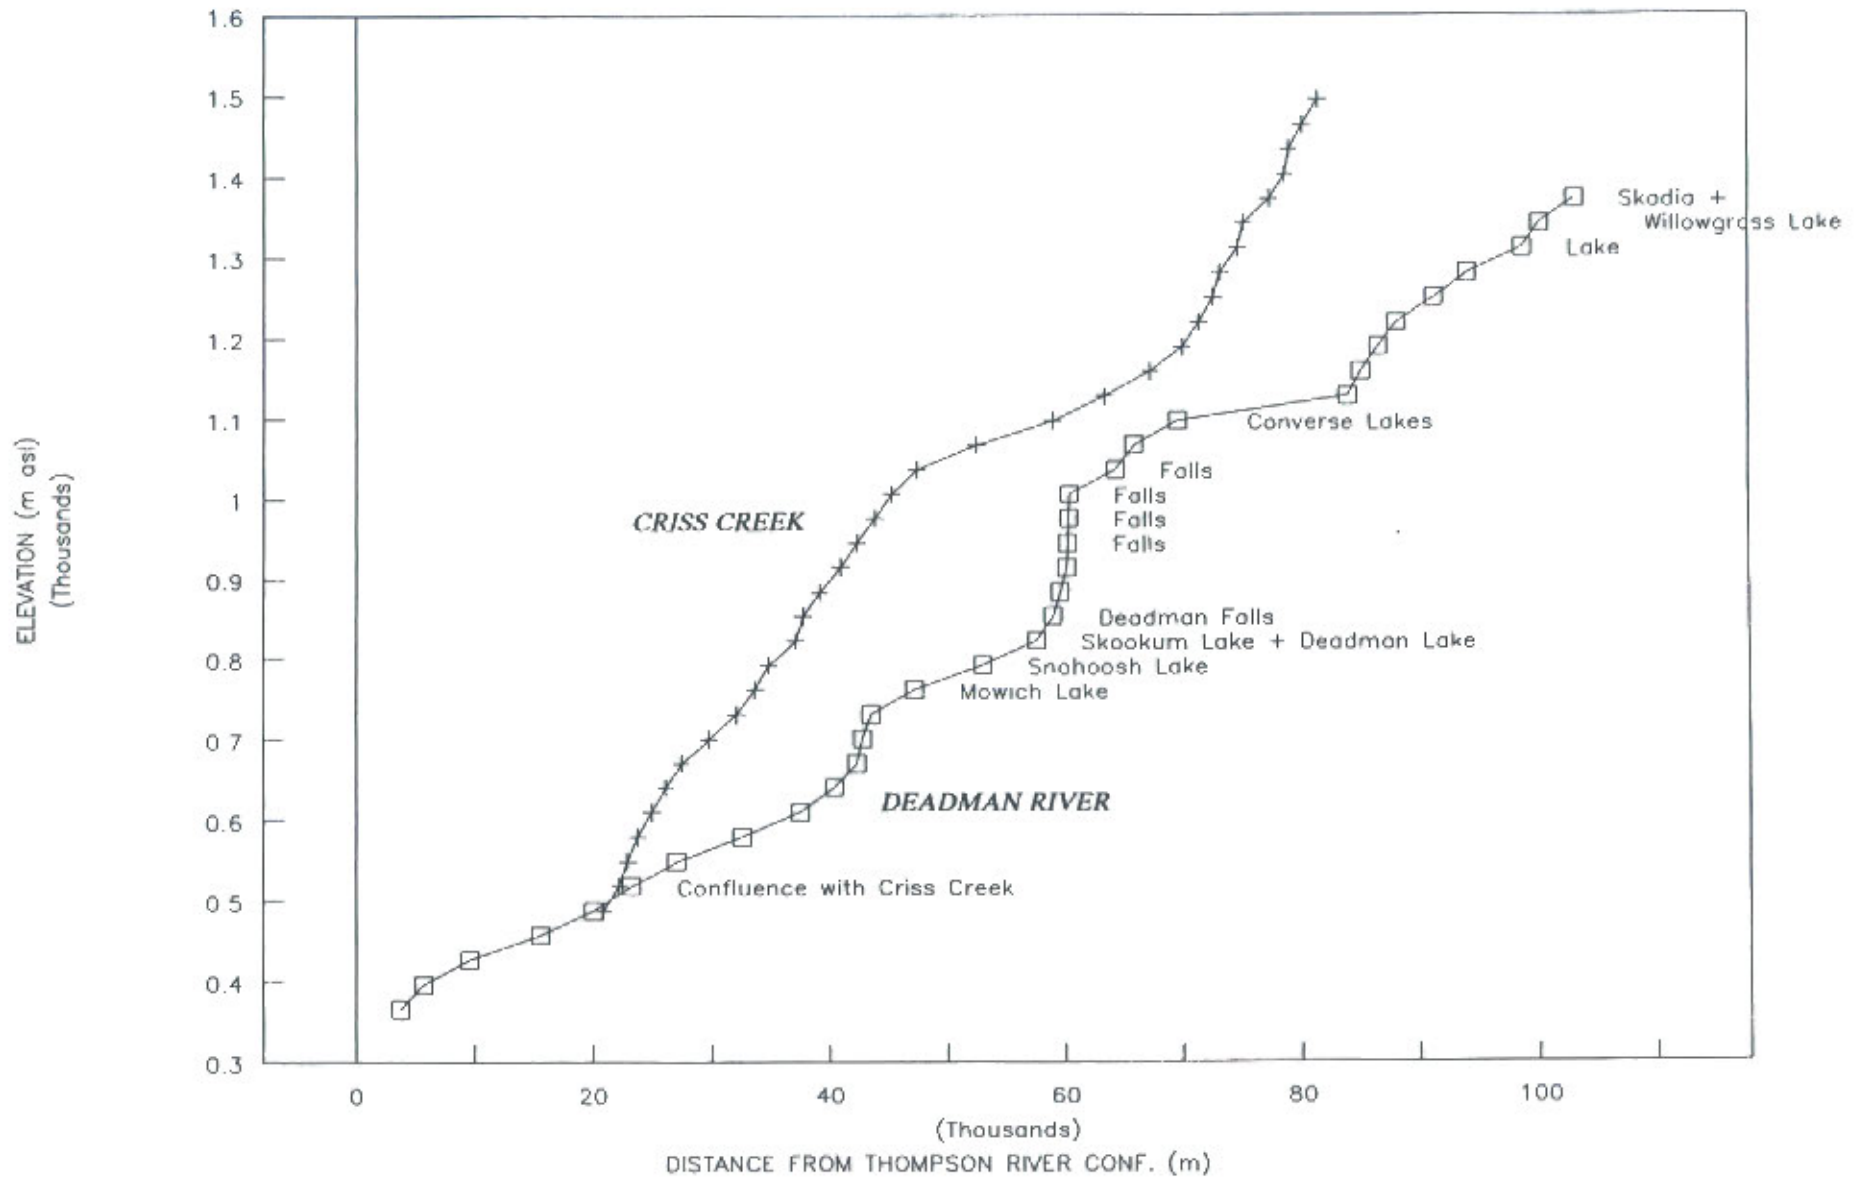
Figure 2.2.1: Long profile of Deadman River, Criss Creek and their principal tributaries

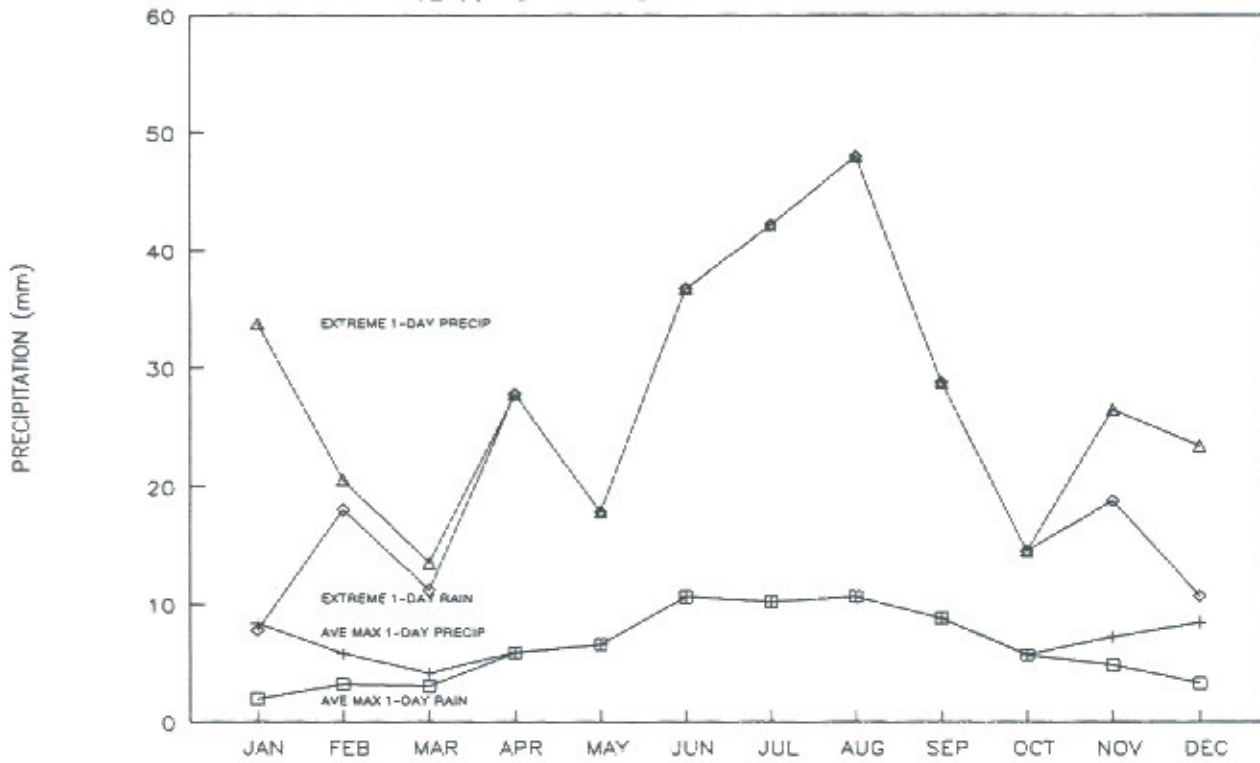
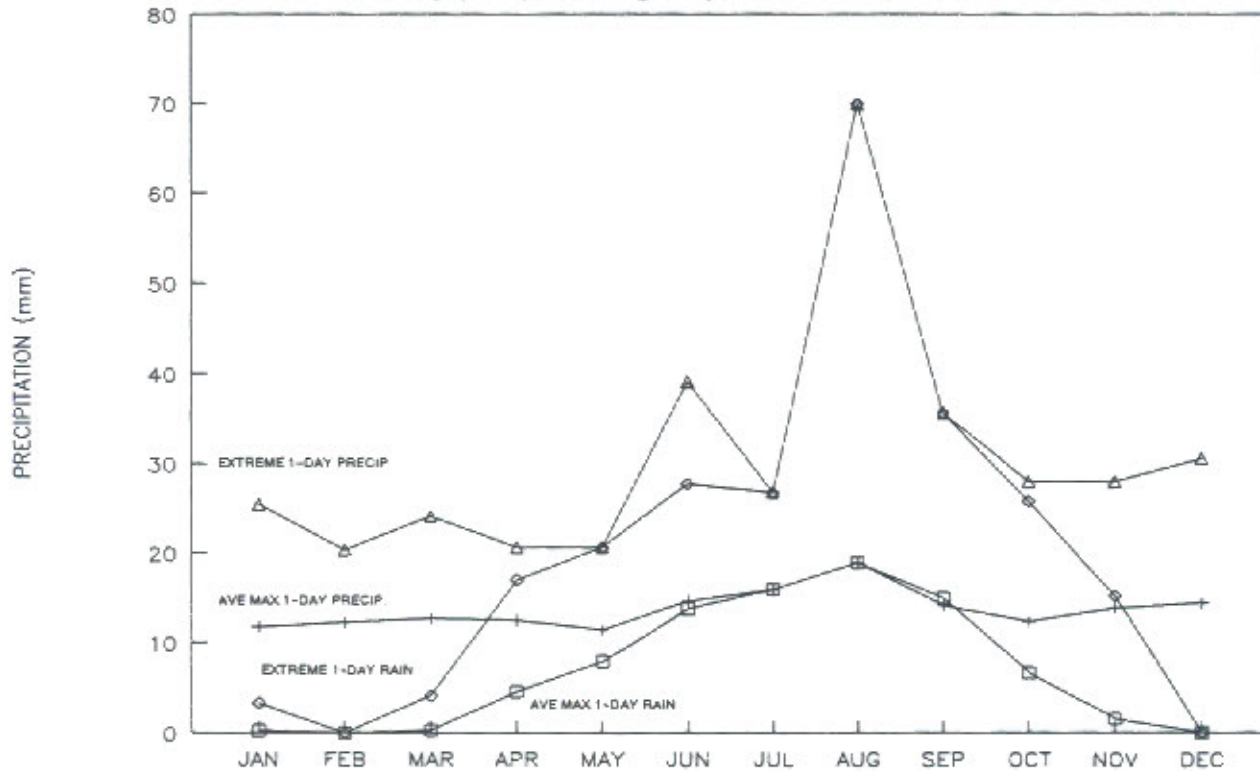
Figure 2.3.5: Seasonal variation in maximum and average 24-hour rainfall and precipitation at Kamloops A and Mt Lolo Kamloops

The seasonal variation in maximum 24-hour rainfall and precipitation at *Kamloops A* and *Mount Lolo* is shown on Figures 2.3.5. In both locations the largest values occur as a result of mid-summer convective activity with the extreme values of record occurring in August. A frequency analysis of short-duration rainfall data and 1 to 10 day precipitation data observed at *Kamloops A* are shown on Table 2.3.2. The analytical technique is described in Hogg and Carr (1985). The results indicate that the predicted magnitude of extreme events at *Kamloops A* are of modest size in comparison to values which can commonly occur along coastal areas of British Columbia. These results must however be interpreted with care as regional analysis of 1 to 10-day precipitation totals in APPENDIX 1 indicate that the predicted 100-year, 1-day rainfall values at *Kamloops* and *Kamloops Airport* are substantially smaller than those predicted at all other stations investigated.

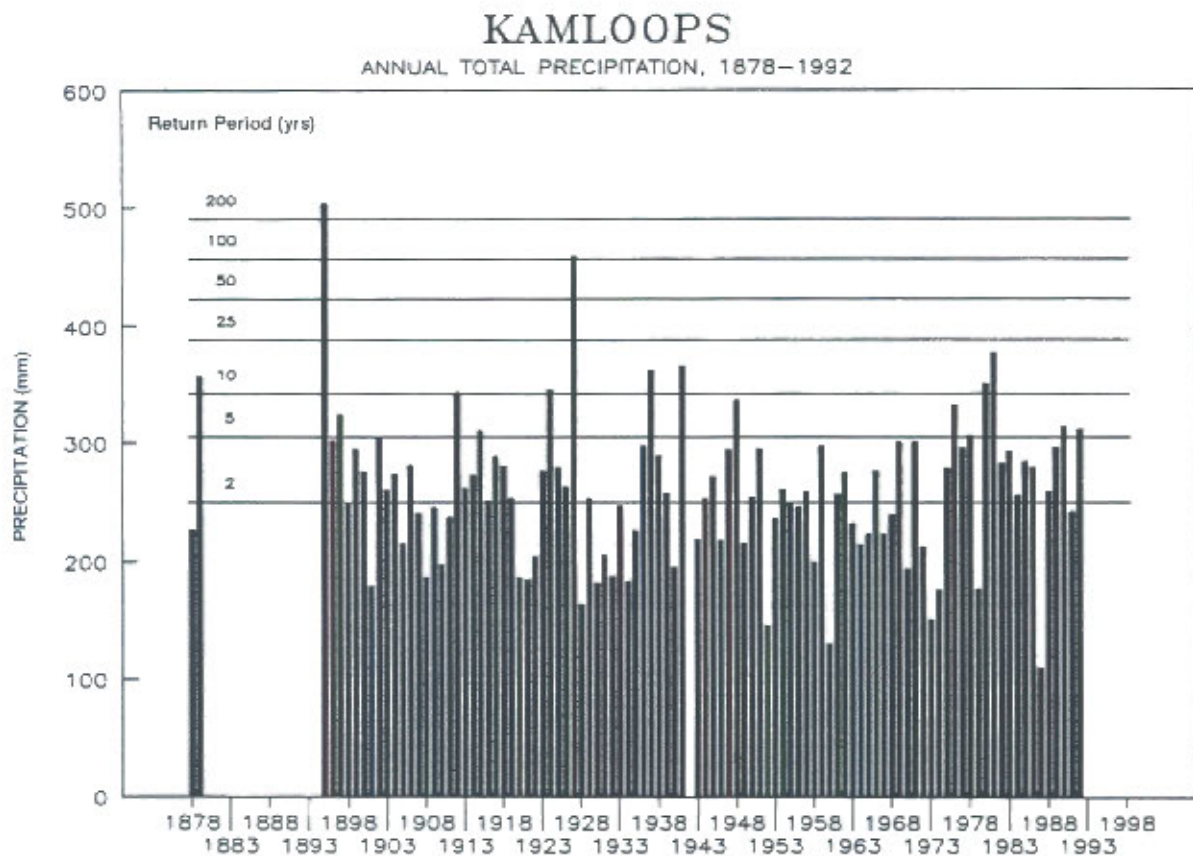
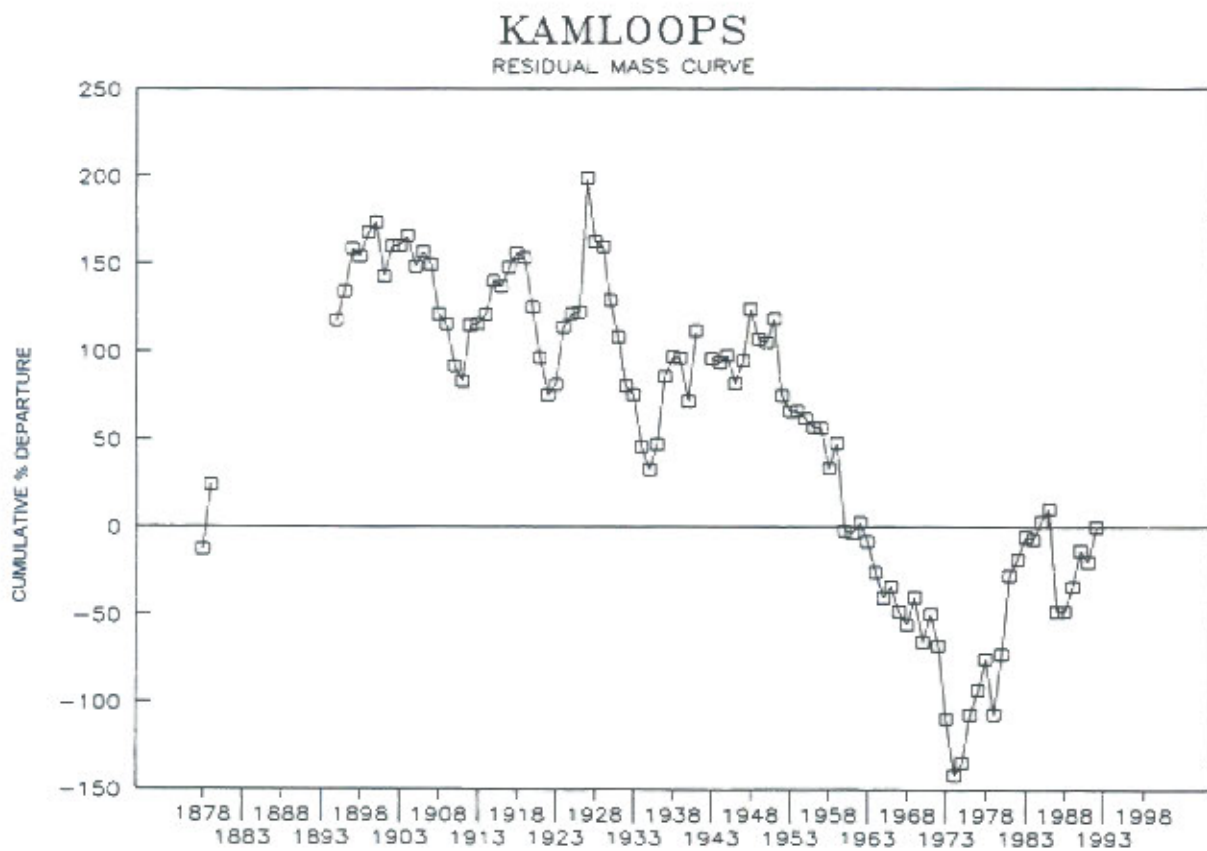
Figure 2.3.6: Historical variation in annual precipitation (synthesized data) at Kamloops, 1878-1992

In order to look at the long term variations in climatic characteristics, the annual precipitation, annual rainfall, greatest 24-hour precipitation and greatest 24-hour rainfall observed at *Kamloops* were correlated with those observed at *Kamloops A* during the common observation period of 1951 to 1982. This analysis, which is summarized in APPENDIX 2, indicates that the data from these two sites are not well correlated (r^2 values range from 0.5 to 0.6). On the basis of the developed regression equations, the data from *Kamloops* has been extended to 1992 and the results are shown on Figures 2.3.6 to 2.3.9. Frequency analyses are summarized on Table 2.3.3.

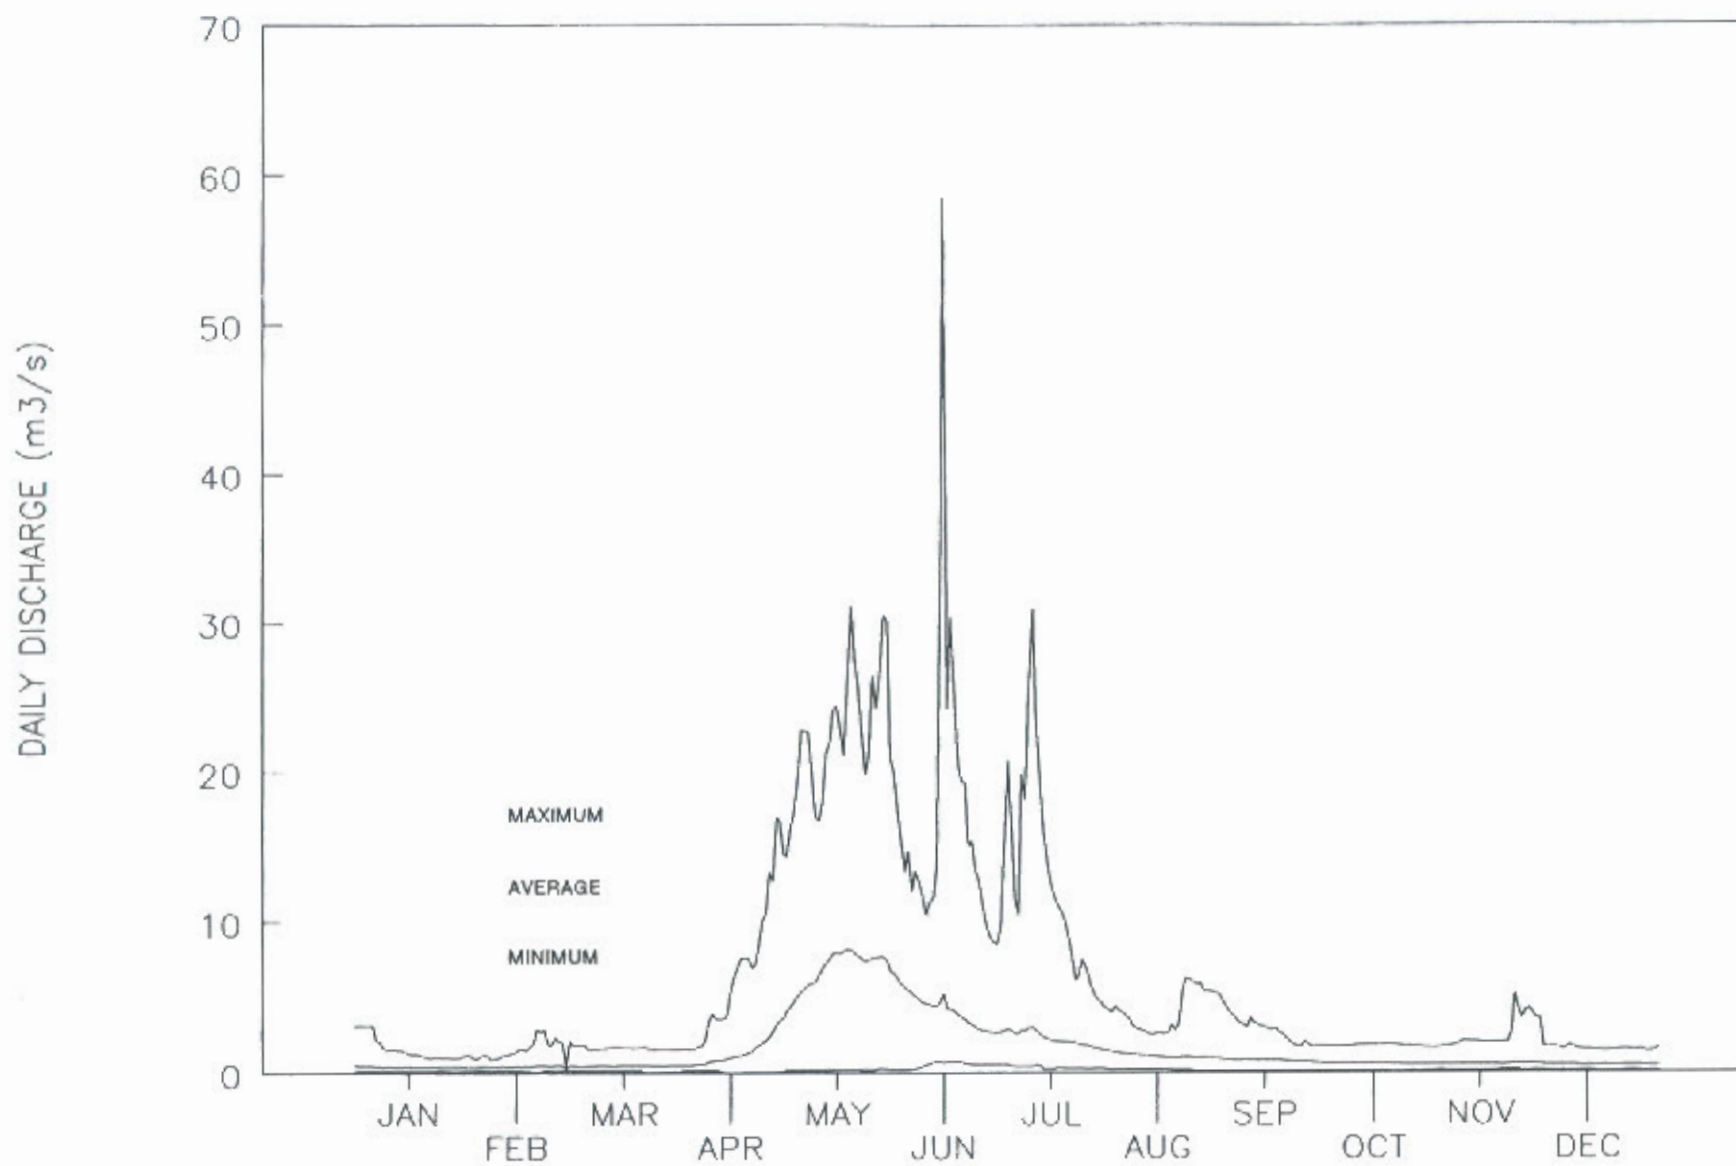
Figure 2.4.1: Seasonal variation in flow, Deadman above Criss Creek, 1913-93

The seasonal variation in observed discharge on the four gauging stations in the Deadman River watershed are illustrated on Figures 2.4.1 to 2.4.4. The spring freshet can be seen to typically occur between April and July, while comparatively low flows occur during the period between October and March.

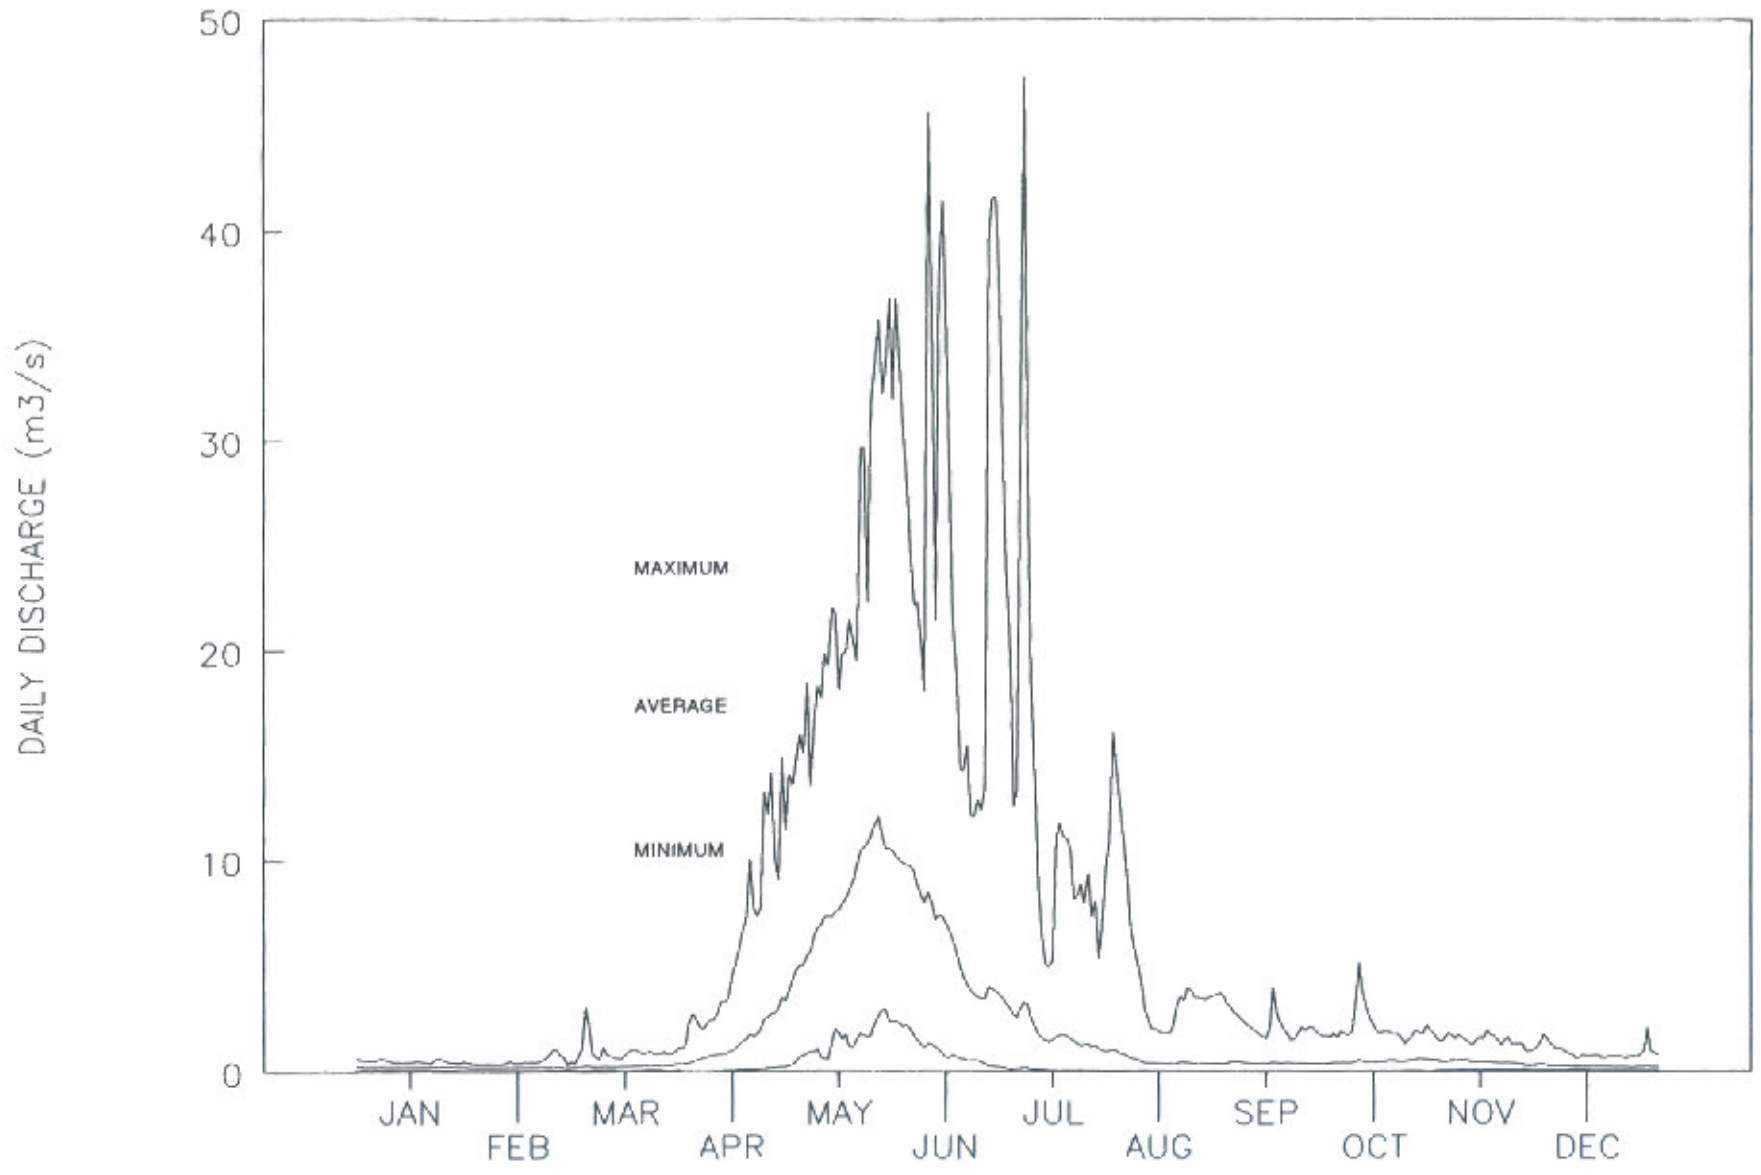
Figure 2.4.2: Seasonal variation in flow, Criss Creek near Savona, 1912-1992

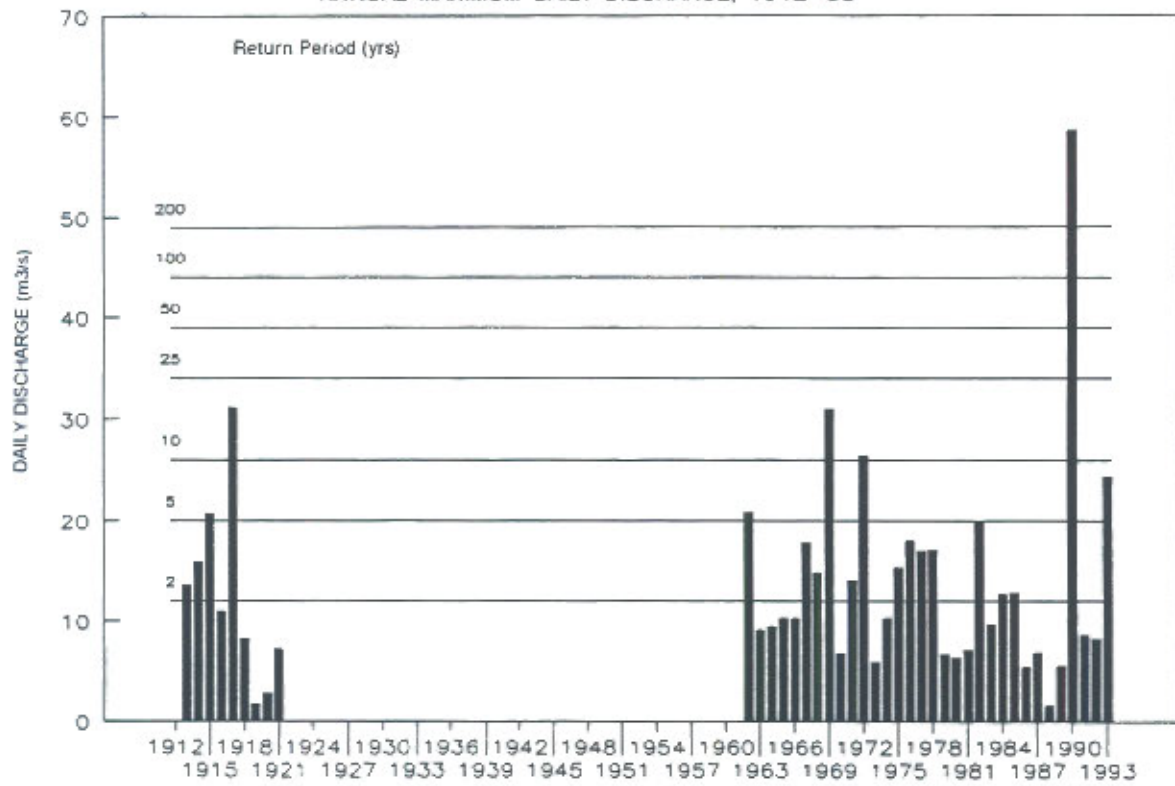
Figure 2.4.5: Historical variation in annual maximum daily discharge, Deadman River above Criss Creek

The historical variation in annual maximum daily and instantaneous discharge observed on the four gauges in the Deadman River watershed and on the Bonaparte River gauge are shown on Figures 2.4.5 to 2.4.9. Flood frequency analyses have been undertaken for each of these sites and the results are shown in APPENDIX 3. The largest discharges on record at all sites occurred in June of 1990. Return periods have been calculated on the basis of four frequency distributions and the results are summarized on Table 2.4.2. There is a wide variation between the return periods calculated on the basis of each of the four frequency distribution and this reflects the unavoidable uncertainties in this type of analysis. On the basis of experience and statistical parameters (such as the Kolmogorov-Smirnov goodness of fit test), the Log Pearson Type III distribution is thought to provide the most reasonable results. However, with four exceptions, all

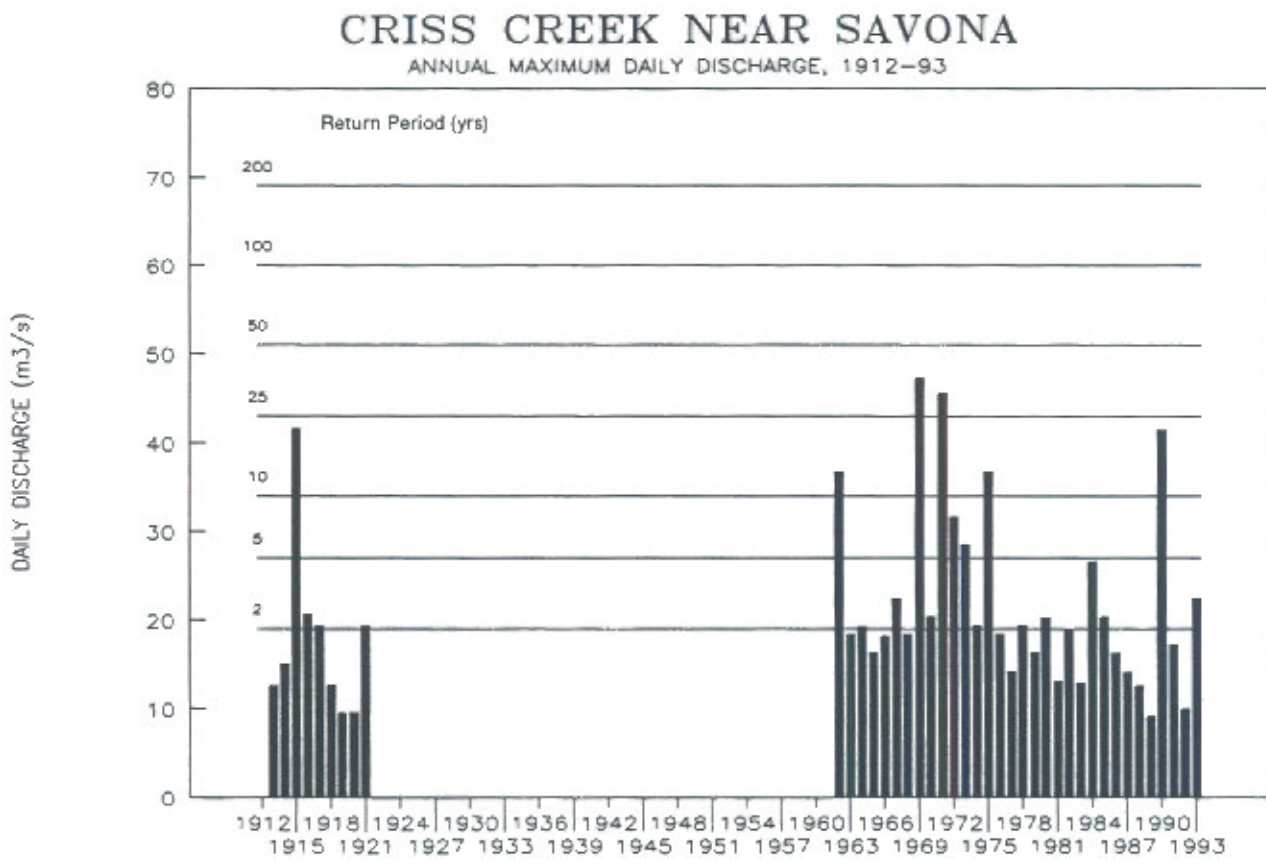
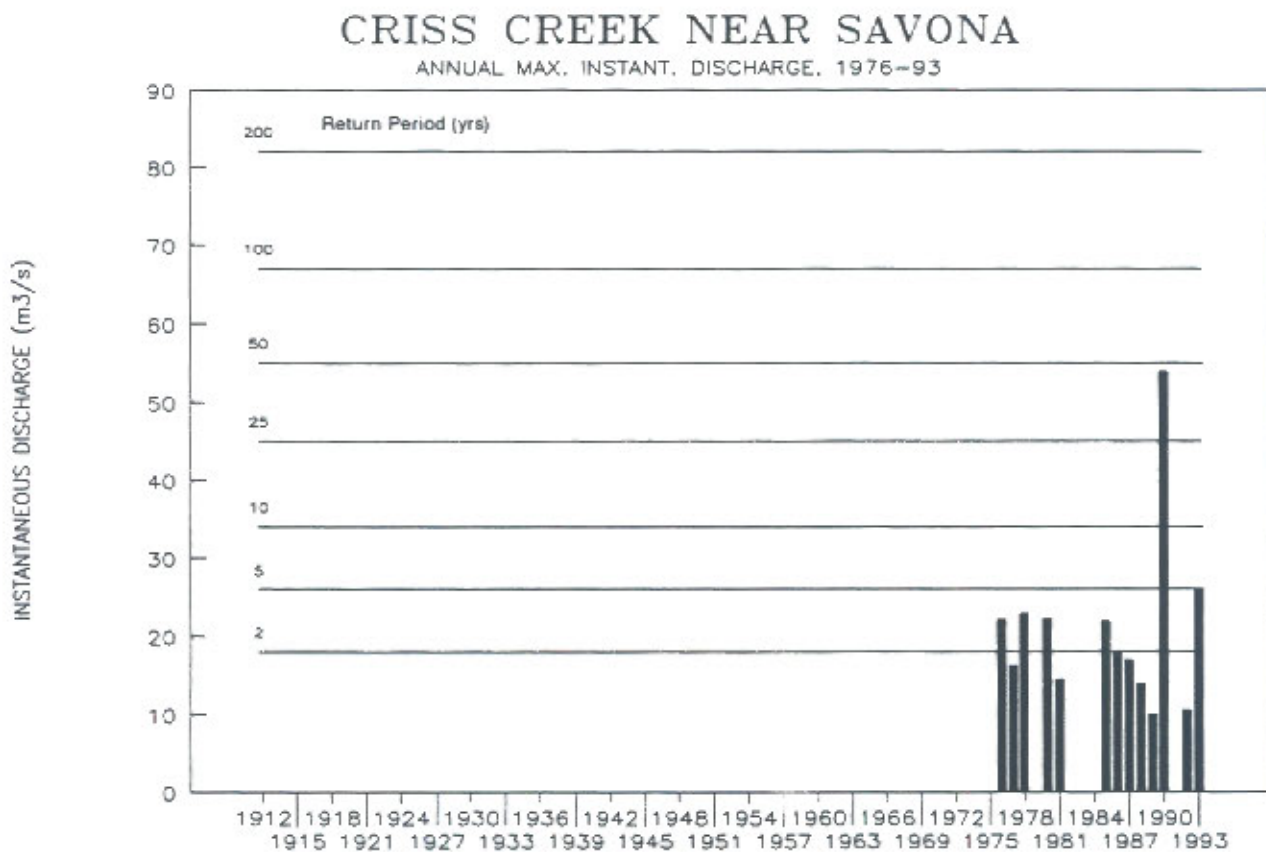
Figure 2.4.6: Historical variation in annual maximum daily and instantaneous discharge, Criss Creek near Savona

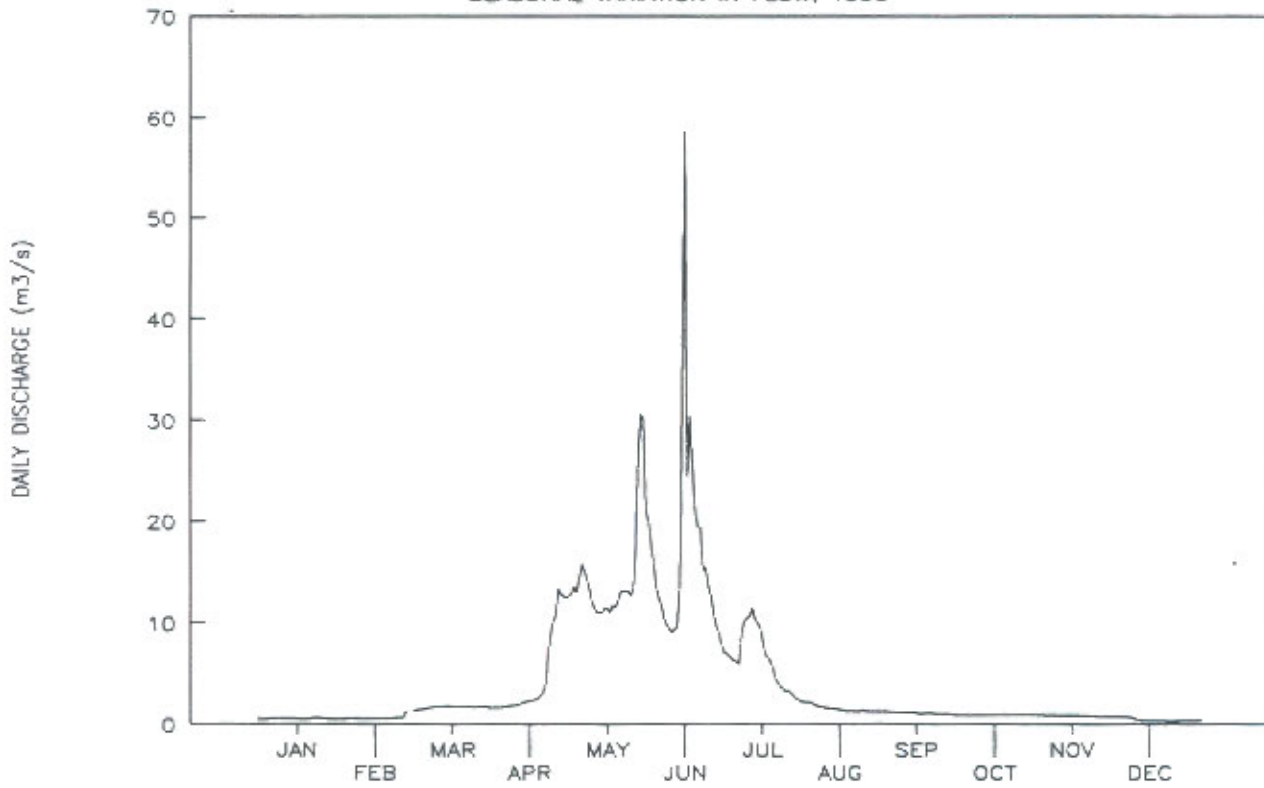
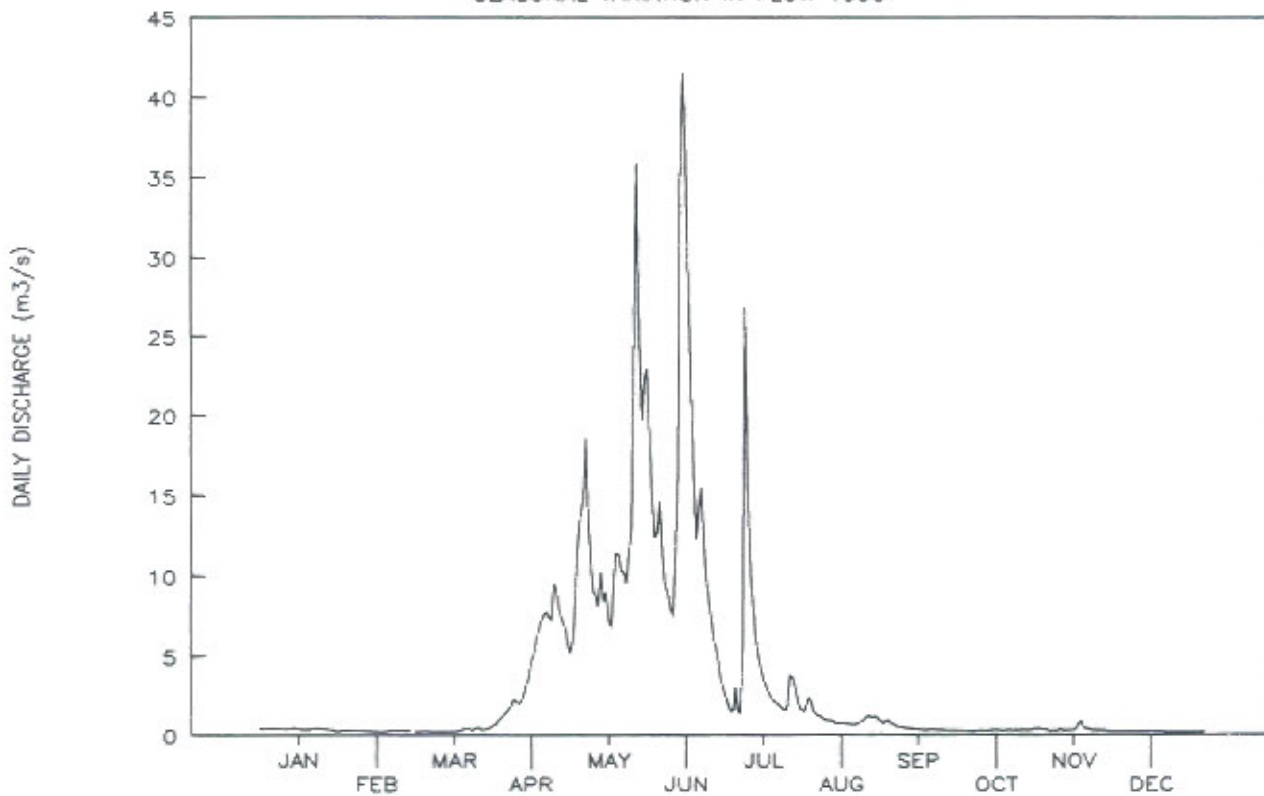
Figure 2.4.10: Seasonal variation in flow, Deadman River above Criss Creek and Criss Creek near Savona during 1990

A variety of studies were undertaken in order to investigate the reliability of the June 1990 flood discharge estimate. Daily discharge on Deadman River and Criss Creek during 1990 are shown on Figure 2.4.10. These graphs indicate that both sites experienced peaks during the spring and early summer with the maximum flow occurring on June 13 on Criss Creek and on June 14 on Deadman River. The June 14 flow on Deadman River was estimated on the basis of Rating Table 33 which was in use between June 13, 1990 and September 12, 1990 at which point the gauge was re-established as channel incision had lowered water levels below the gauge 0 elevation (Ken Barker, Pers. Comm.). The above analyses indicate that Rating Table 33 was in use for such a short period of time, and the river bed was sufficiently mobile, that the reliability of the June 14/94 discharge needed to be reviewed with the WSC district office in Kamloops. Discussions with Ken Barker, the officer in charge, indicate that streamflow was measured on June 14, 1990 as 60.6 m³/s and the daily discharge value of 58.5 m³/s therefore appears to be reliable.

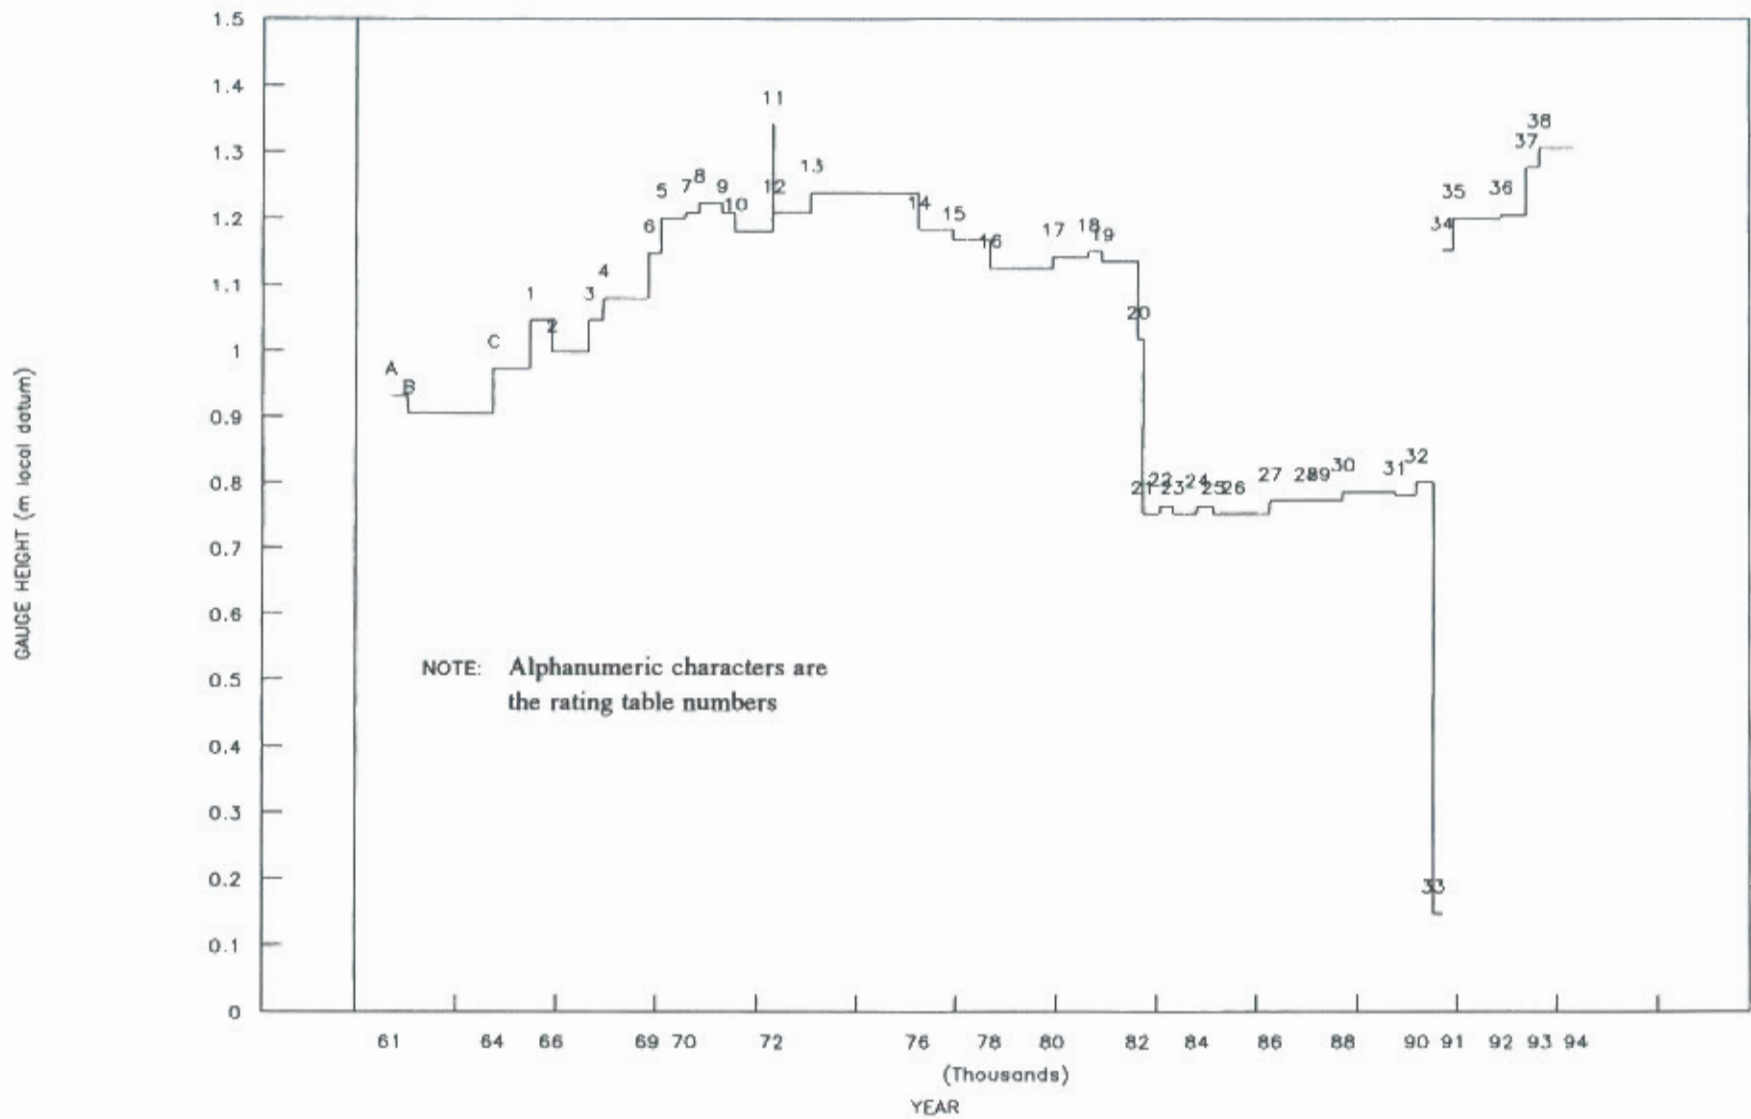
Figure 2.7.1: Specific gauge plot for Deadman Creek above Criss Creek showing the historical variation in the gauge elevation for a discharge of 1.65 m³/s.

again in 1990 (of about 70 cm). Discussion with Steve Maricle indicates that a weir was placed across Deadman River approximately 150 m downstream of the Criss Creek gauge in approximately 1920 to divert water into an irrigation channel. This weir washed out in approximately 1978. The documented channel aggradation and downcutting may therefore merely reflect channel readjustment following the loss of the downstream weir, rather than a more widespread phenomenon resulting from a change in sediment loading.

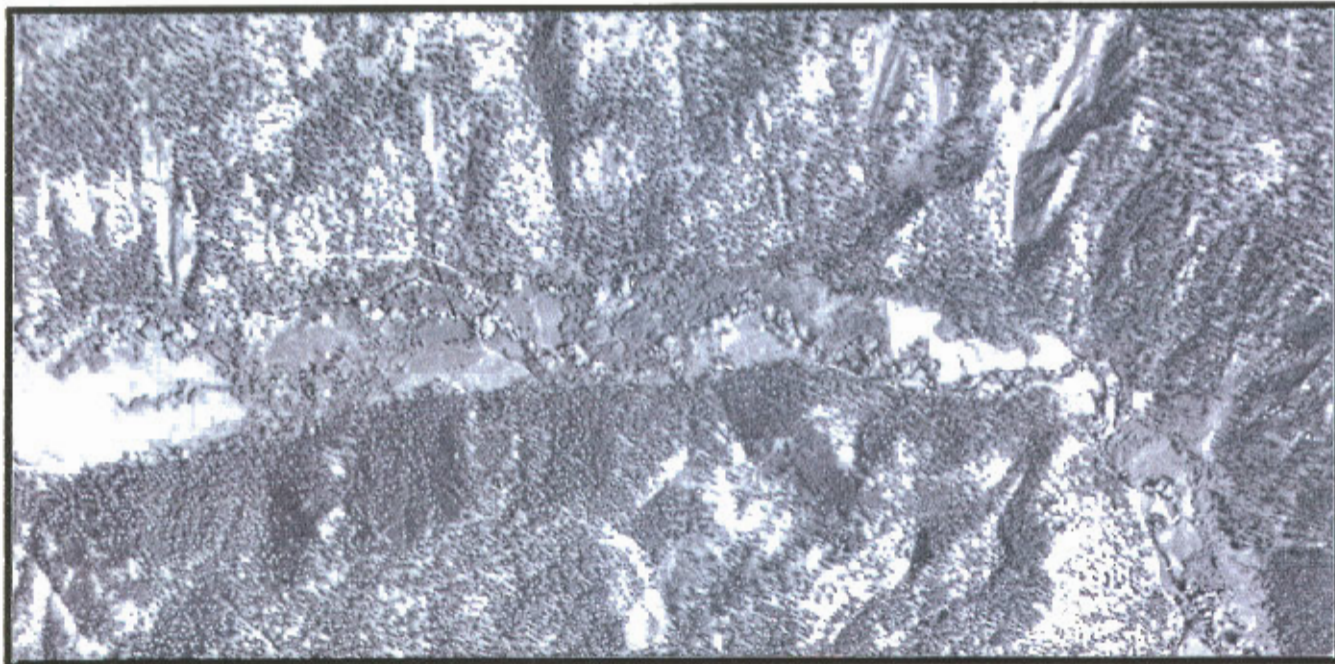
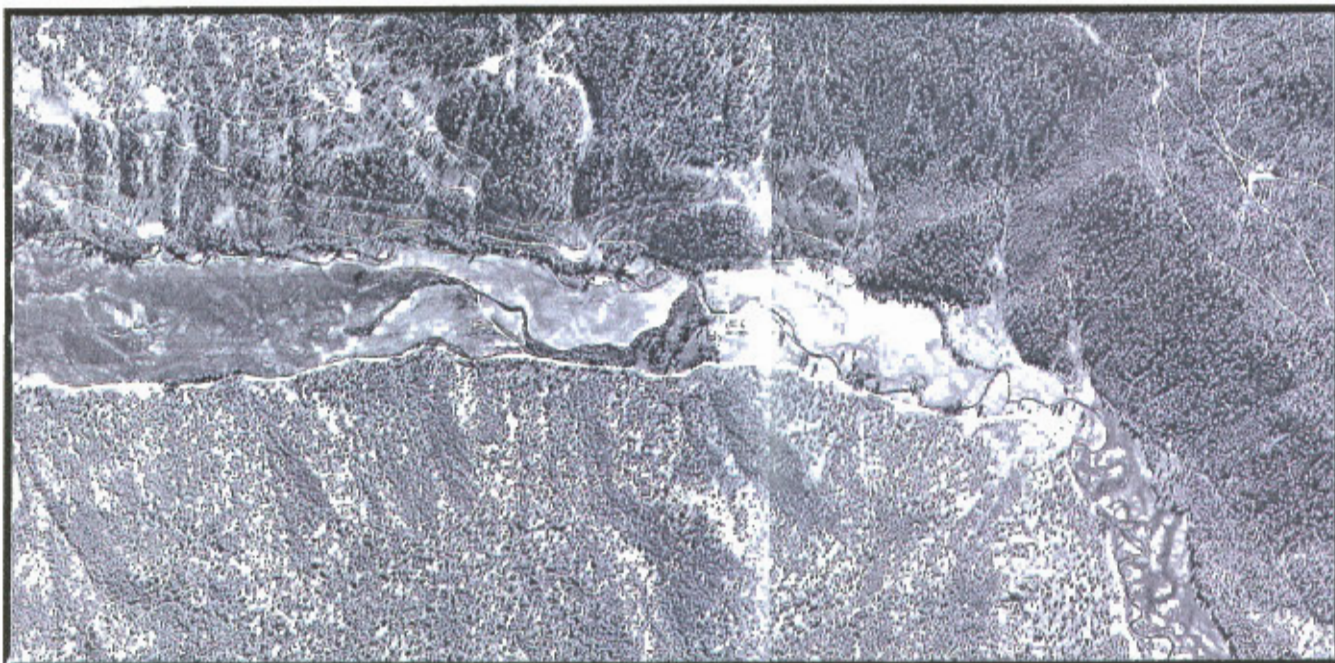
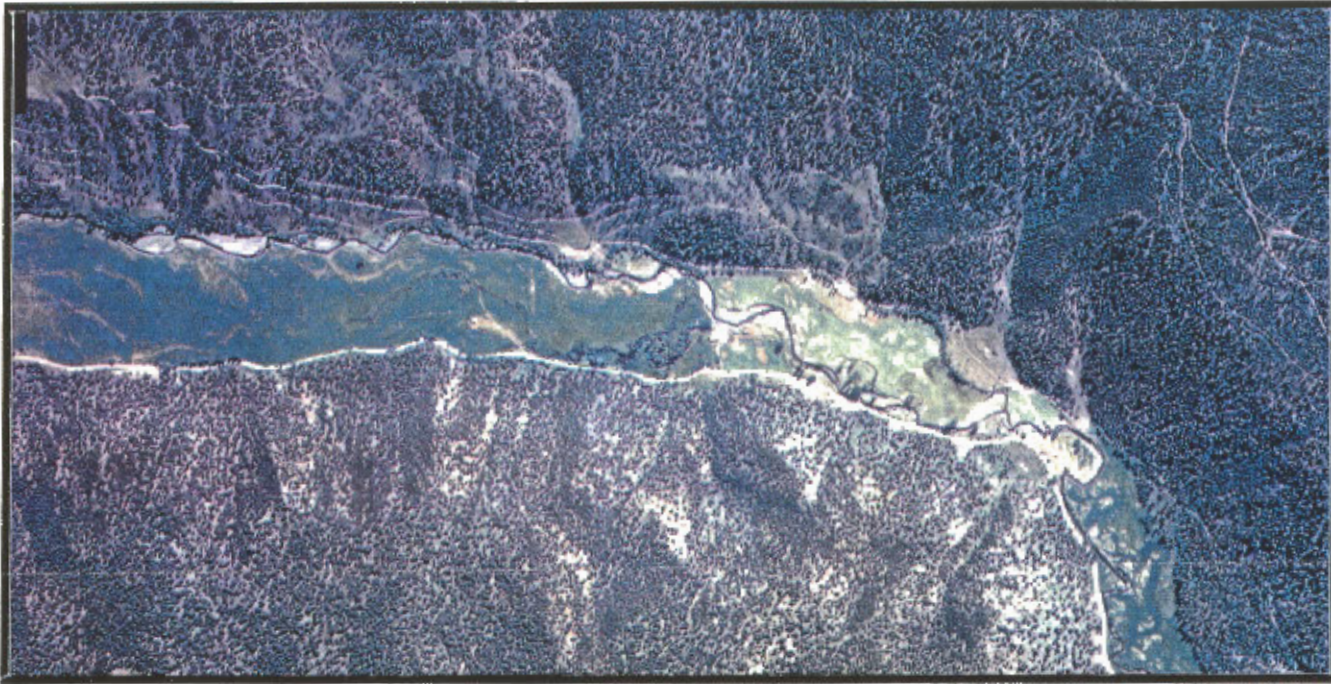
Figure 3.1.4: Historical changes in channel morphology, Upper "Dockstader" Ranch.

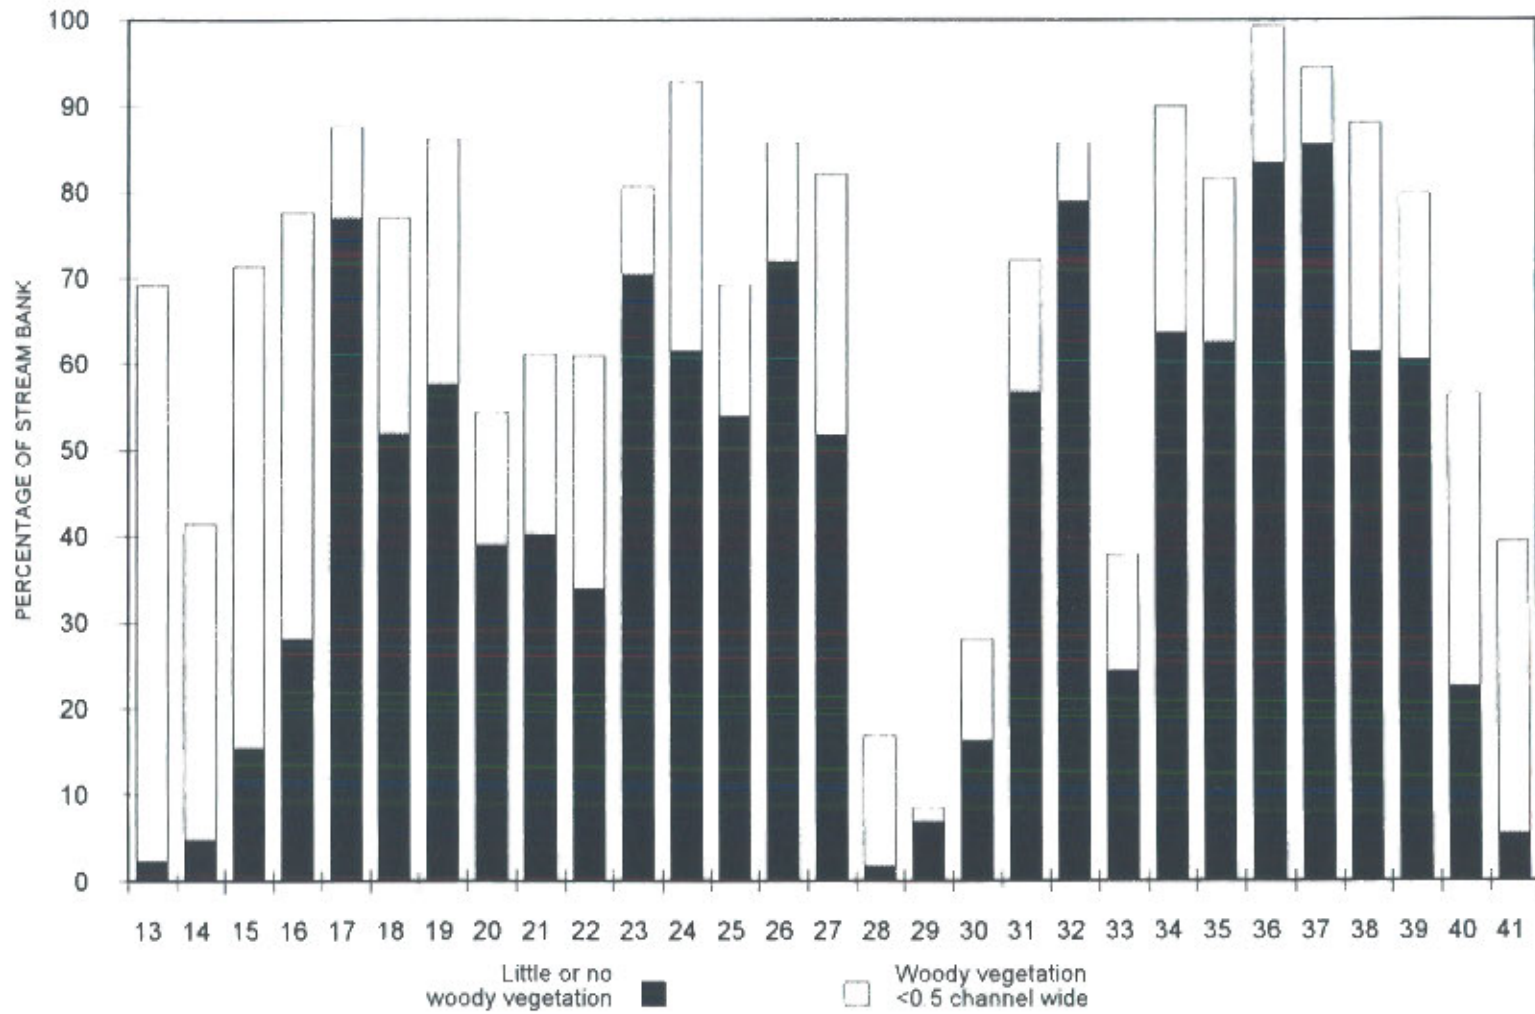
Figure 3 1.5: Distribution of unvegetated or poorly vegetated banks on Deadman River between Km 12 and Km 41
