Deadman River Channel Stability Analysis

Fraser River Action Plan
Department of Fisheries & Oceans
555 West Hastings Street
Vancouver, B.C. V6B 5G3

**Canadian Manuscript Report of
Fisheries and Aquatic Sciences No. 2310**

DEADMAN RIVER
CHANNEL STABILITY ANALYSIS

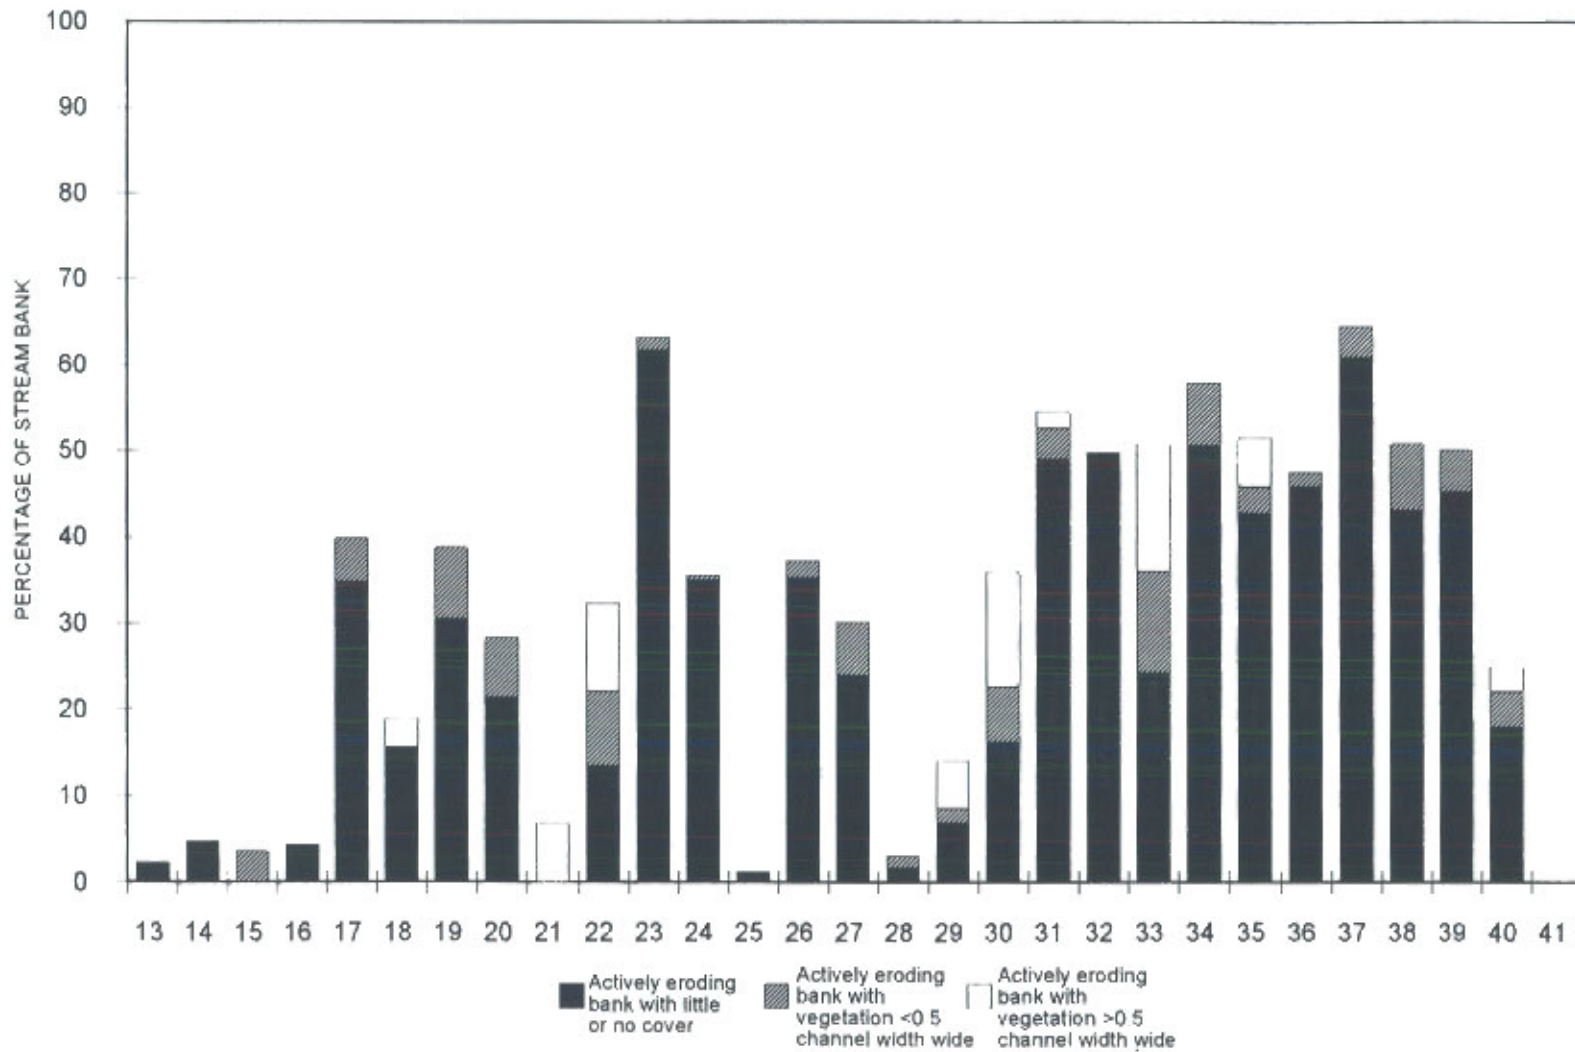
Figure 3.1.6: Distribution of actively eroding stream banks on Deadman River between Km 12 and Km 41

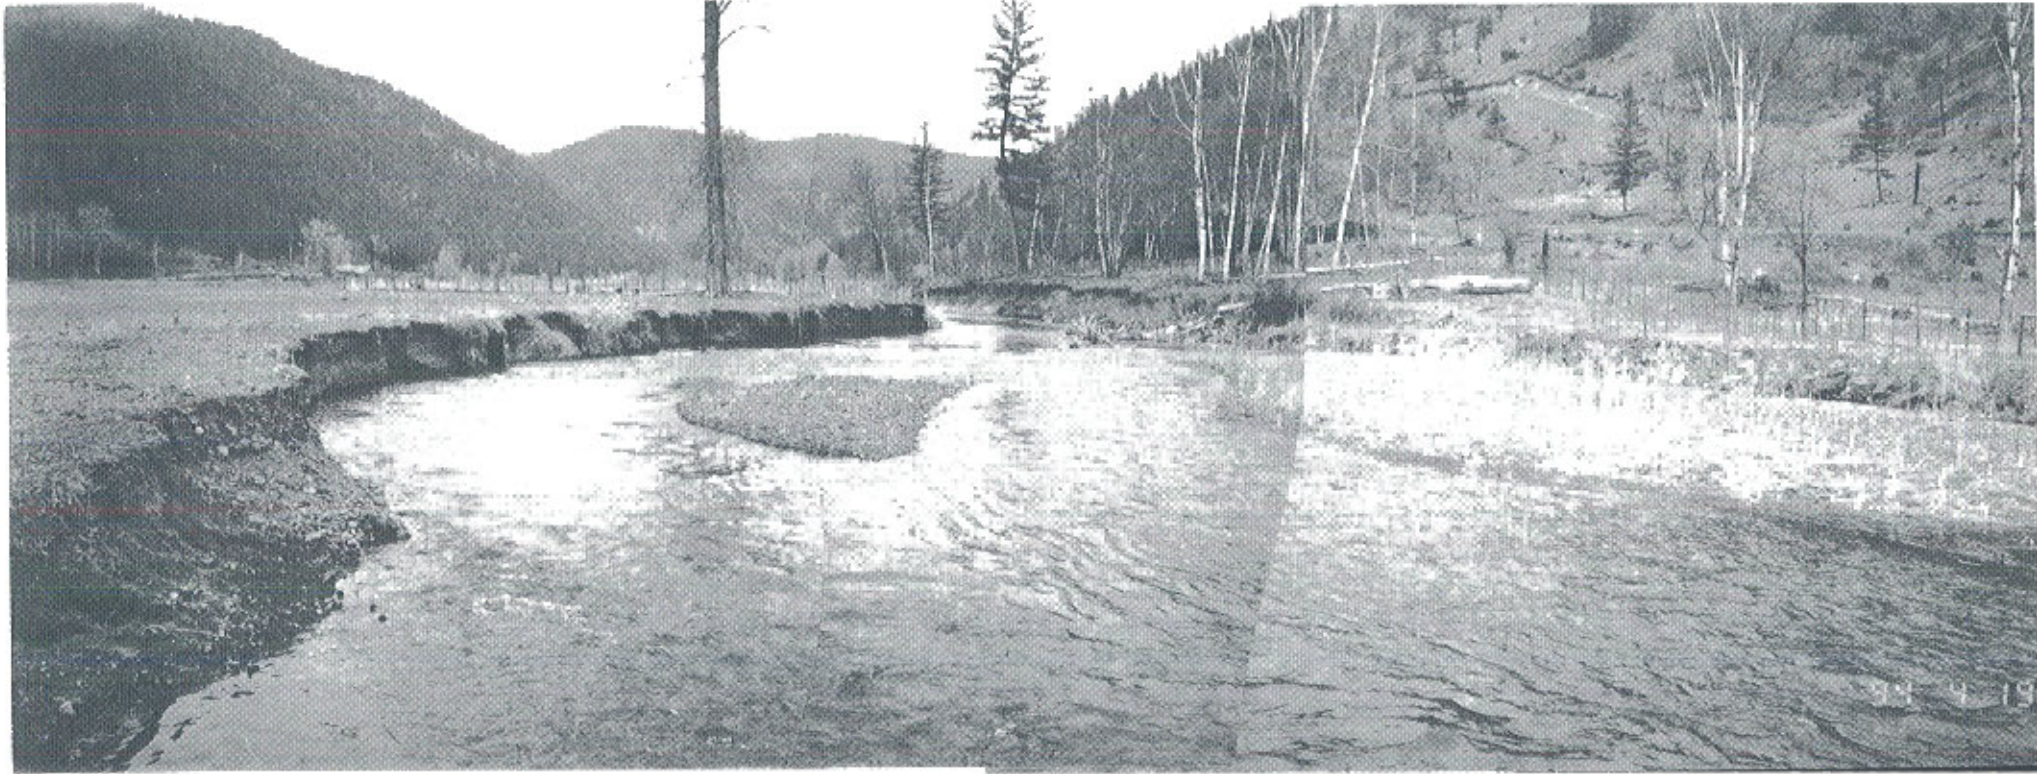
Plate 3.2.1: Looking upstream to an eroding section of pasture located on the "Dockstader" Ranch.

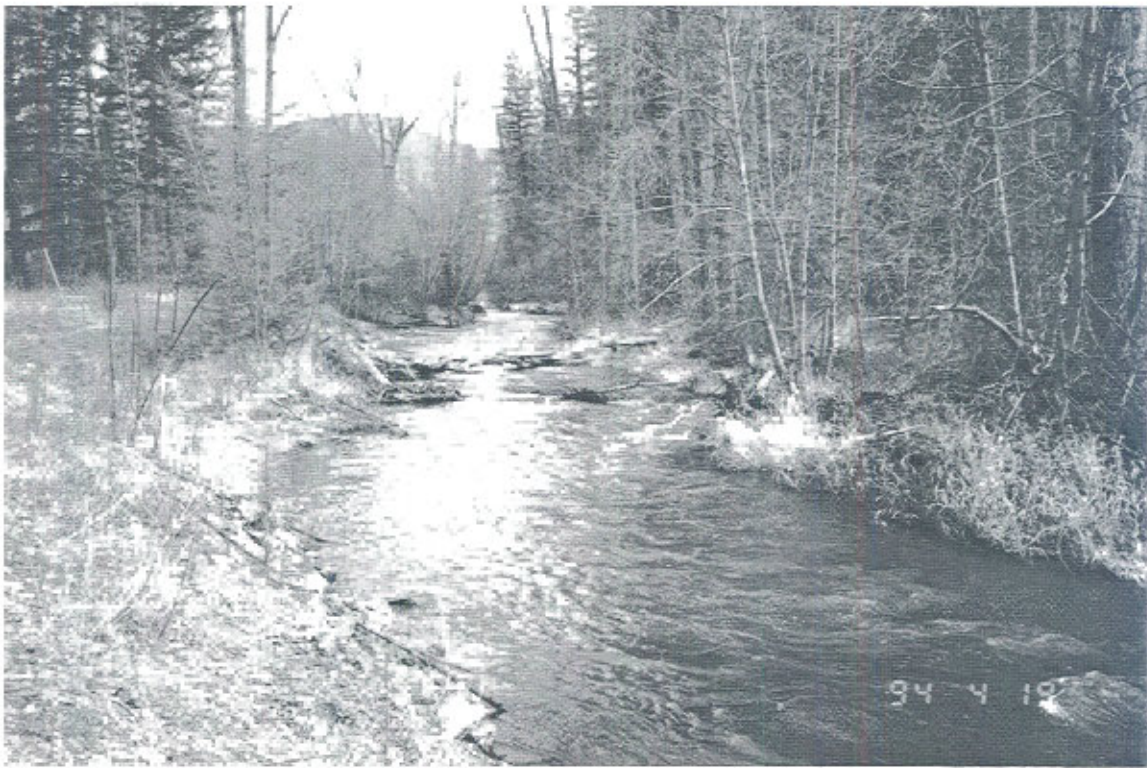
Plate 3.2.4: Looking upstream on Deadman River below Gorge Creek, showing the stable character of well-vegetated banks.

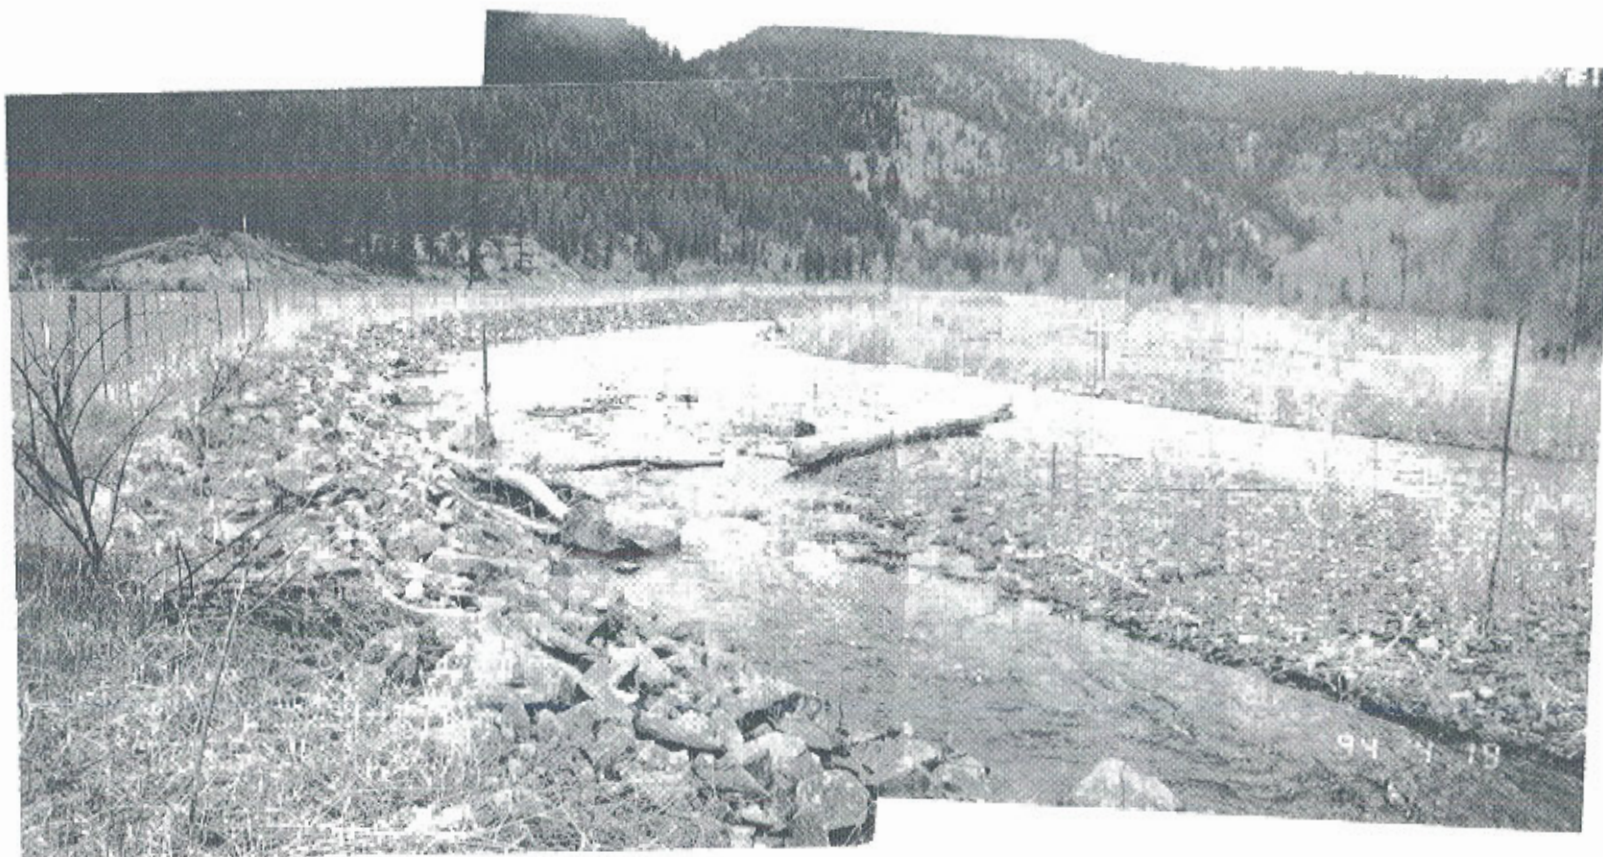
Plate 3.2.5: Looking upstream on rip-rap placed in the "Dockstader" Ranch. Note the single boulders used to enhance fisheries habitat values.

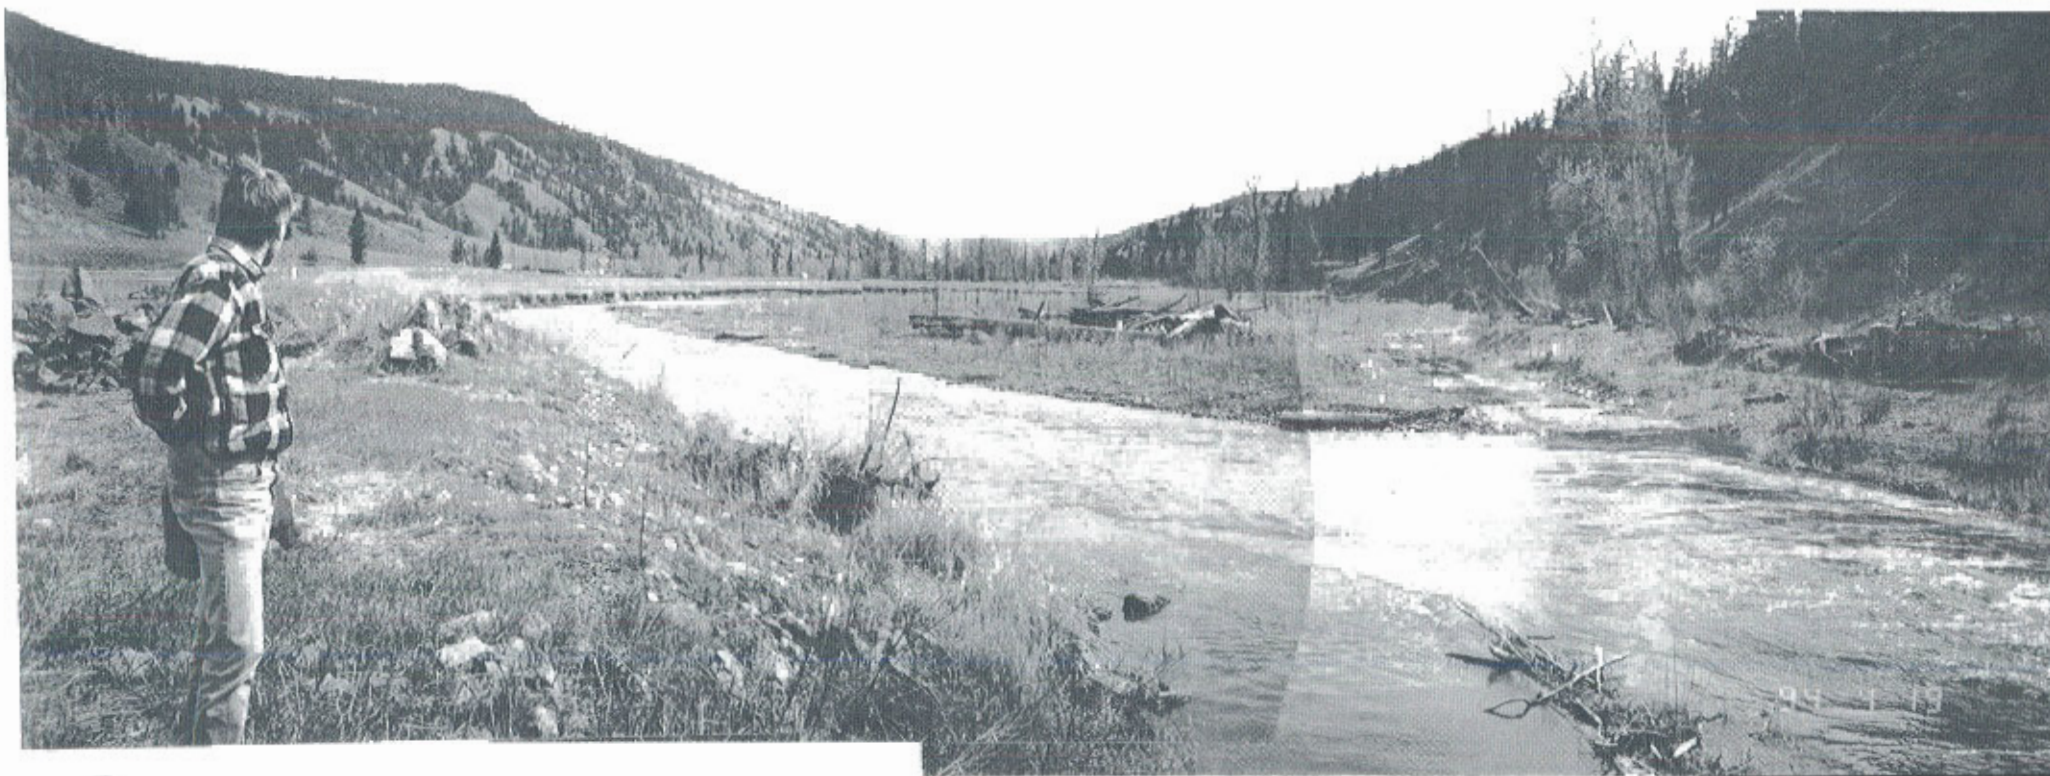
Plate 3.2.7: Looking downstream towards an area of sediment accumulation which occurs immediately downstream of a rip-rapped section of channel on the Craig Ranch, showing the resulting erosion of pasture land.

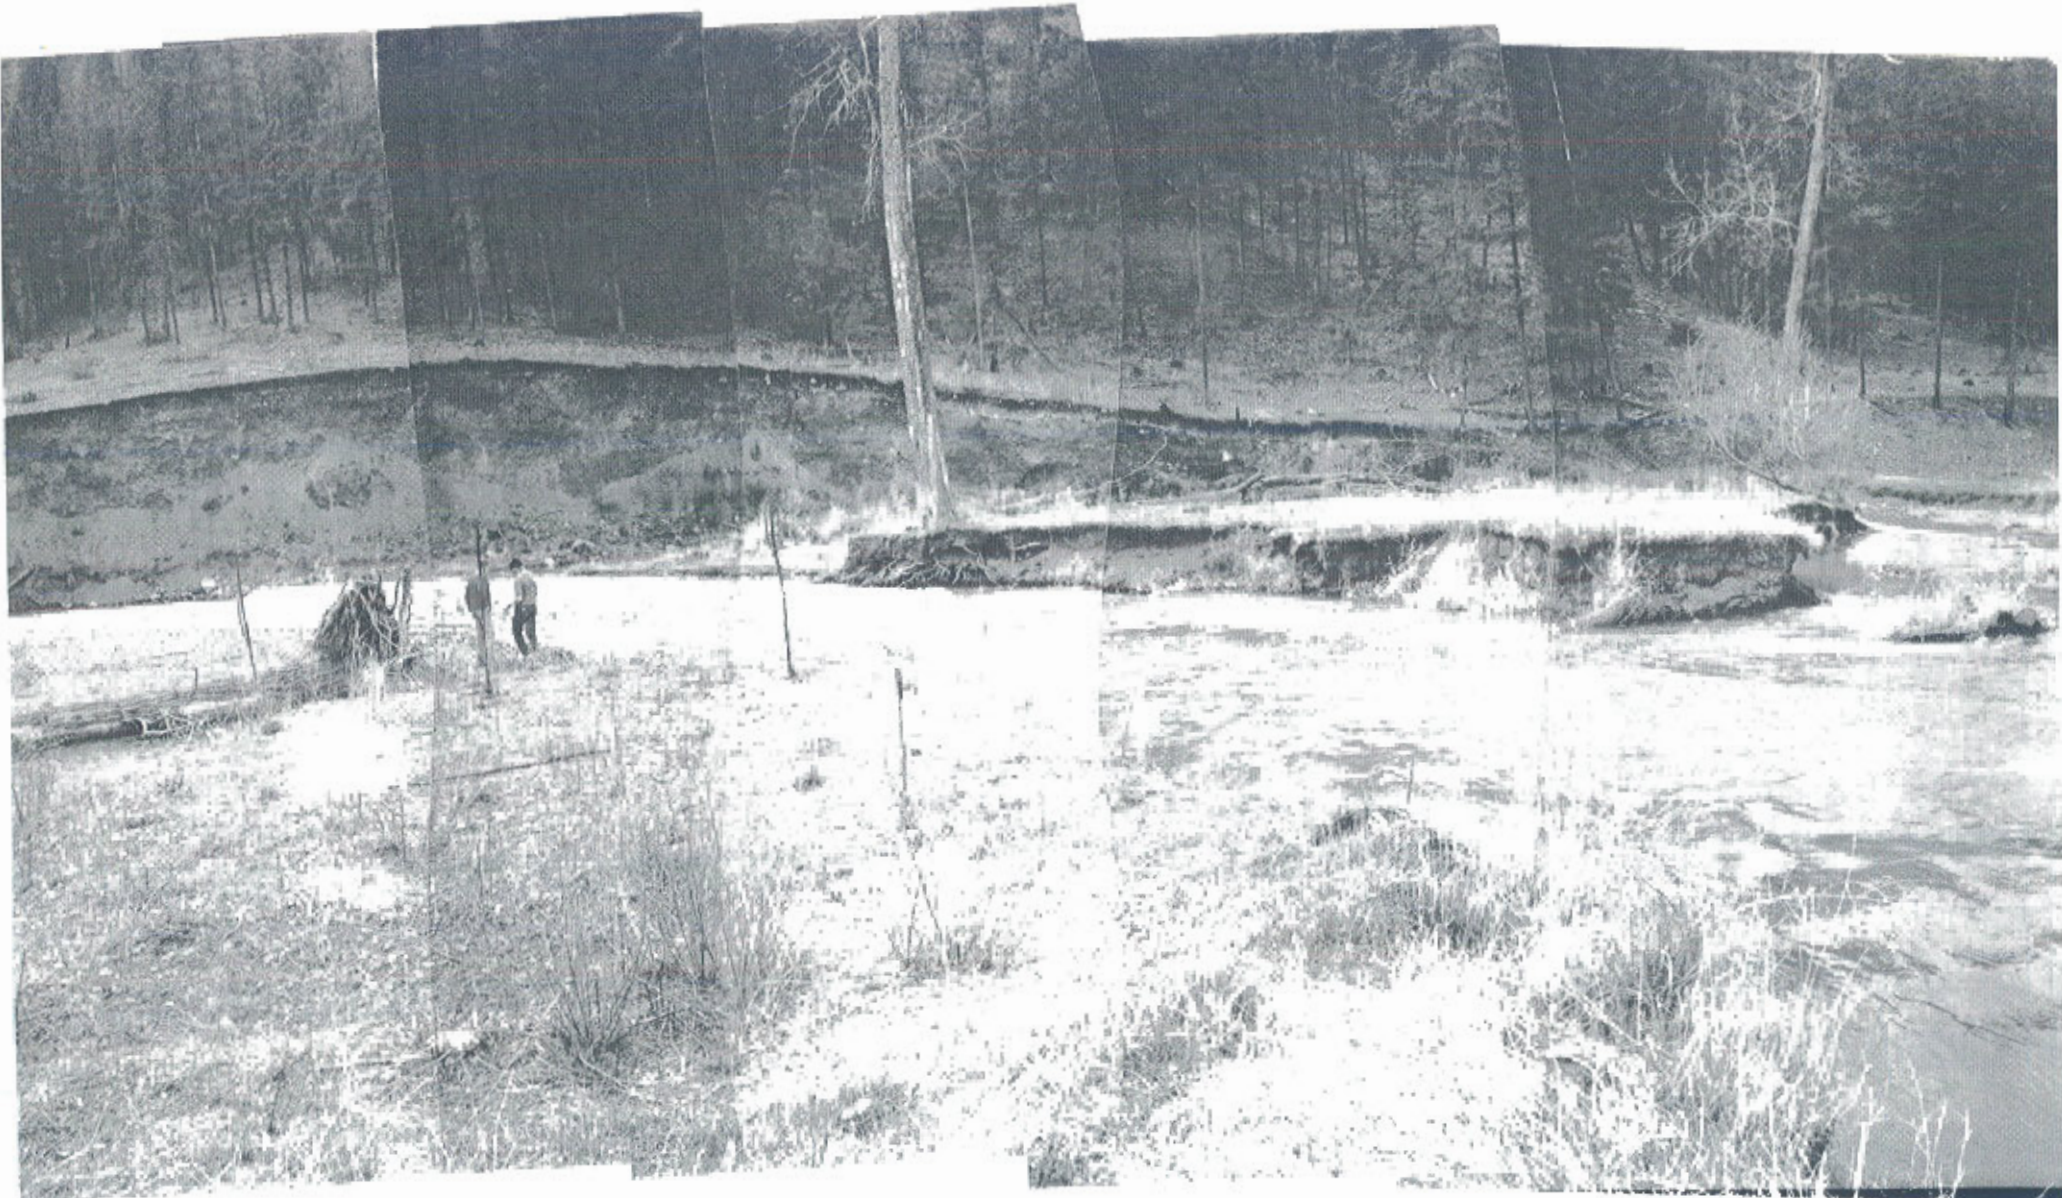
Looking downstream on Deadman River to an eroding section of valley wall located immediately downstream of a rip-rapped section of channel on the Craig Ranch.

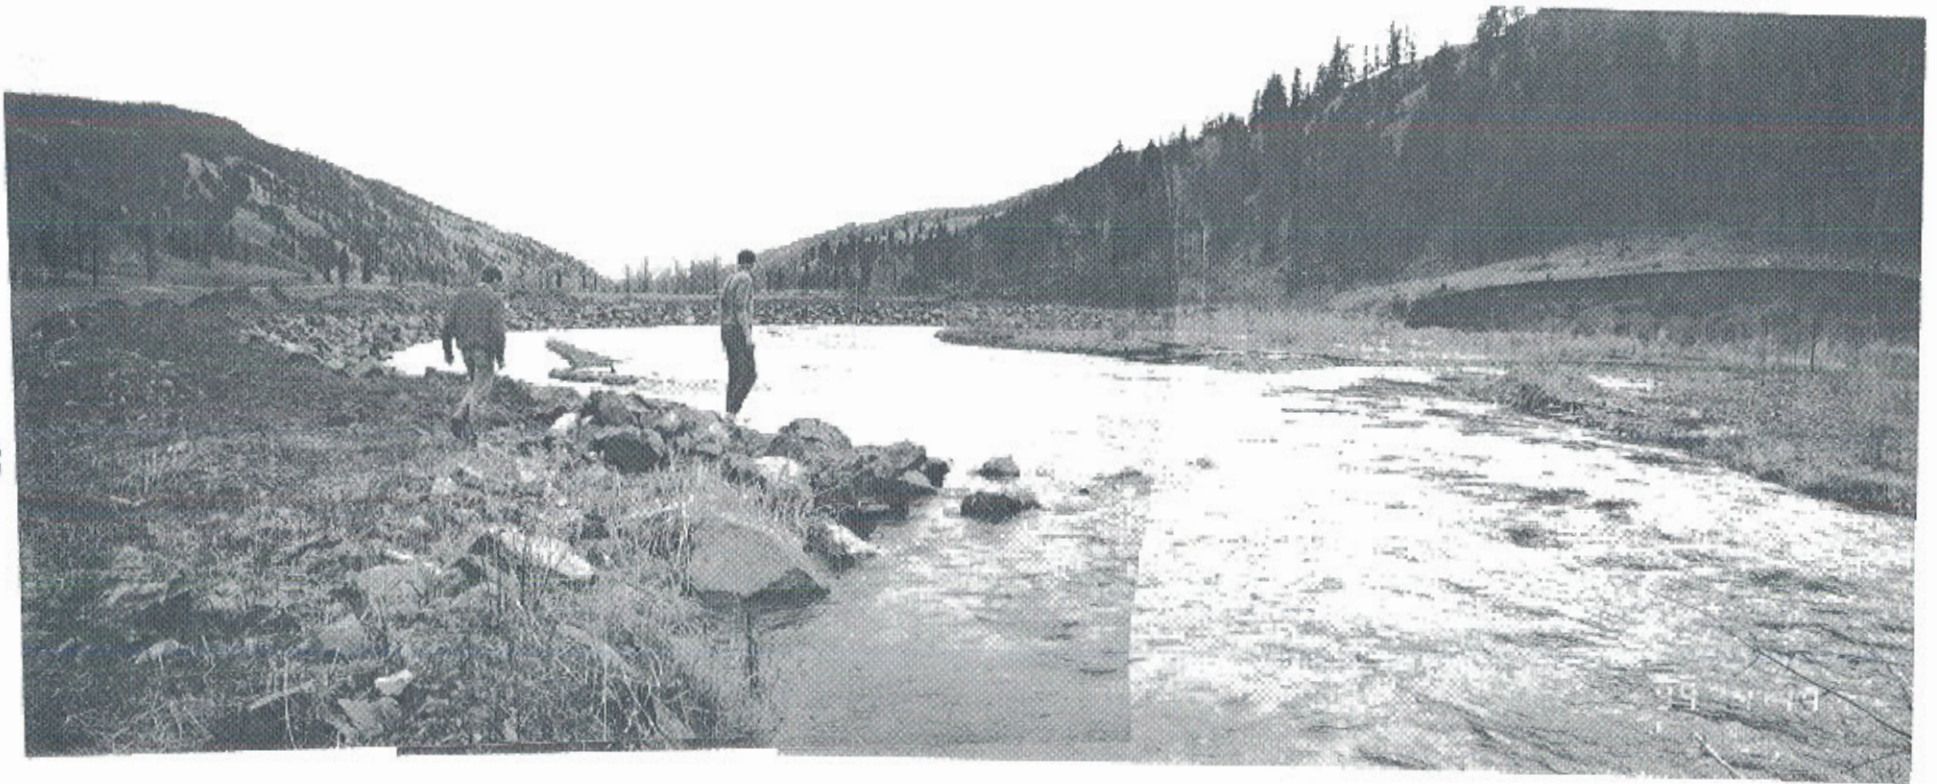
Plate 3.2.9: Looking downstream to a short spur placed on Deadman River in an attempt to direct the stream back into a former channel on the Craig Ranch.

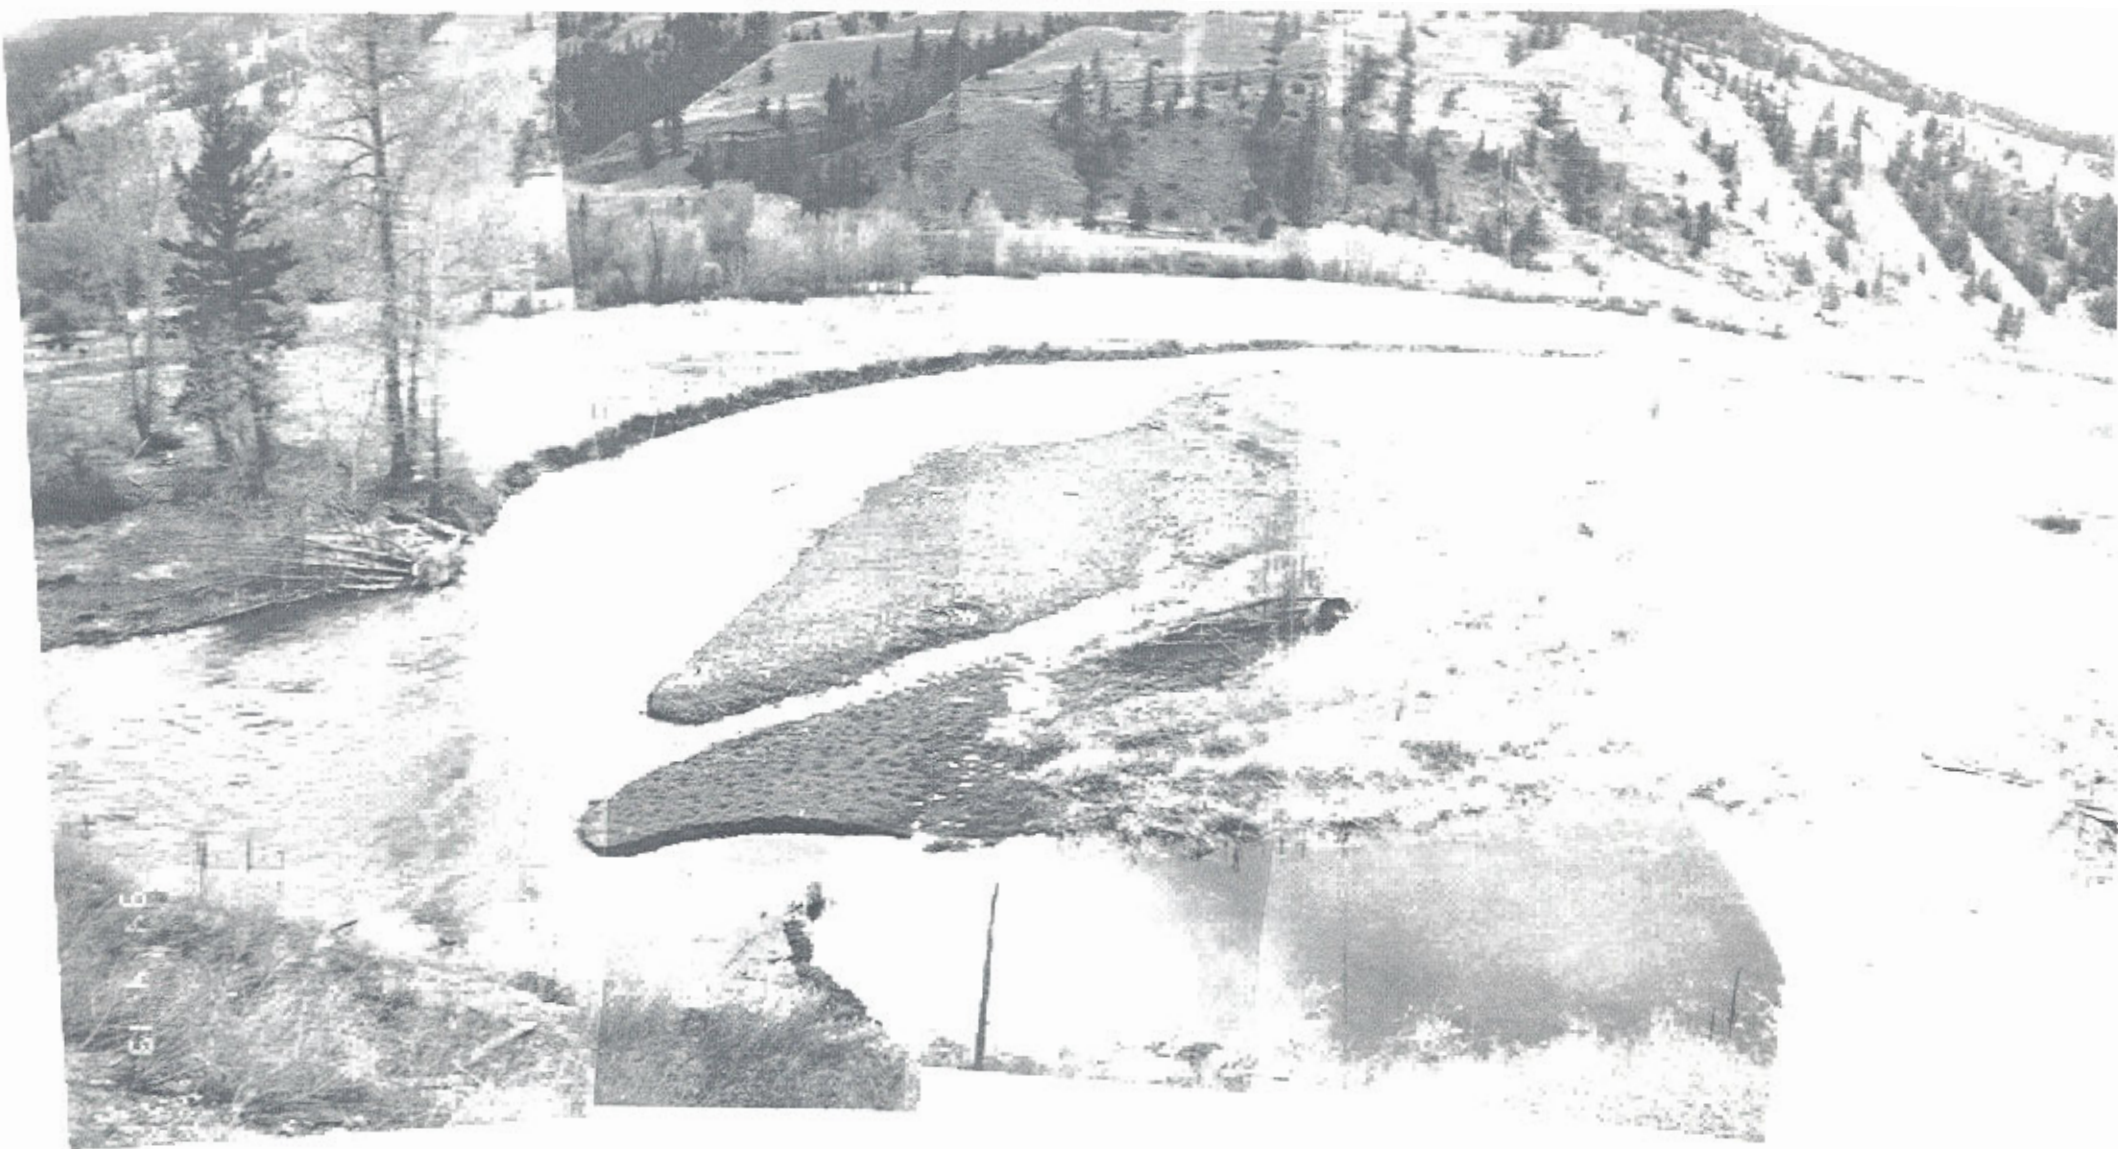
Plate 3.2.10: Looking upstream to an eroding section of pasture and a large point bar on lower Deadman River. Note fencing and cabled debris.

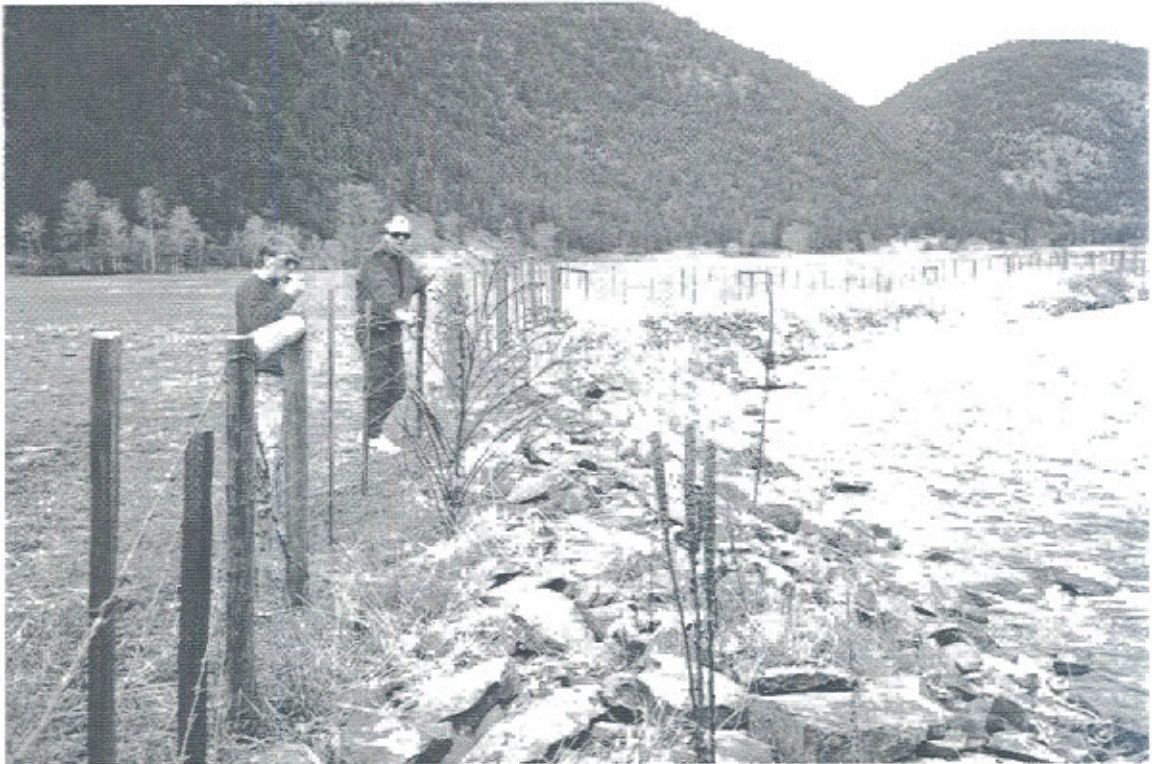
Plate 3.2.12: Looking upstream along fencing on the "Docksteader" Ranch, showing the establishment of burdock

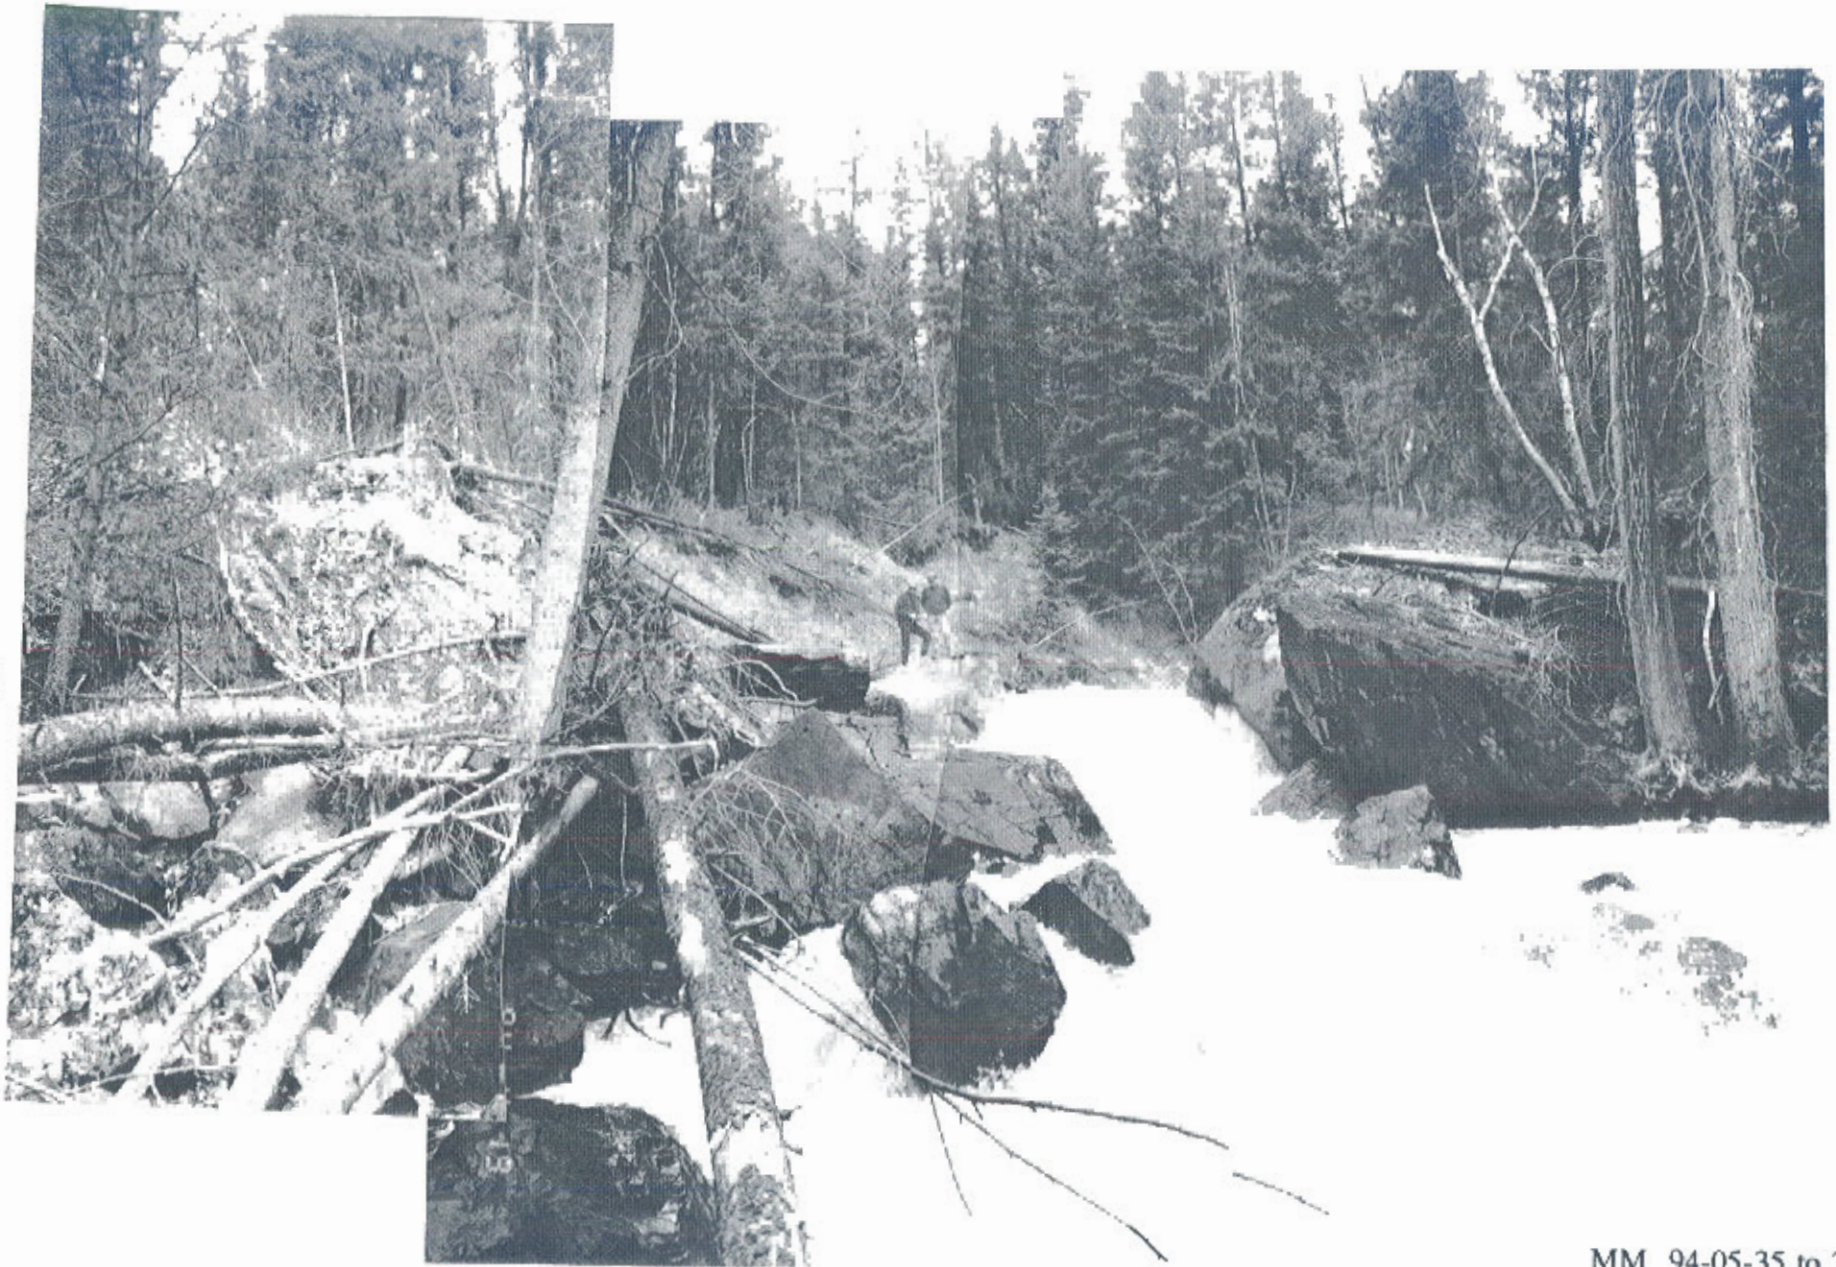
Plate 4.2.2: Looking upstream to the terminus of an earth flow located approximately 700 m downstream of Mowich Lake.

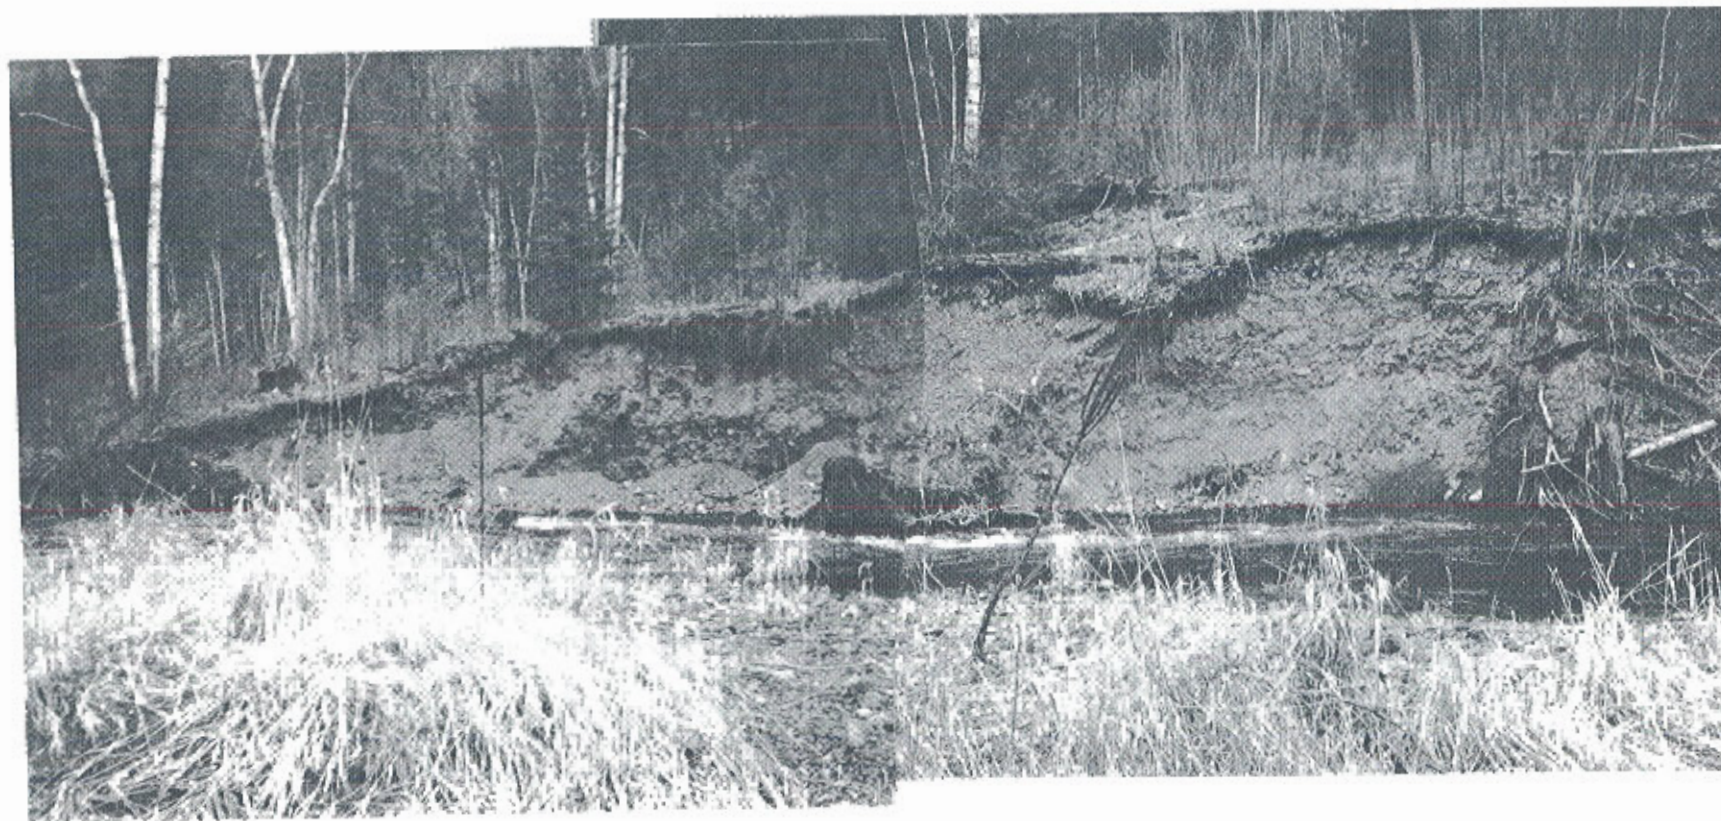
Plate 4.2.3: Looking upstream to an eroding area on the left bank valley wall. Location is below Vern Bullwinger's property and 2 km upstream of the "Dockstader" Ranch.

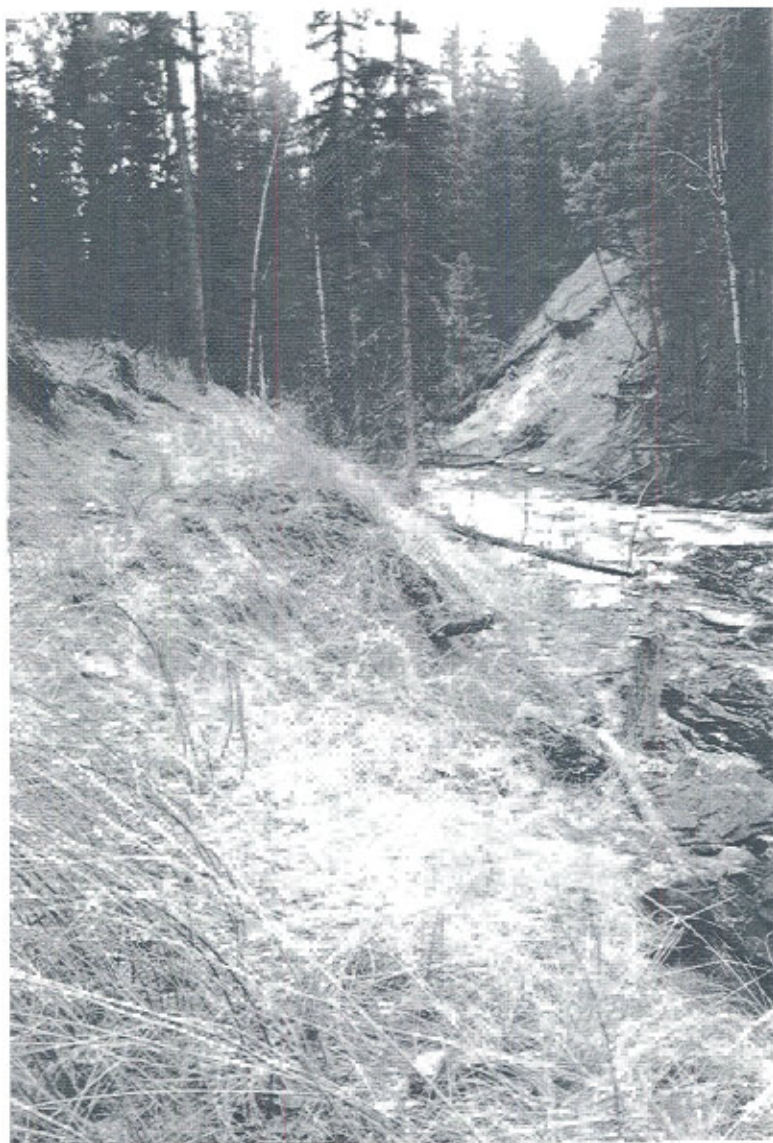
Plate 4.2.4: Looking downstream from the 1st bridge below Mowich Lake showing an area where sidecast material (foreground) from skid road construction has entered Deadman River.

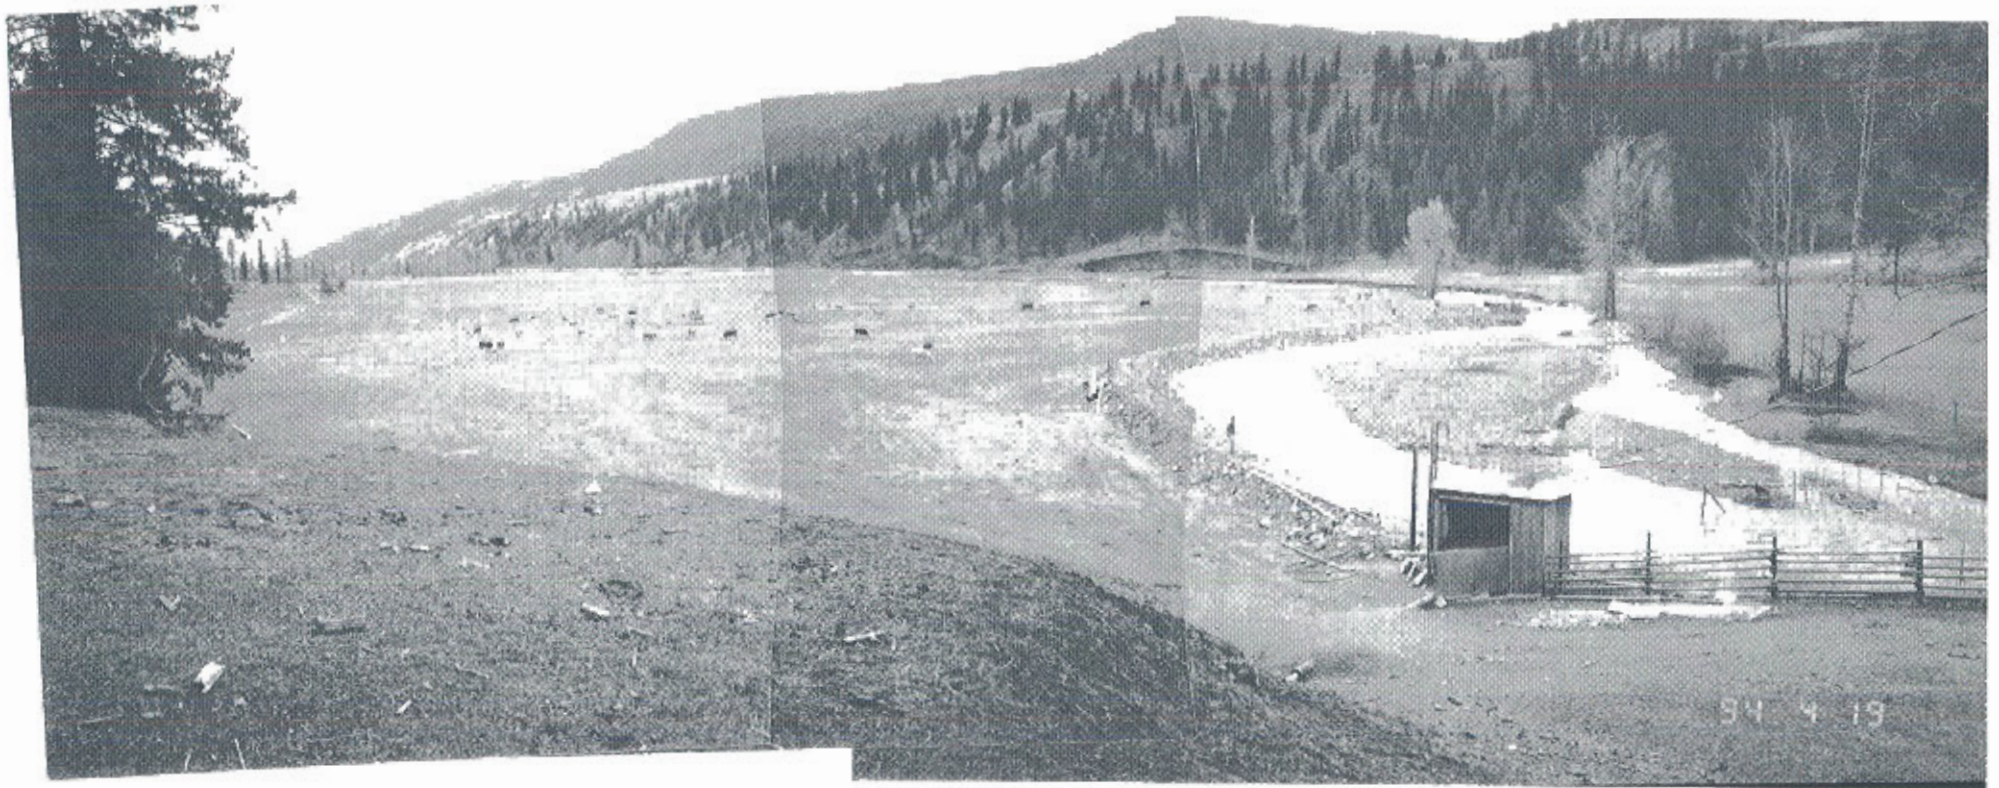
Plate 5.0.1: Looking upstream to a remnant back channel on the "Dockstader" Ranch. The channel was observed to contain considerable numbers of juvenile salmonids.
