**INVENTORY AND RATING OF
SALMONID HABITATS IN THE
VICINITY OF QUESNEL, B.C.
I. Report**

D.G. Hickey and J.A. Trask
ECL ENVIROWEST CONSULTANTS LIMITED
Suite 204 - 800 McBride Boulevard
New Westminster, B.C.
V3L 2B8

ECL Project No. 101-14

July, 1994

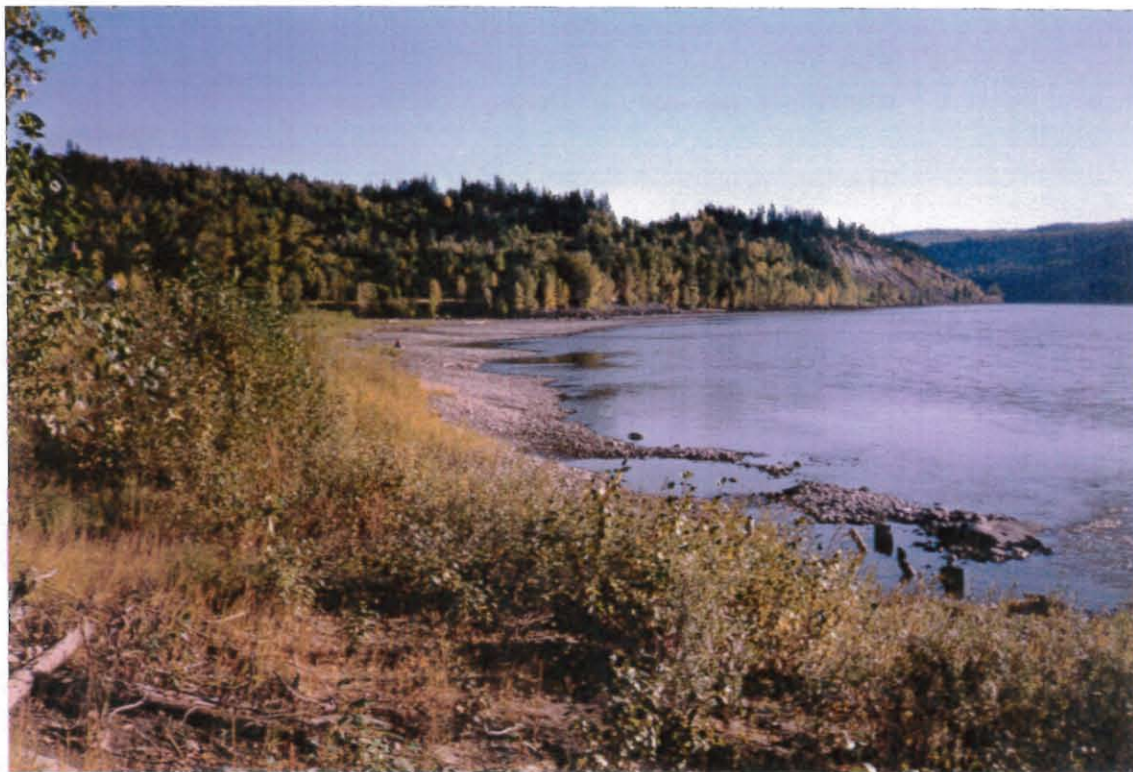
Photograph 1. Lower riparian community - Fraser River

Photograph 1 shows a representative lower riparian community established in sandy soils deposited over a cobble/boulder shoreline adjoining a low floodplain bench. The foreshore is dominated by sandbar willow and the backshore is predominantly young black cottonwood saplings. Such streambank sections have high salmonid habitat values associated with them.

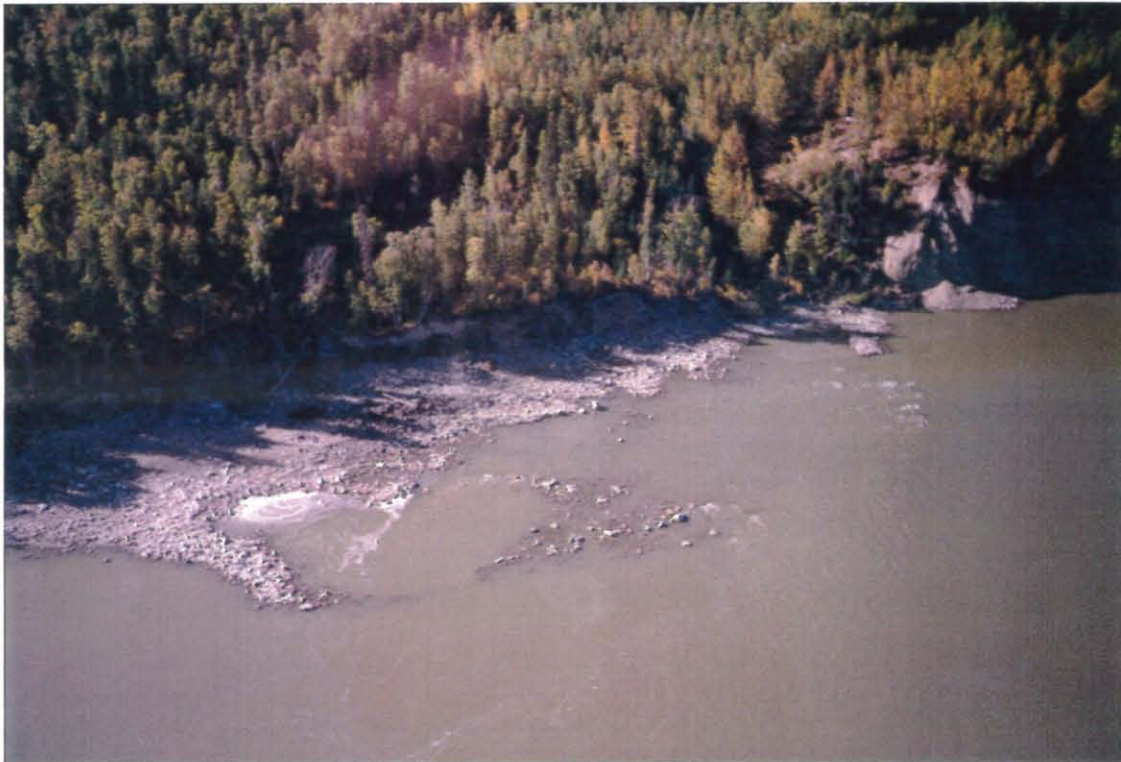
Photograph 2. Coarse substrates and complex current patterns with high salmonid habitat values - Fraser River.

Photograph 2 shows a boulder-strewn shoreline where breaks and eddies in the flow adjacent to deeper water offer protection from mainstem flows, foraging opportunities and cover for juvenile salmonids in the interstices between boulders. Such areas are likely important resting areas for fry, and, where deep enough, would provide adequate overwintering habitat for resident and anadromous species. Adult fish migrating upstream may also favour such an area for resting or simply to take advantage of reduced nearshore flows.

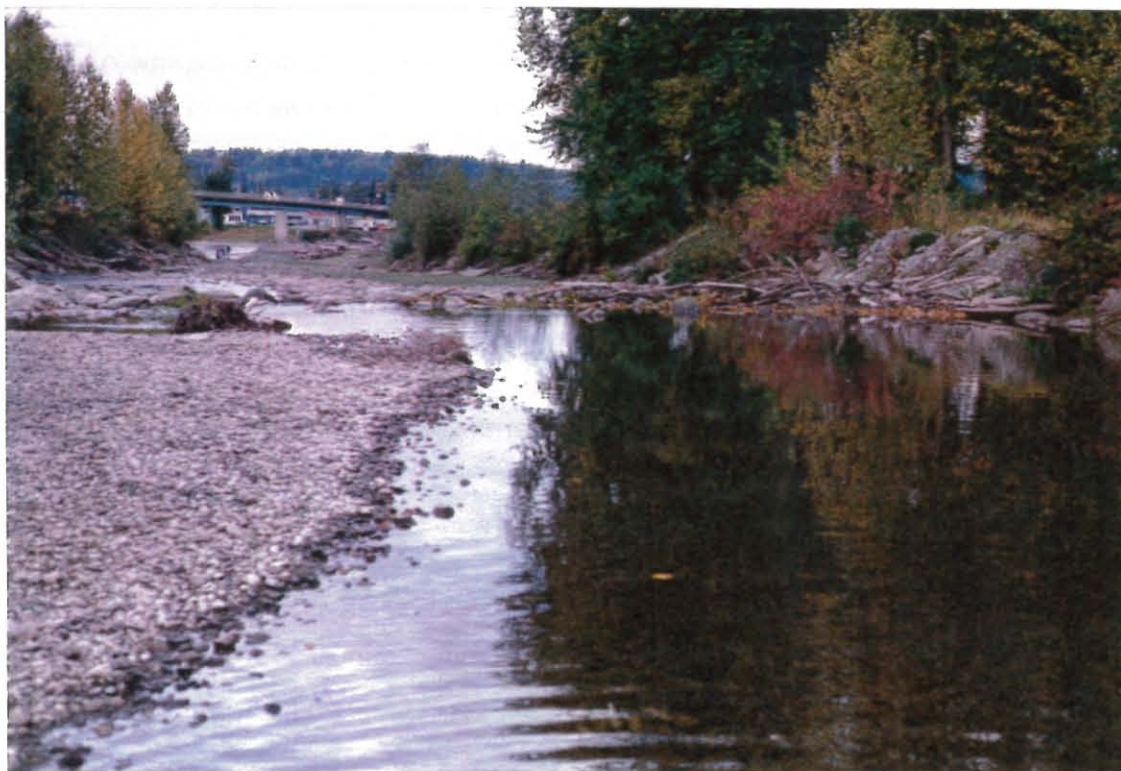
Photograph 5. Spawning gravels in the lower portion of Baker Creek.

The first 500 m of Baker Creek upstream from the confluence with the Fraser River contains relatively high proportions of gravels that have washed downstream during flood events and have accumulated in this lower gradient section. Photograph 5 shows much of this long section in which pink salmon were observed spawning. Note that this section is easily accessed by people and salmon are easily disturbed where water depth and overhead cover is limited. A man-made dam constructed with large

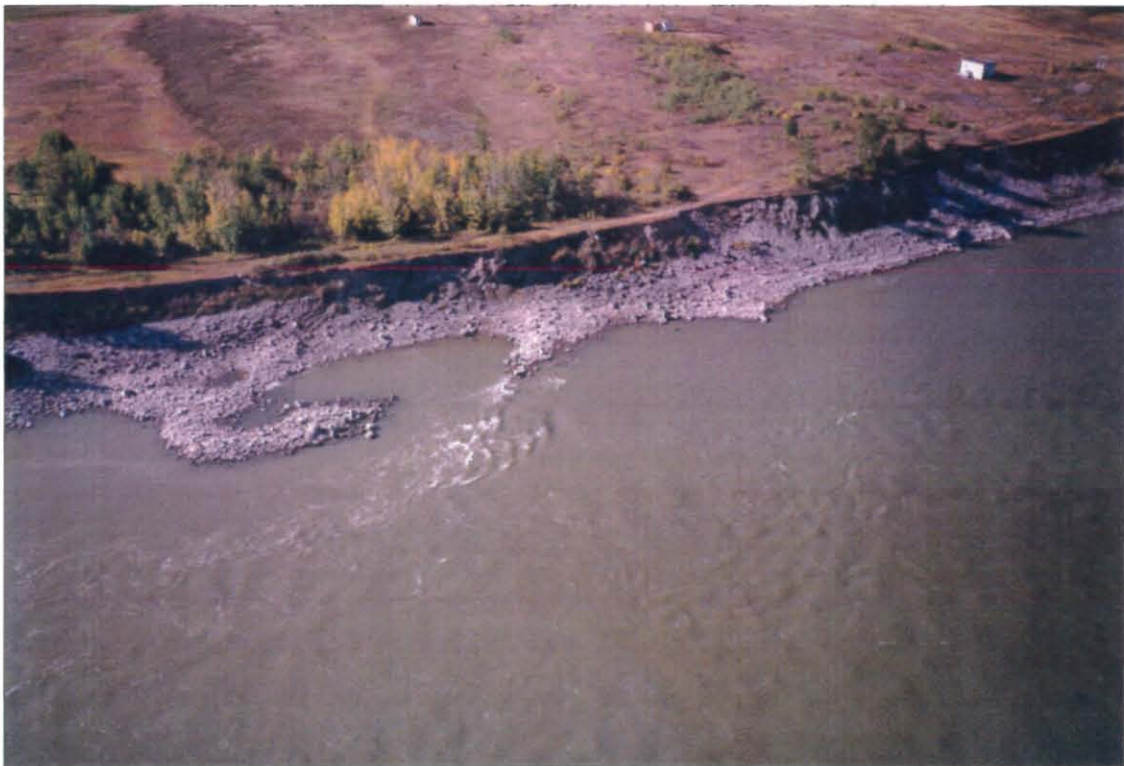
Photograph 7. Removal of riparian shrubs and trees can destabilize banks - Fraser River.

shrubs and trees from the banks which subsequently causes instability due to the fragile nature of bank substrates (Photograph 7). Once destabilized and bank erosion initiates, the slope of the banks general increases, lowering the possibilities for the establishment of native shrub and tree species which would encourage streambank stability.

To achieve restoration of natural riparian plant associations it is necessary to first address bank stability. Where sections of eroding bank are relatively steep it may be necessary to construct a berm of large rip rap materials along the bottom of the bank with concurrent regrading of the bank to achieve a minimum 2:1 slope. Where streambanks are fairly high (> 5m), regrading to a 2:1 slope may involve relatively large dedications of shoreline (> 10 m from the waters edge). While greater benefits would be provided by vegetated riparian zones, it may be difficult to secure large parcels of land. In cases where an agreement with the land owner cannot be reached to secure these dedications, alternatives should be pursued towards reaching a compromise that still affords a reasonable reestablishment of riparian communities. One such compromise could feasibly include creating a low riparian bench with steeper rip rapped banks upslope. This would decrease the overall width of riparian plant reestablishment but in doing so offers a compromise or basis for negotiations with land owners to achieve riparian dedications and bank stabilization. Constructing a series of 2 or more steps, contained by berms of rip rap materials, would also allow limited riparian planting in the different riparian zones and would provide the vertical stratification found between the herbaceous and shrub species of the lower riparian zone and larger shrubs and trees of the upper riparian zone. This would be preferred over more extensive rip rapping to achieve bank stability and would allow for better development of plant communities.

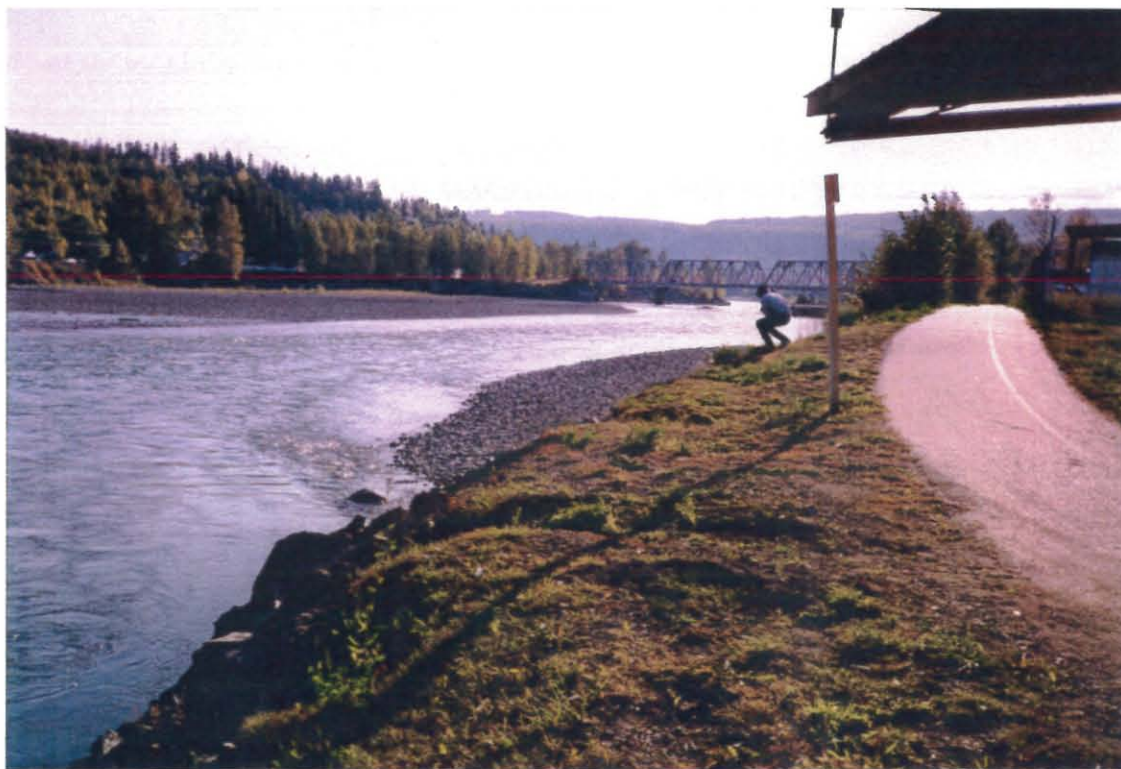
Photograph 8. Recreational trail encroachment to the top of bank - Quesnel River.

The Riverfront Trail system links several of the City's parks and follows along the banks of the Fraser and Quesnel rivers, and the lower section of Baker Creek. Pedestrian traffic and landscaping activities are the primary sources of disturbance to the riparian communities along the trail. Controlling access points and decommissioning trails in riparian zones

would encourage the restoration of riparian plant communities through natural seed and vegetative propagation from the existing fragmented areas of natural vegetation. Additional plantings of shrubs and trees along sections of the upper banks currently dominated by grasses would promote the stabilization of banks. The width recommended in the current *Land Development Guidelines for the Protection of Aquatic Habitat* (Chilibeck 1992) for riparian zone leave strips is 15 m from the top of bank, or first significant break in bank slope. A strip of this width vegetated with shrubs and trees is recommended as a long term erosion control measure. It is recognized that recreational areas along the river provide opportunities for the public to interact and learn about the aquatic environment, therefore, public access should be maintained. However, limiting access points and controlling pedestrian traffic may be necessary measures to protect spawning areas and sensitive plant communities. Where sections of trails encroach to the top of the bank as seen below (Photograph 8), they could be moved farther away and the bank planted with trees or shrubs in such a manner as to maintain viewpoints. A well identified and maintained trail system could be developed to both encourage public use and minimize the impacts to riparian plant communities.
