FINAL FIELD REPORT
CCGS VECTOR / CGSL OTTER BAY
North Coast Surveys

26 June – 31 July, 2006

Document Reference #: 5026444

Department of Fisheries and Oceans, Science Branch
Canadian Hydrographic Service, Pacific Region
Institute of Ocean Sciences, Sidney, BC
9860 West Saanich Road V8L 4B2

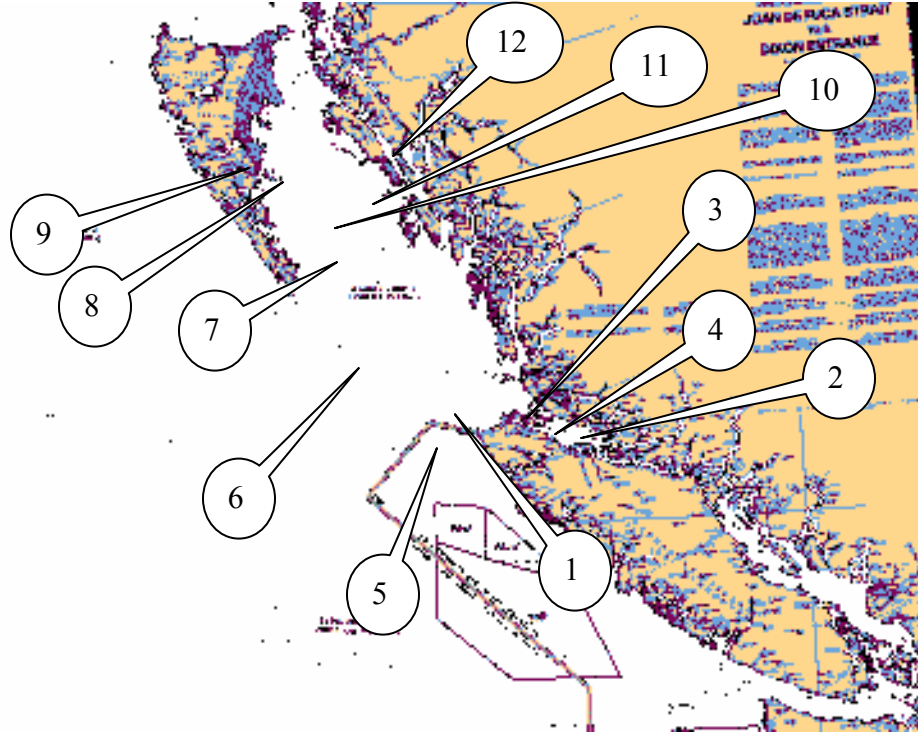
VECTOR Survey Project Location Diagram

Project Name	CHSDir #	Client
1	Cook Bank	5026017	NRCan
2	Malcolm Island	5026045	NRCan
3	Goletas Channel	5026290	CHS
4	Hardy Bay	5026289	CHS
5	StAD Sites (Stock Assessment Division)	5026036	MEAD
6	Shelf Break	5026018	CHS
7	Seep Sites	5026019	NRCan
8	Laskeek Bank	5026027	NRCan
9	Dana Inlet	5026329	CHS
10	103B09 (NTS #)	5026028	NRCan
11	Caamaño Tanker Route	5026029	CHS
12	Otter Channel	5026369	CHS

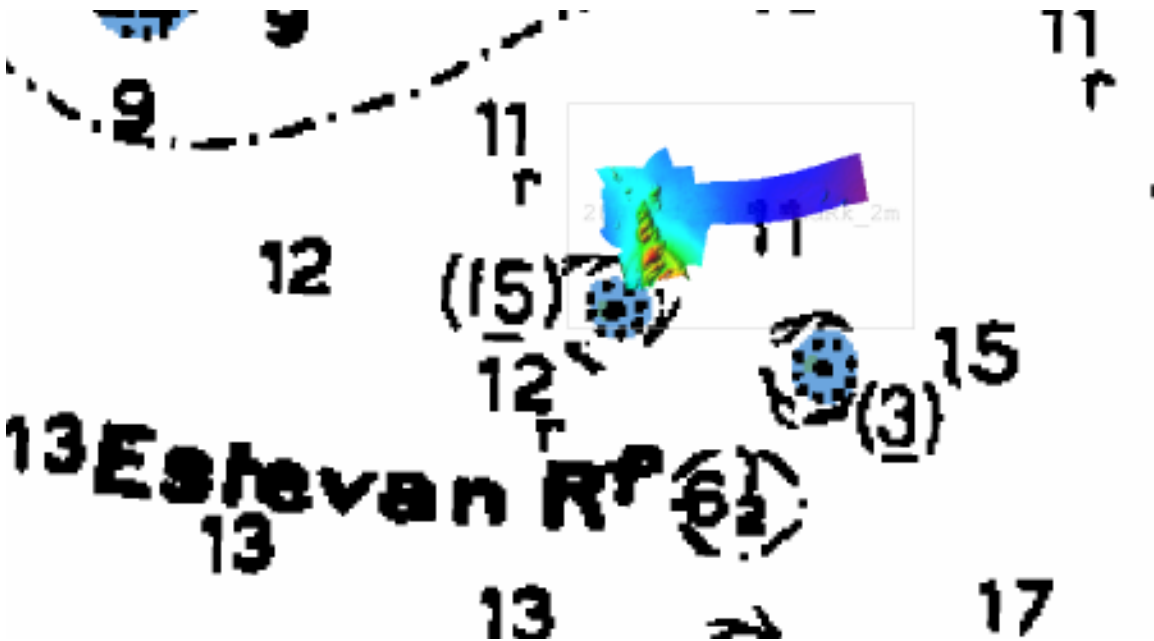
(13) 2006EstevanSoundRk, July 25, 0.1 Sq. km. (chart 3724)

CHS Otter Bay hazard investigation of a reported rock in the shoals that make up Estevan Reef. A 4m shoal was found approximately 100m from the reported position.
