A Video, Sidescan and Echosounder Survey of Nearshore Halifax Harbour

H. Vandermeulen

**Canadian Technical Report of
Fisheries and Aquatic Sciences 3162**

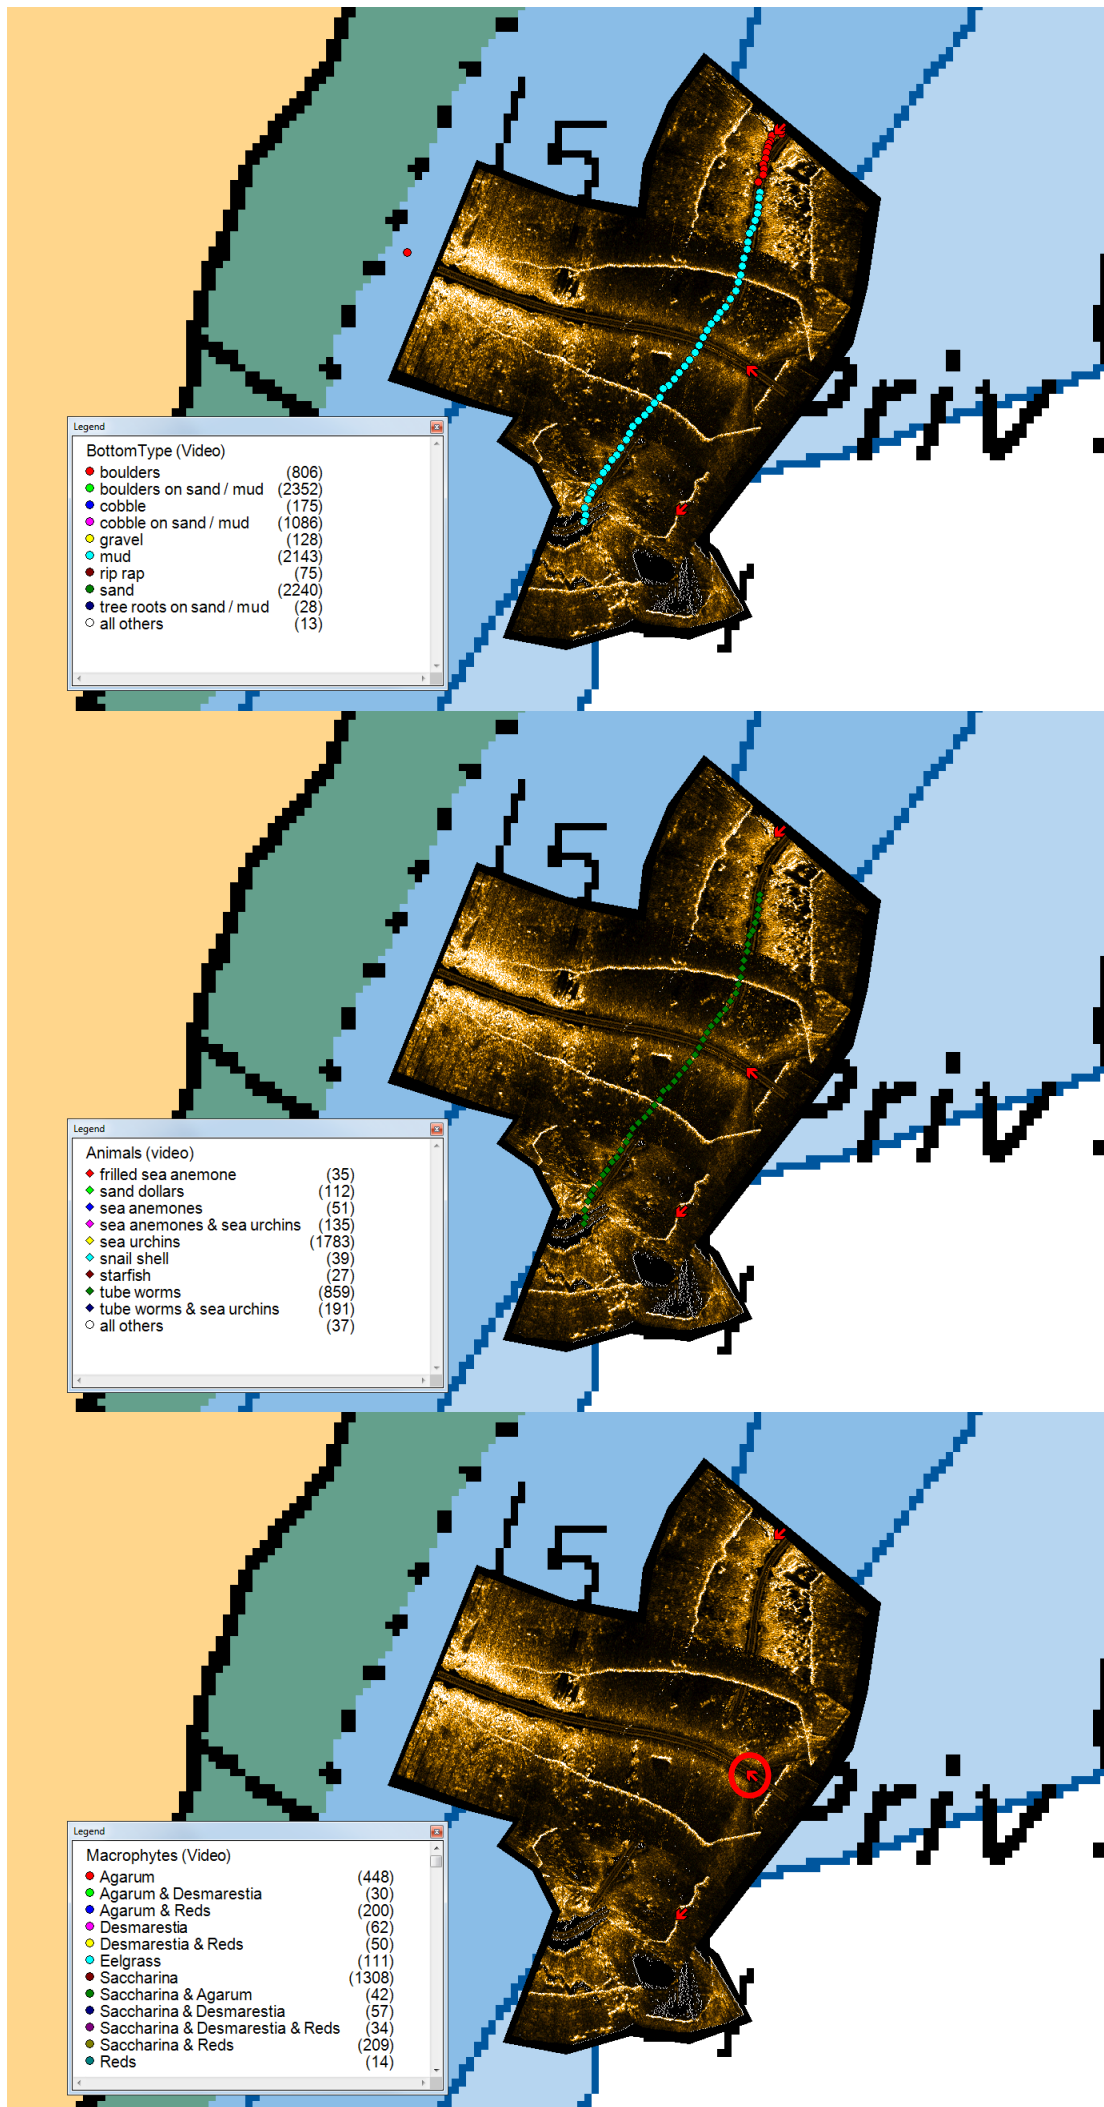
Figure 25: Transect BB18 showing towfish classification results. The red arrow start point for the main transect run (perpendicular to shore) is circled in red and located at 44.722062N 63.668225W.

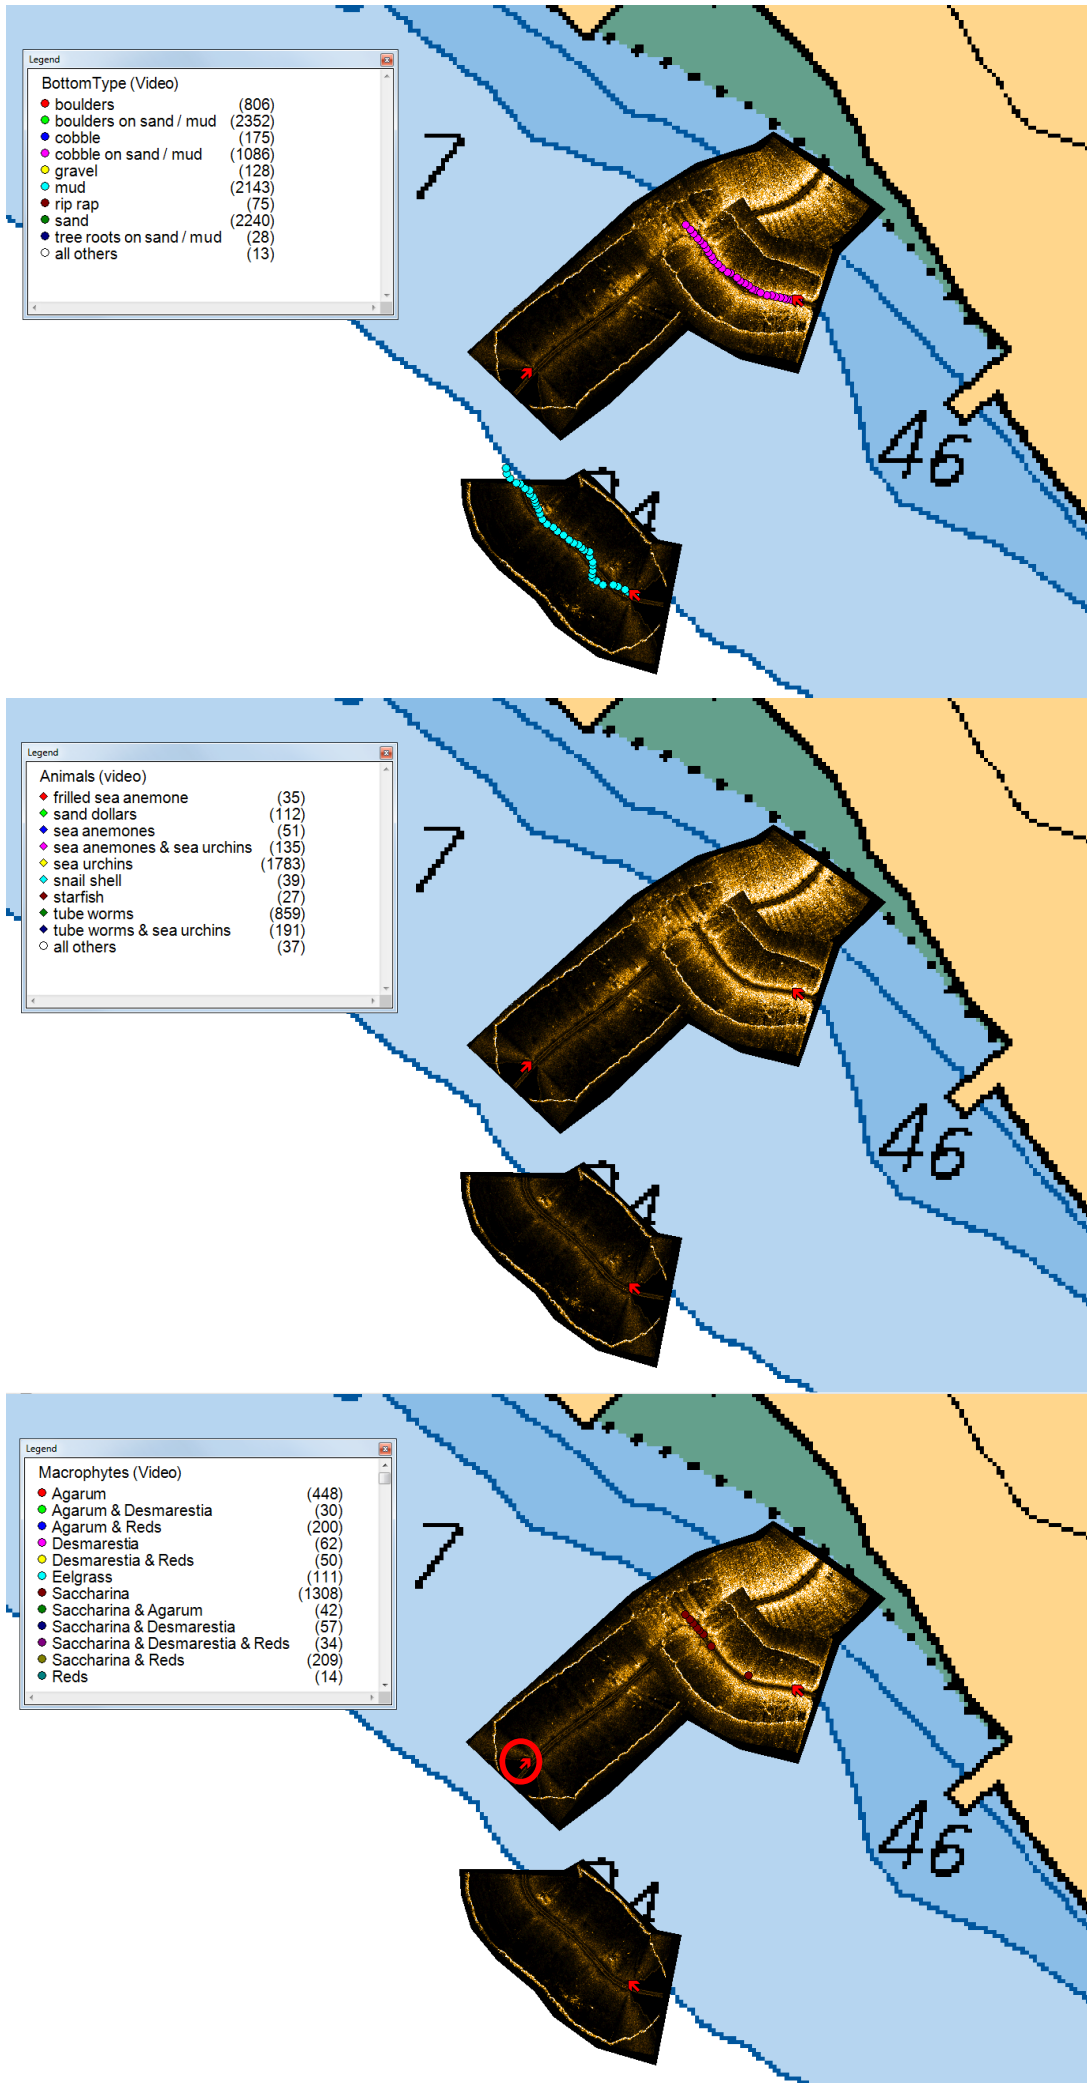
Figure 62: Transect IH22 showing towfish classification results. The red arrow start point for the main transect run (perpendicular to shore) is circled in red and located at 44.636612N 63.604648W.

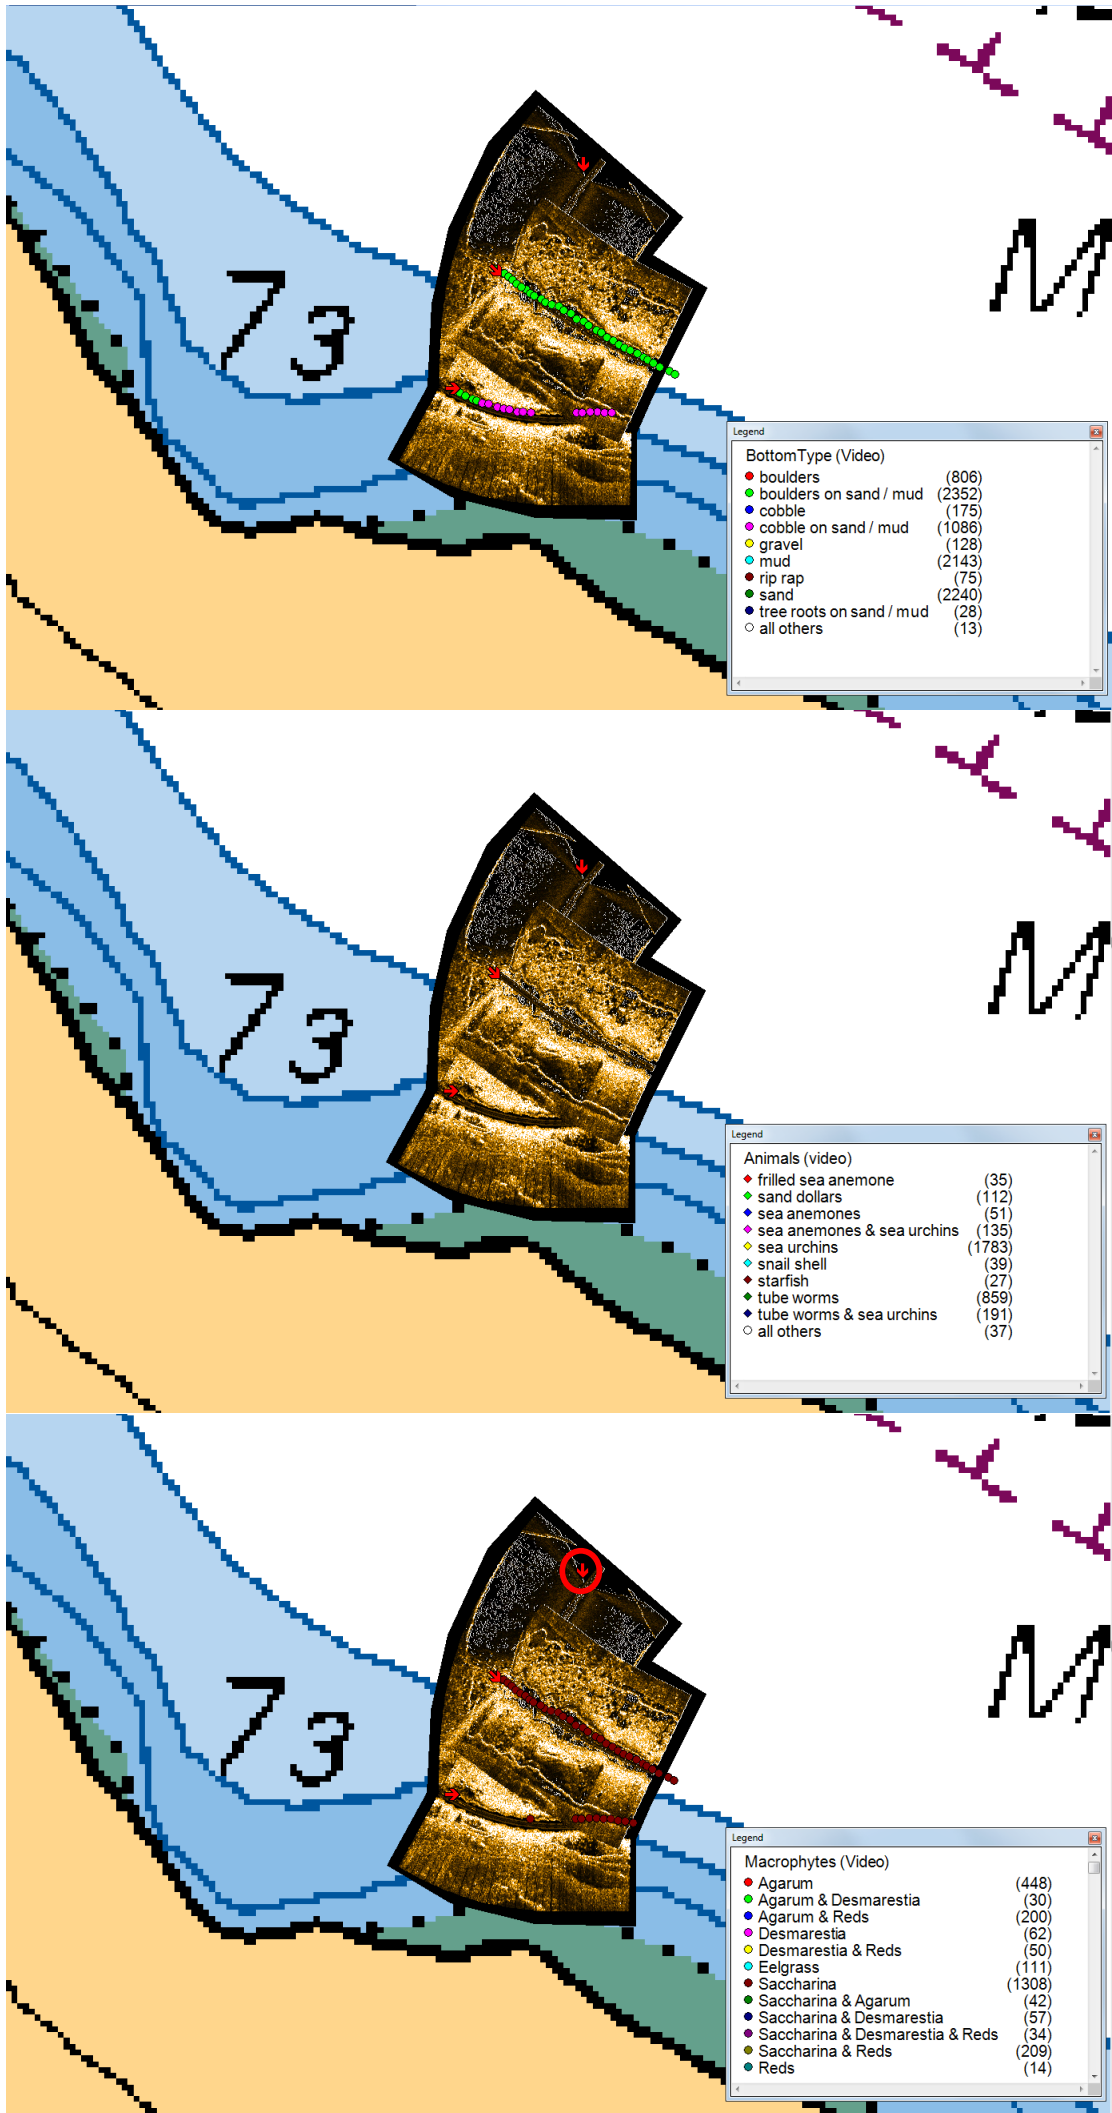
Figure 65: Transect IH25 showing towfish classification results. The red arrow start point for the main transect run (perpendicular to shore) is circled in red and located at 44.632792N 63.601908W.

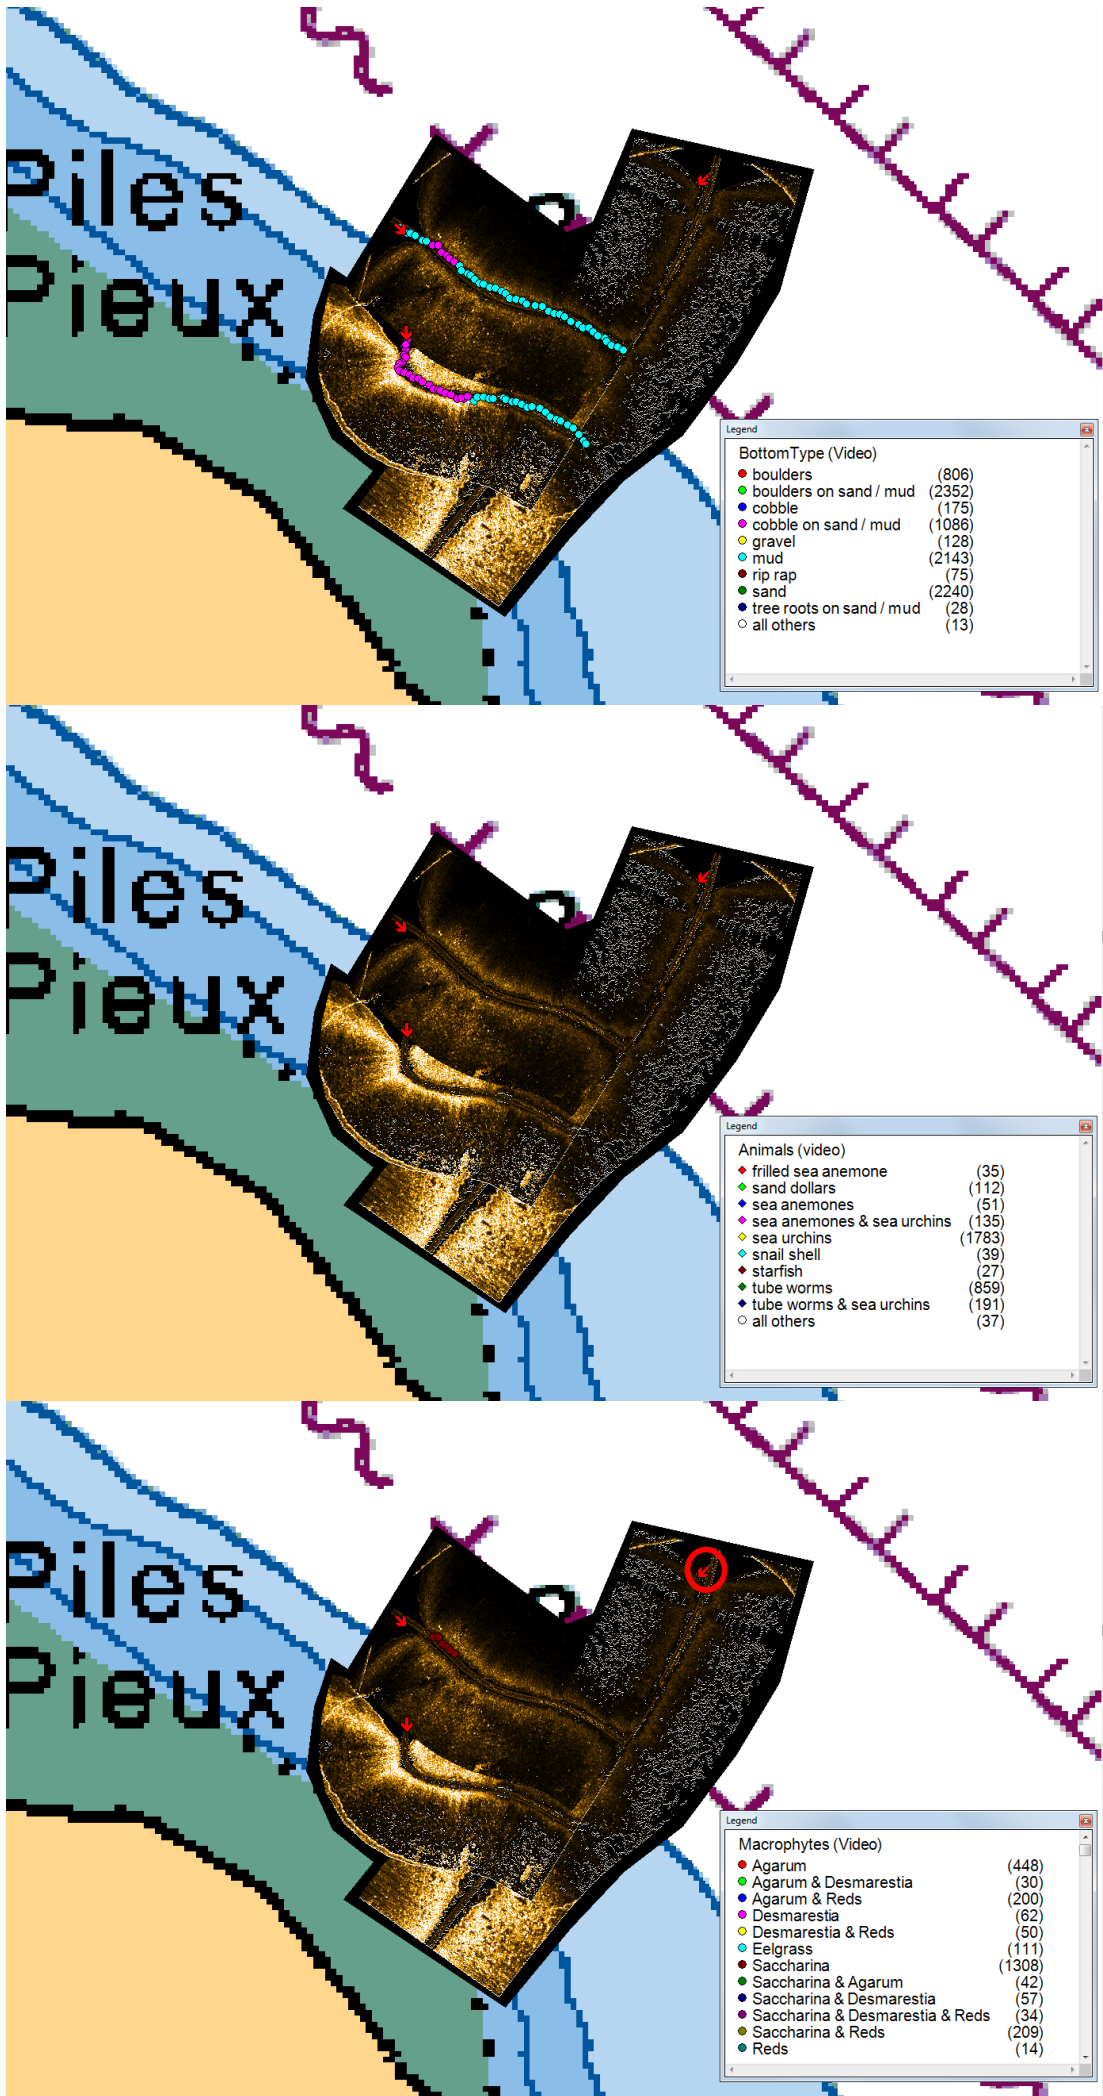
Figure 70: Transect IH30 showing towfish classification results. The red arrow start point for the main transect run (perpendicular to shore) is circled in red and located at 44.617780N 63.573112W.

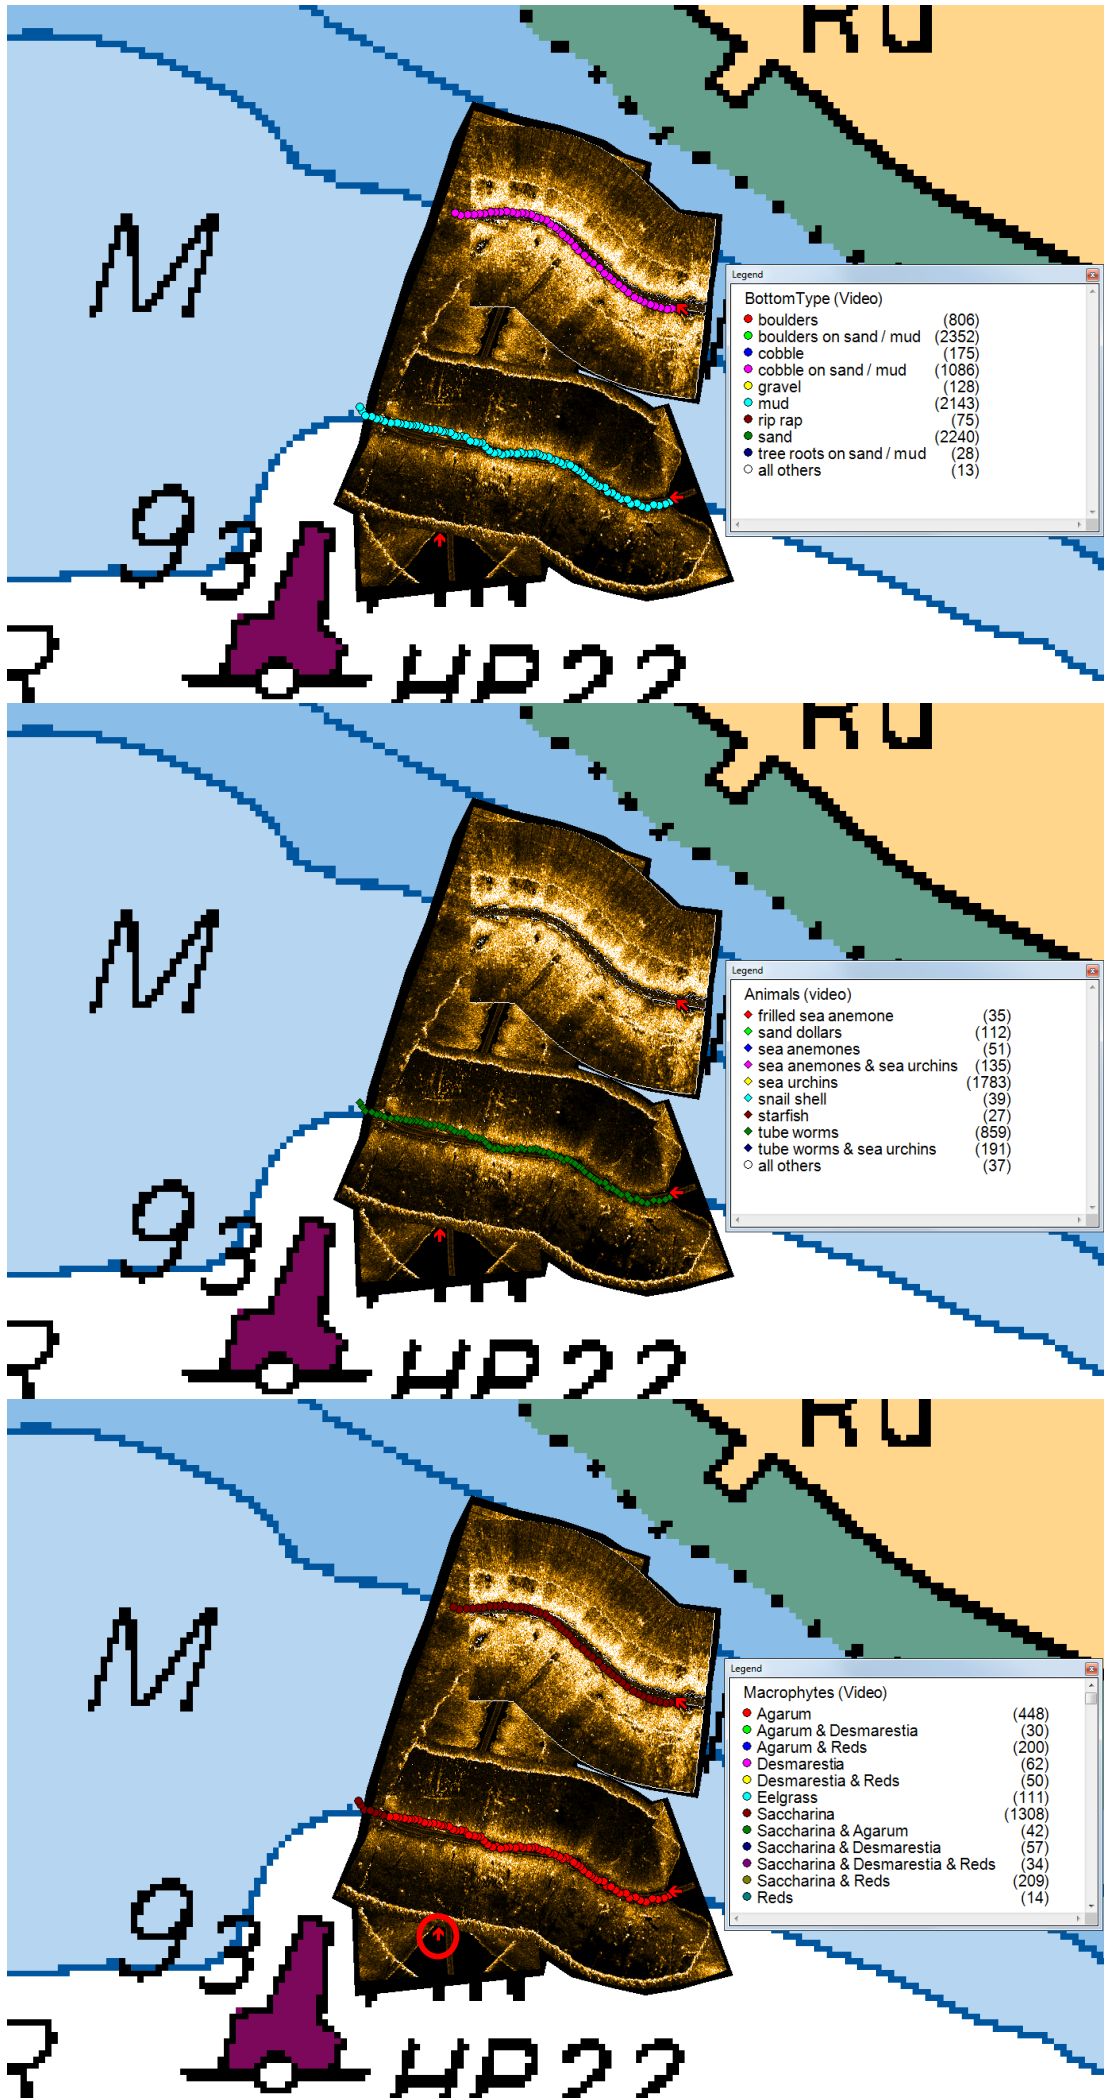
Figure 75: Transect IH35 showing towfish classification results. The red arrow start point for the main transect run (perpendicular to shore) is circled in red and located at 44.634195N 63.532057W.

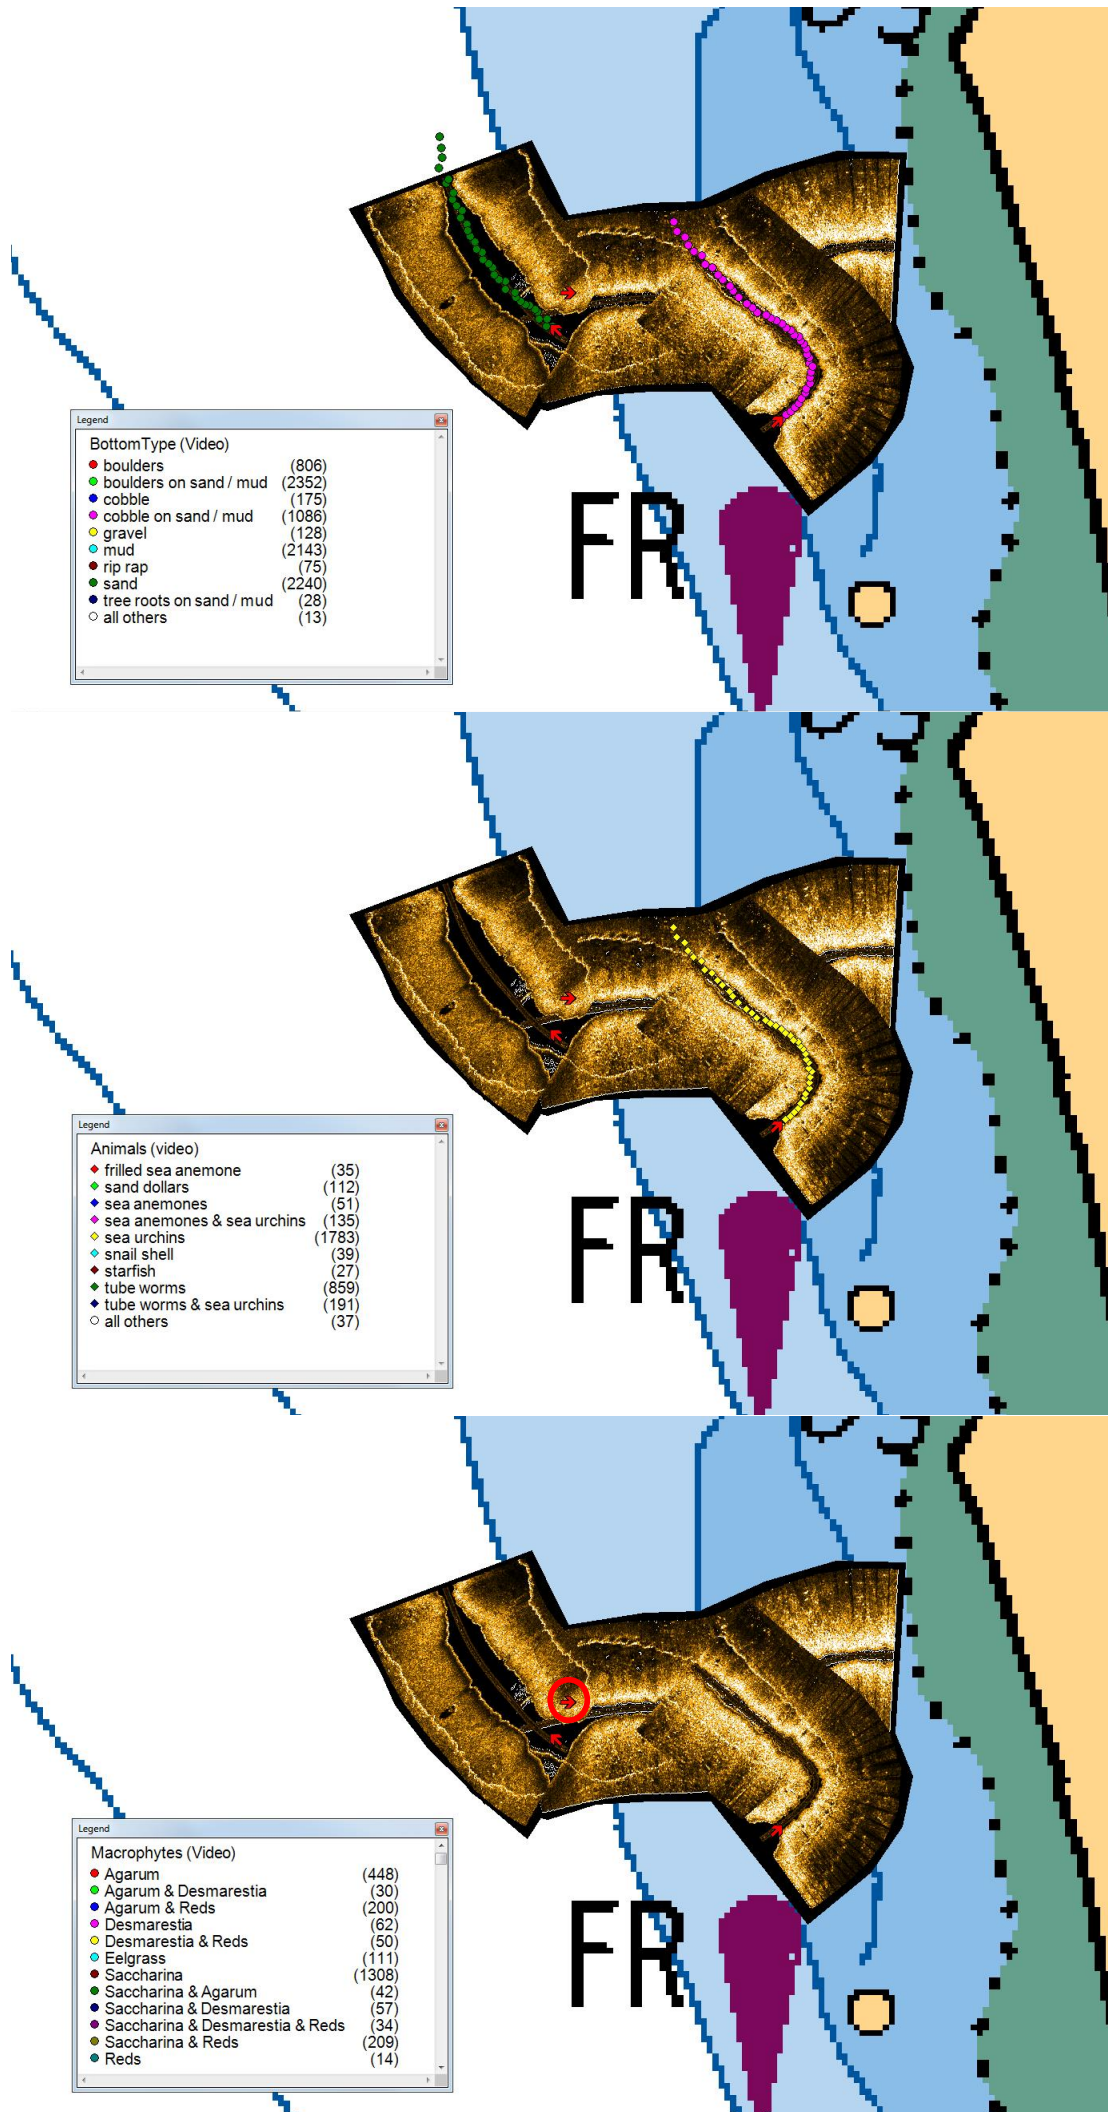
Figure 76: Transect IH36 showing towfish classification results. The red arrow start point for the main transect run (perpendicular to shore) is circled in red and located at 44.641025N 63.543447W.

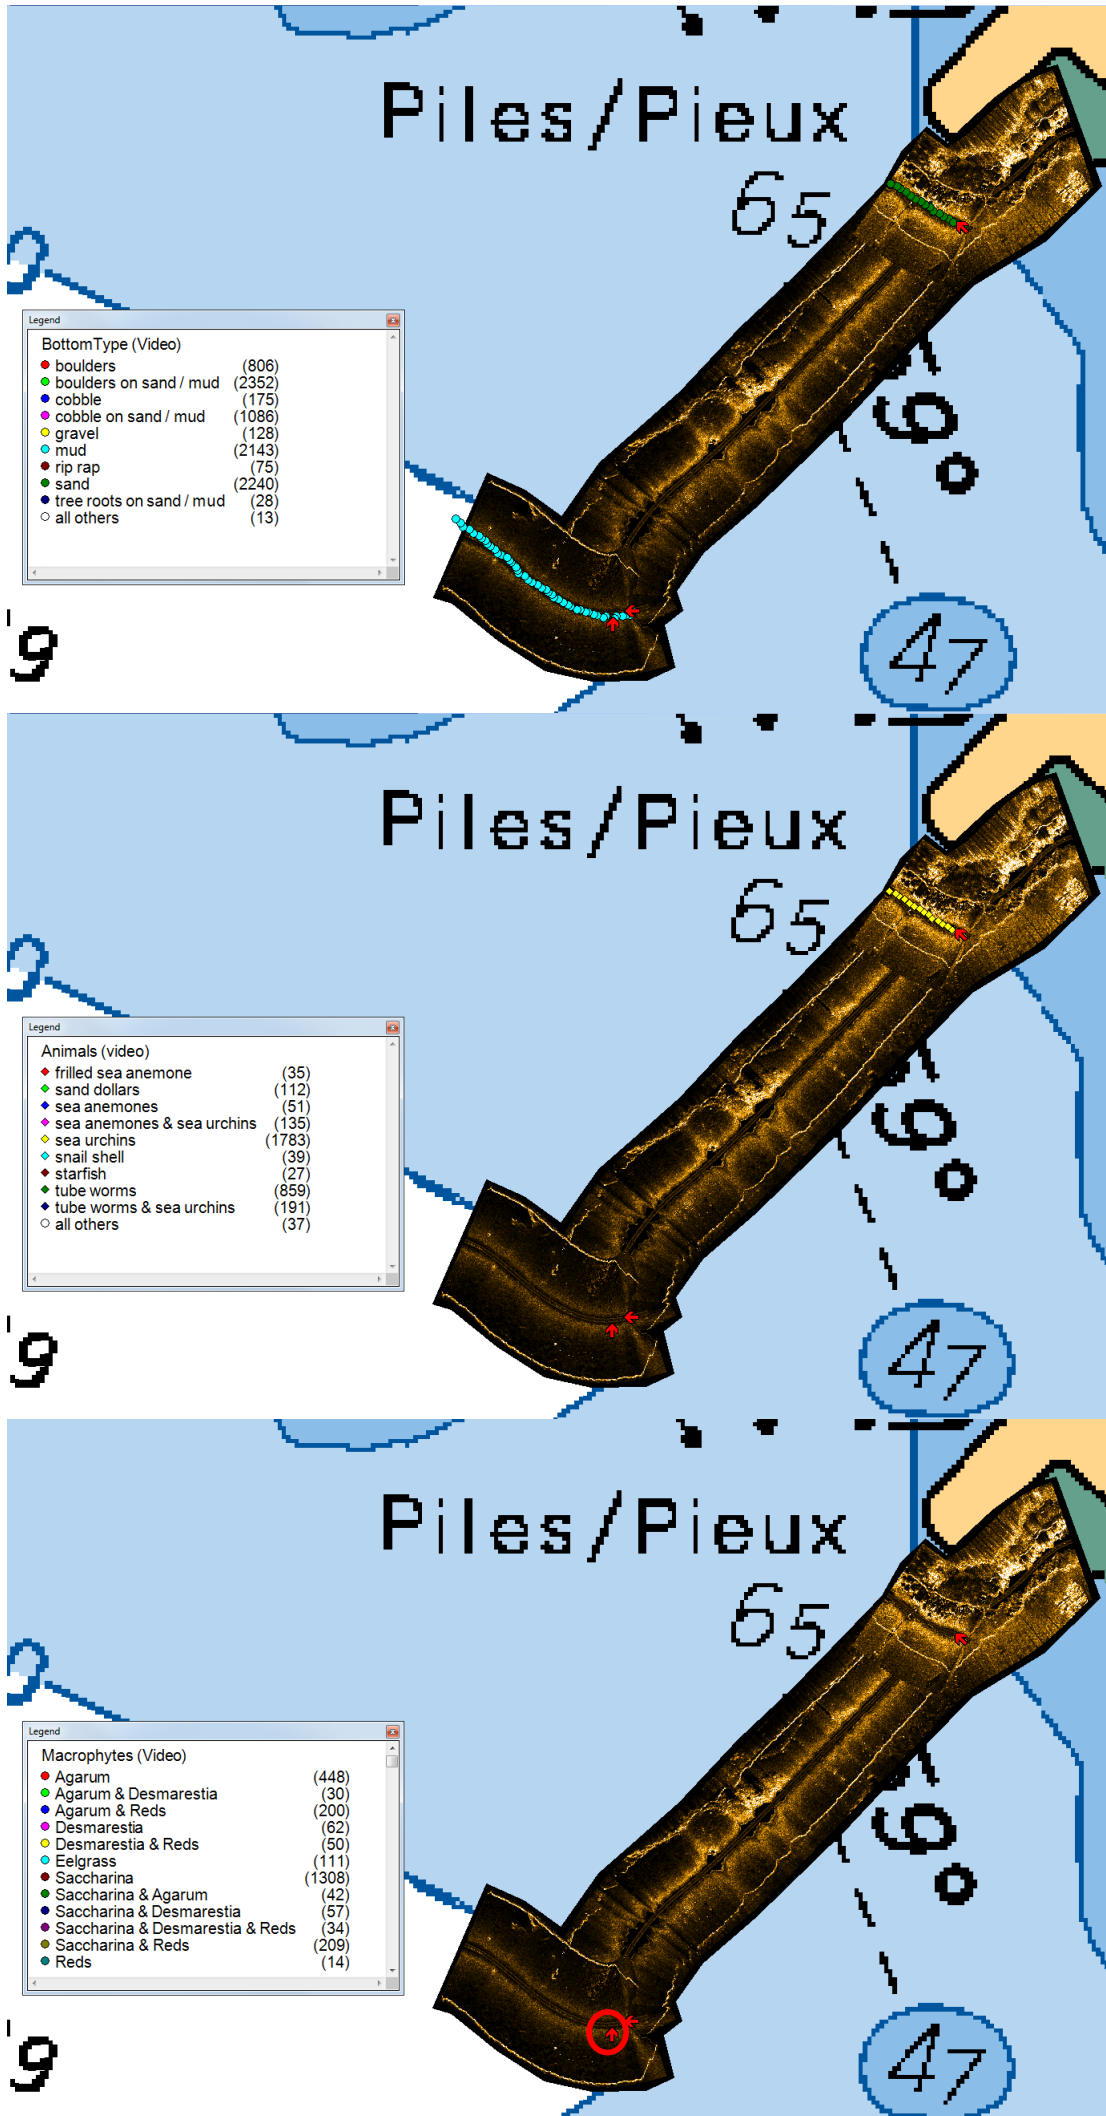
Figure 82: Transect IH42 showing towfish classification results. The red arrow start point for the main transect run (perpendicular to shore) is circled in red and located at 44.663247N 63.573290W.

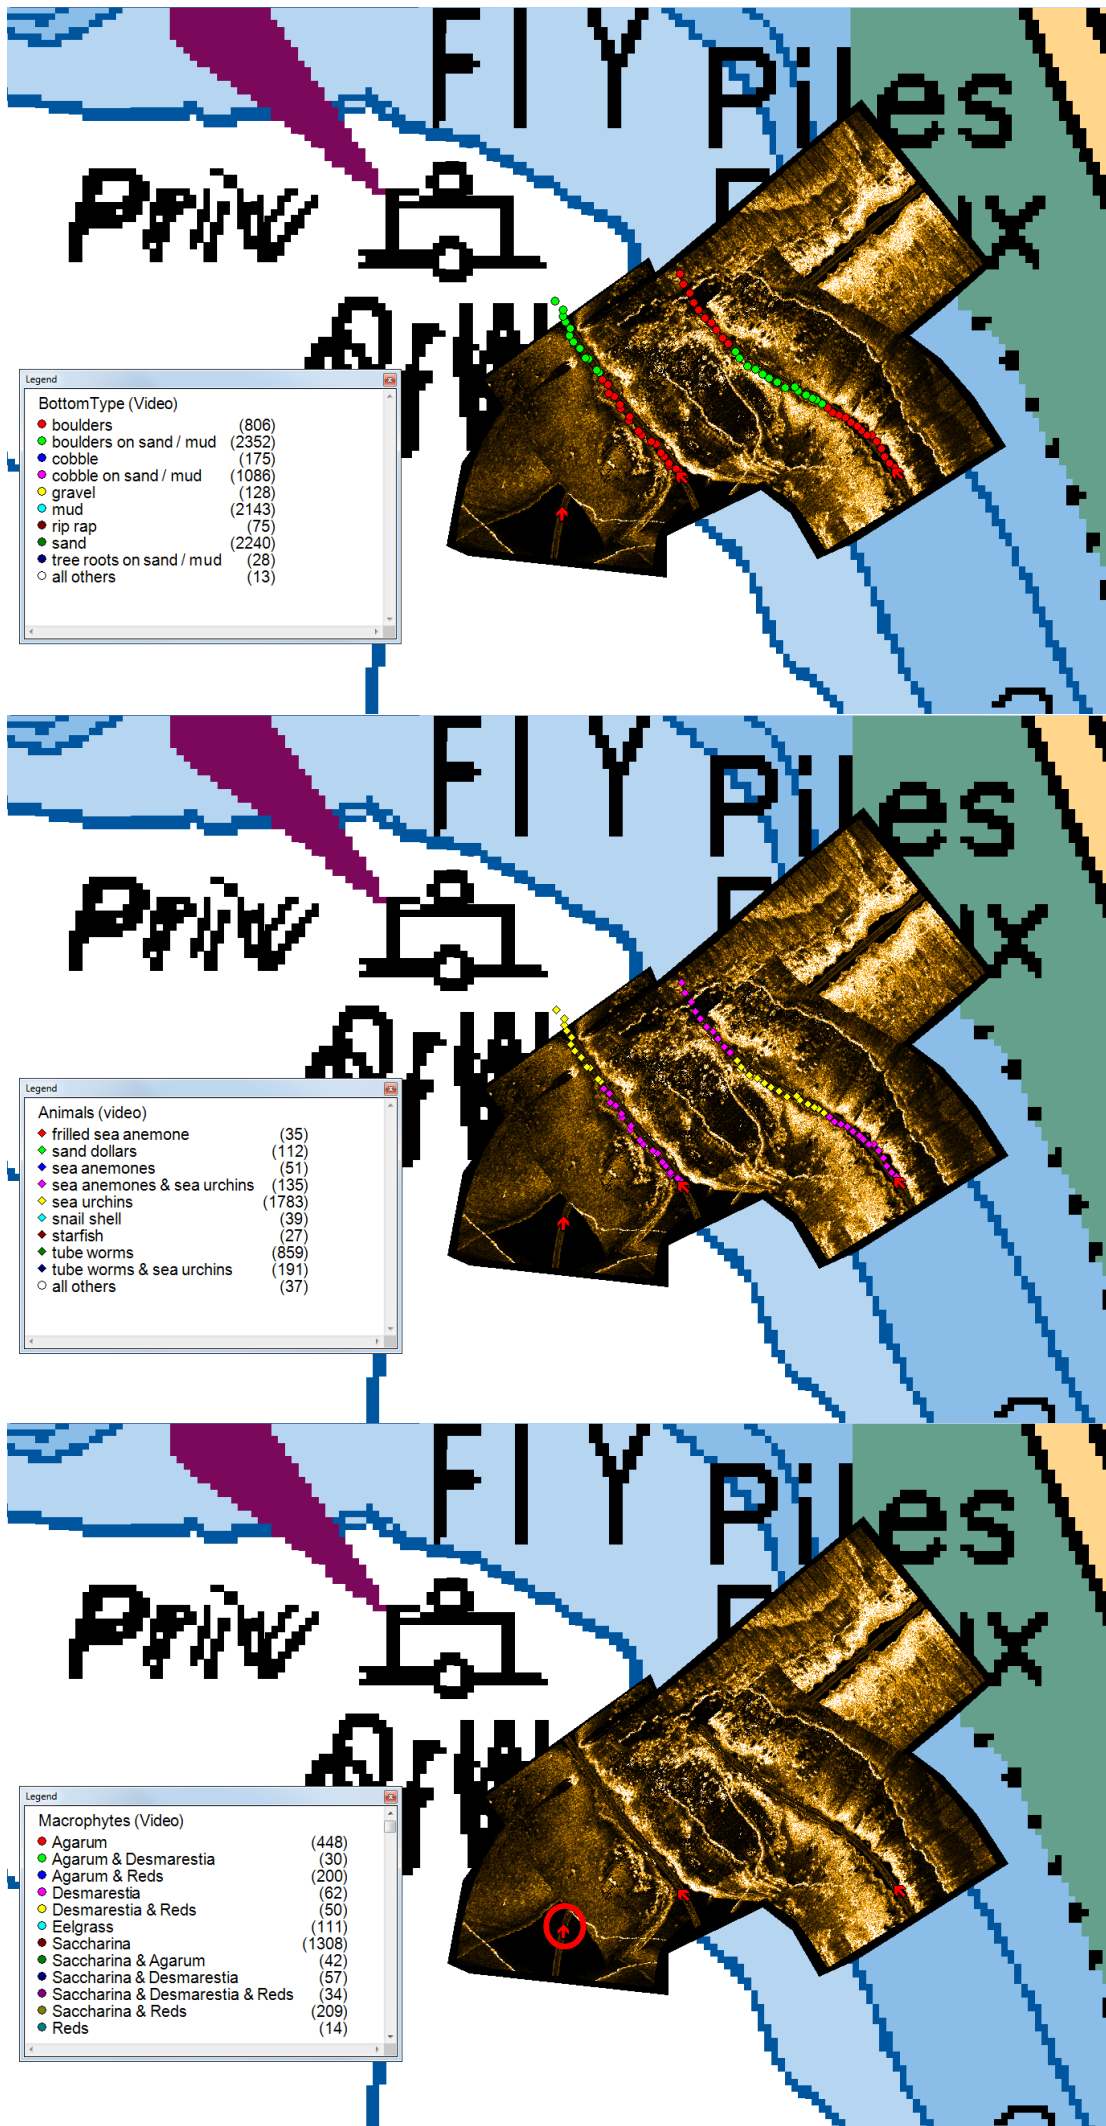
Figure 85: Transect IH45 showing towfish classification results. The red arrow start point for the main transect run (perpendicular to shore) is circled in red and located at 44.674128N 63.595117W.

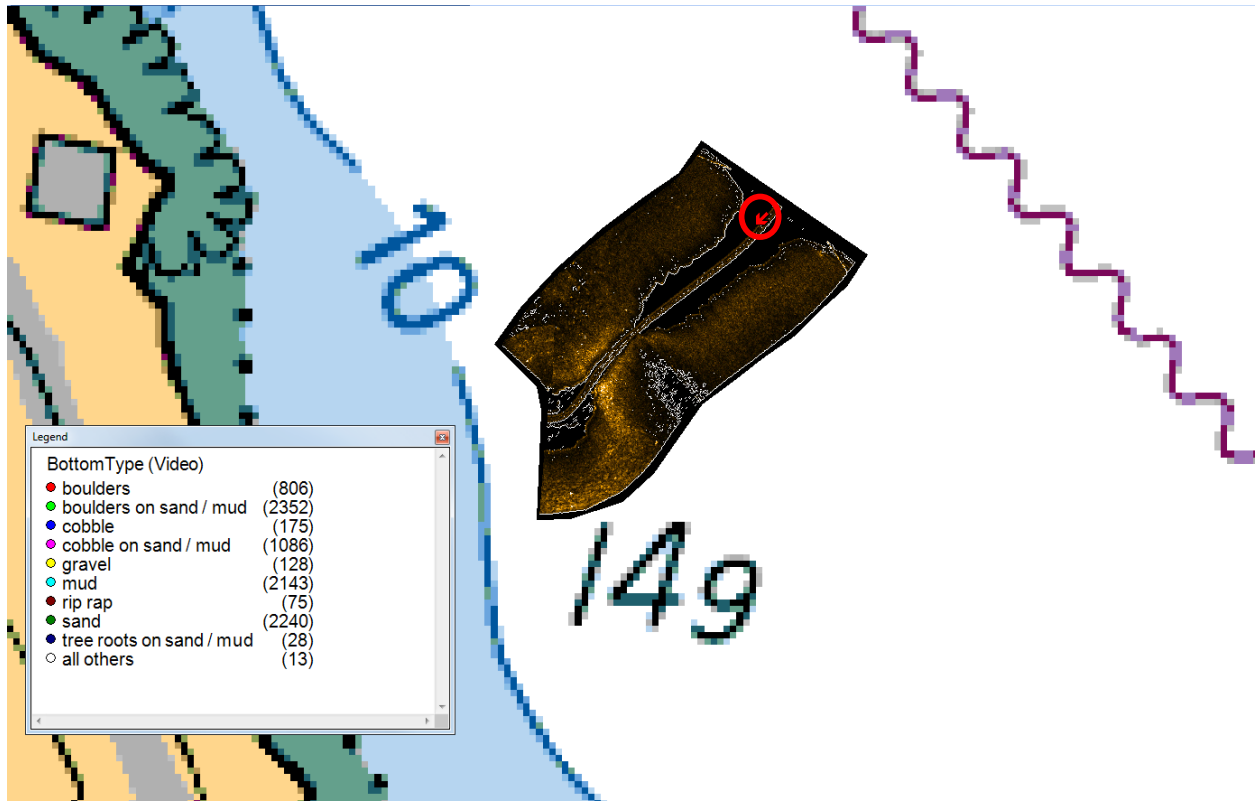
Figure 90: Transect OH03 - No video analysis or bottom classification due absence of cross run data. The red arrow start point for the main transect run (perpendicular to shore) is circled in red and located at 44.605565N 63.557898W.

In some cases it was not possible to produce towfish classifications for a particular transect. In one instance, IH01 (Figure 41), the cross run data was too poor to produce a classification. In other cases, cross runs were not made for a particular transect due to field conditions or a lack of time (IH02, IH03, IH09, OH03, OH08, OH17, OH18, OH22).
