**MANUSCRIPT
REPORT SERIES**

No. 19

*The restoration of beaches contaminated by oil
in Chedabucto Bay, Nova Scotia*

E.H. Owens

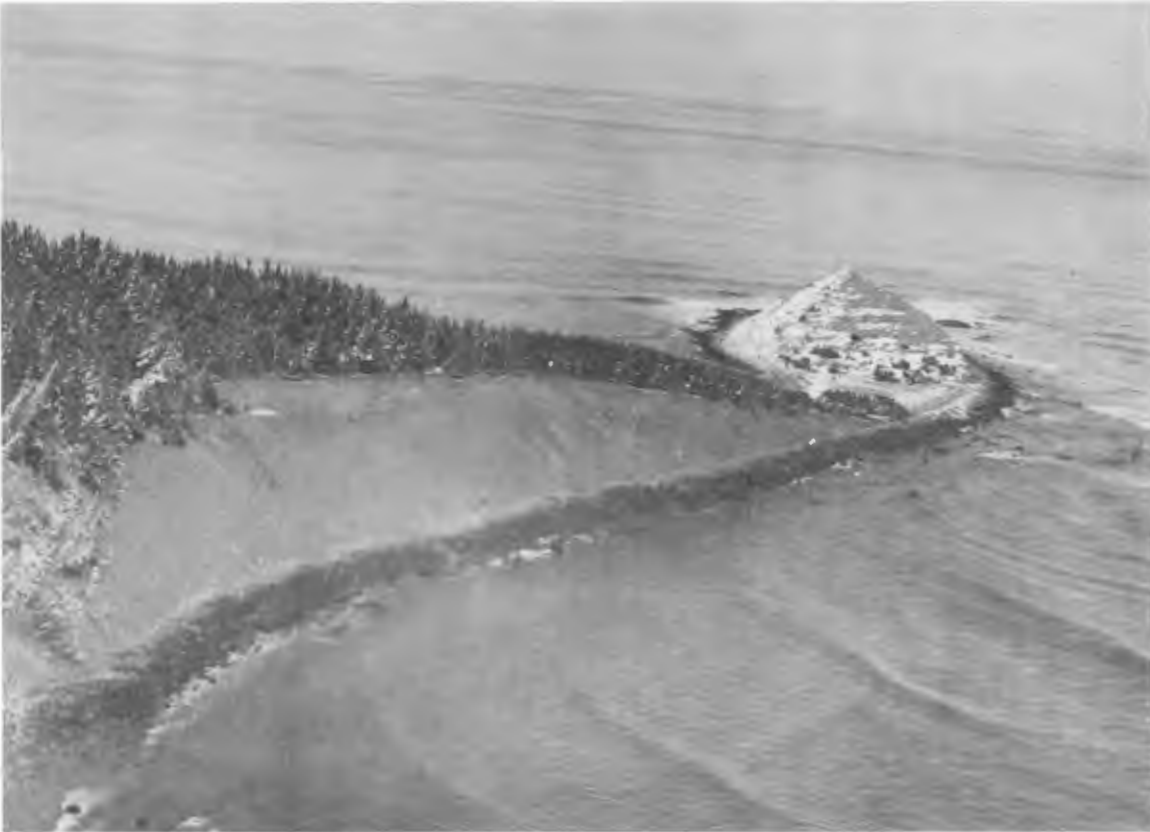
Photograph 1

Air view of a partially eroded drumlin and an actively eroding till cliff with a narrow but heavily polluted beach at its base. The beach material here is almost entirely derived from the erosion of the cliff.

At the base of till cliffs which are in active retreat there is usually a narrow cobble and boulder beach (Photograph 1). This material is derived largely from the erosion of the free face, which is a limited supply source as most of the till is clay and silt sized material. The retreat of the cliff leads to the development of a small platform at the cliff base on which rests the thin cover of beach material. In the sketch below it can be seen that on removal of the beach mantle the till base is exposed and becomes subject to erosion by marine agents. The protection that is afforded by the thin beach mantle is not great but with the loss of this mantle the level of the till platform is lowered by marine erosion and this in turn leads to a temporary acceleration of cliff retreat until an equilibrium condition is achieved by erosion of the free face.

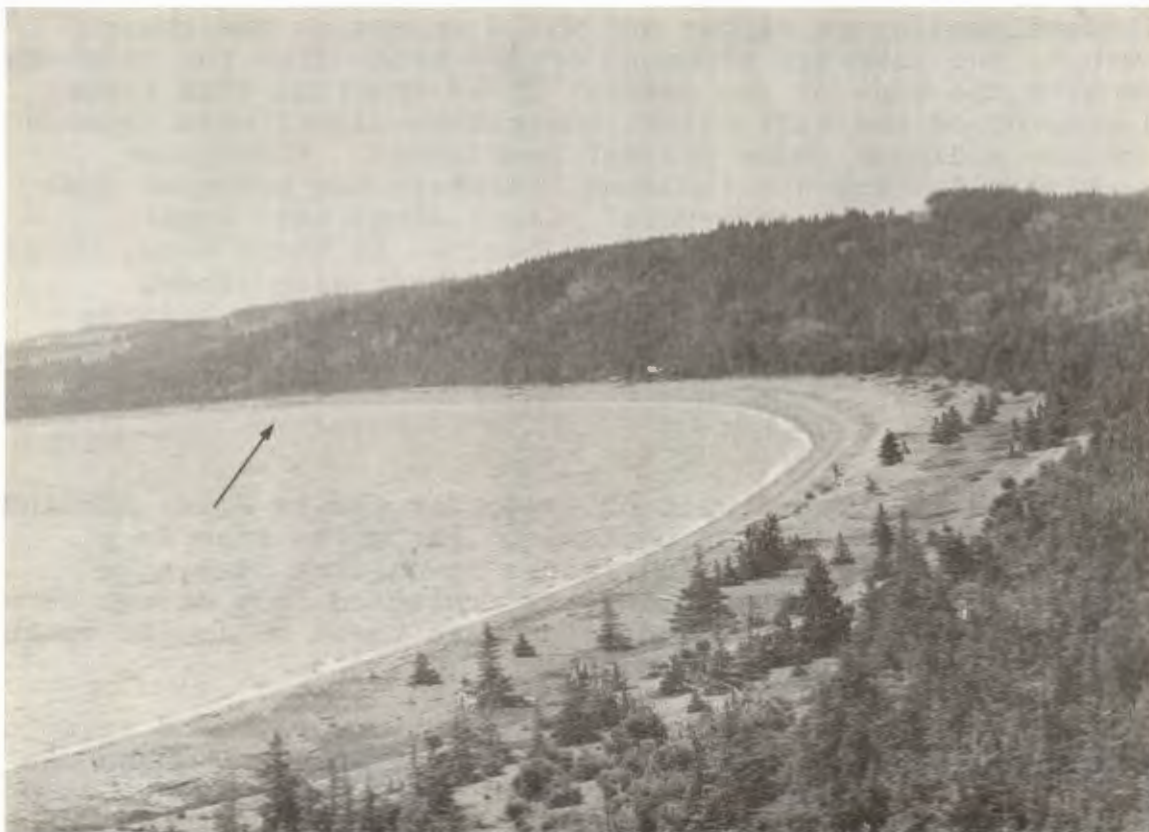
Photograph 2

Air view of the main section of the beach at mid tide before restoration. The main storm ridge is backed by a vegetated swale which in turn is replaced by a higher vegetation sequence. A squad of "slick pickers" is removing contaminated material manually (see also photograph 18), these are located by an arrow. No sections of this beach were paralyzed; although originally heavily polluted, most of the oil was buried or removed by normal wave action.

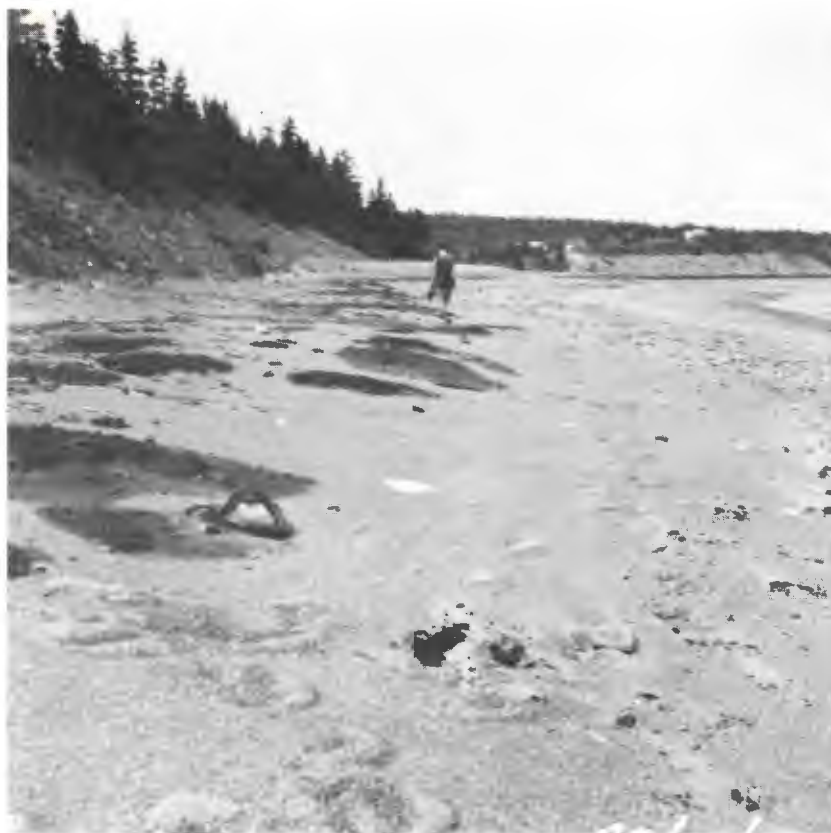
Photograph 3

The east end of the beach was made up of coarse sand and the oil remained as large pans which had a surface layer of fines or was buried to a depth of several feet. No oil was visible in the intertidal zone.

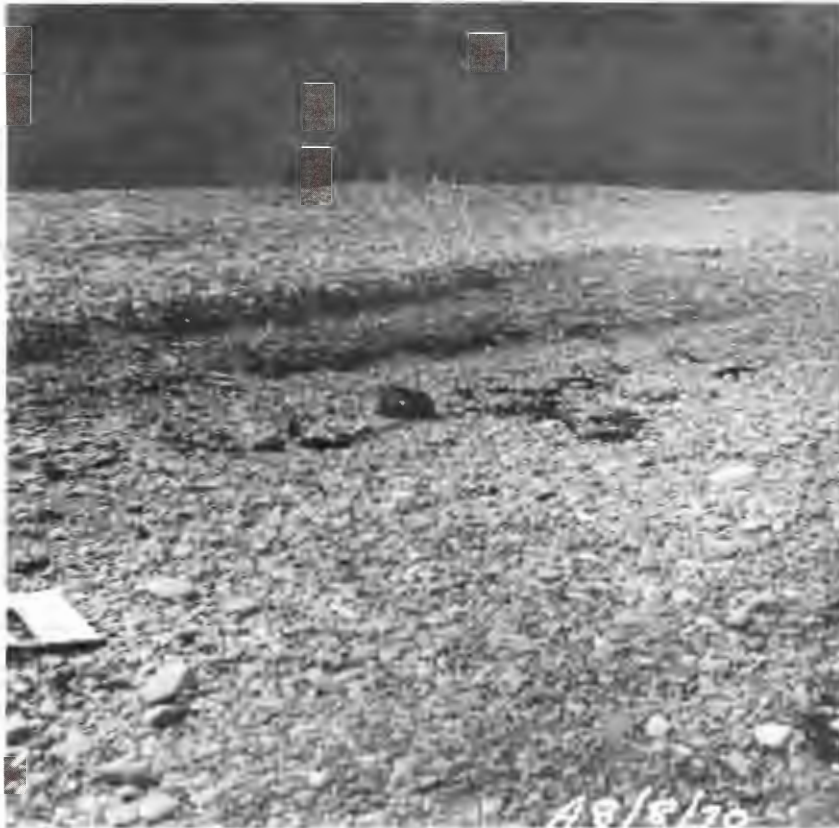
Photograph 4

On the west end of this beach at low tide. The layers of oil, when exposed by wave action, are more resistant to erosion but quickly collapse through sunlight and gravity.

Drapeau also noted that within one month of contamination, gravel bars directly exposed to wave processes cleaned themselves naturally and effectively, while in protected areas the beaches remained polluted. This is particularly evident in Photograph 5 of Blackduck Cove. The lagoon remained heavily polluted throughout the summer while the exposed side of the spit was "cleaned" by the end of March. In many of the exposed areas the intertidal zone was rapidly cleaned leaving a concentration of oil where it had been deposited above the high water mark beyond normal wave action (Photographs 6 and 7). Although oil polluted much of the upper part of the intertidal zone, wave action is continuously active in this zone and any oil laid down above mean high water mark would remain undisturbed by normal processes. During periods of storm waves or spring tides the remainder of the beach would be subject to wave action so that eventually all contaminated areas would be cleaned naturally. On cobble and shingle beaches, oiled material originally in the intertidal zone was often moved up the beach by storm or swell waves and deposited as part of the storm ridge. This may have occurred on several occasions so that with subsequent exposure the contaminated material would appear as layers interbedded with clean sediments (Photograph 4).

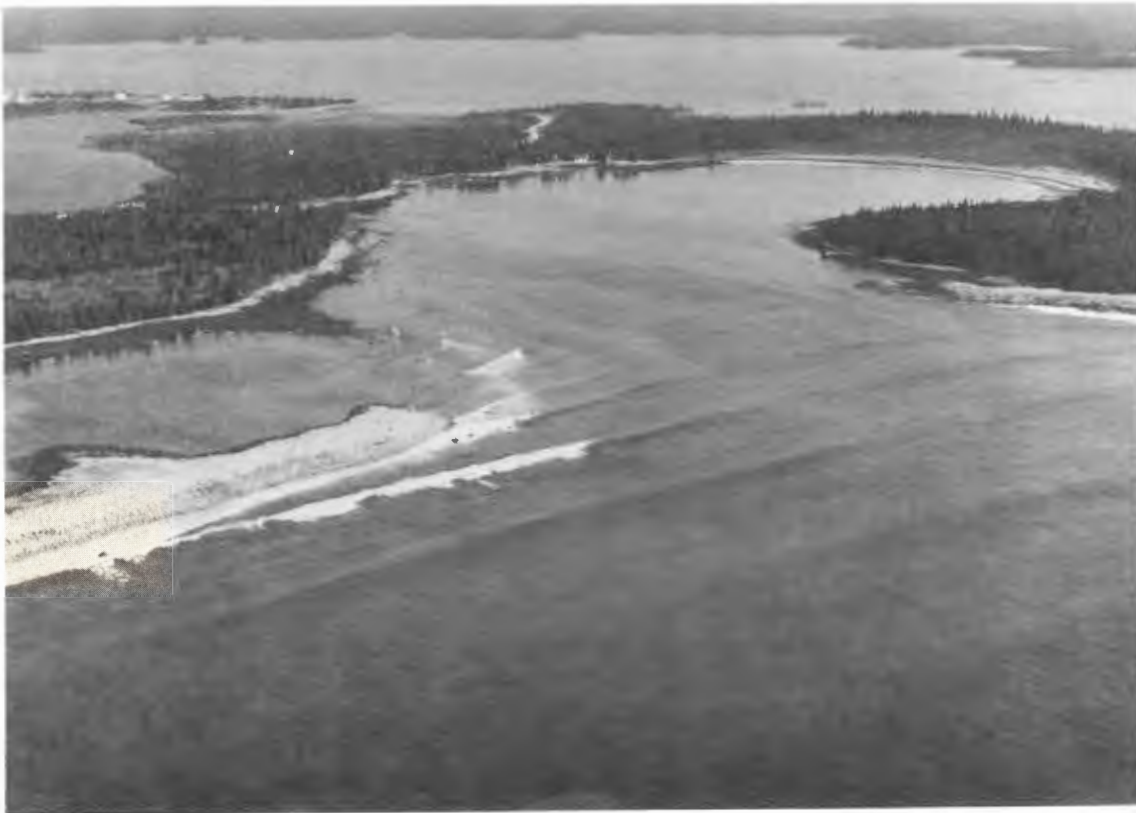
Photograph 5

Air view of spit, lagoon, and cove from the south at high tide. The lagoon is virtually cut off from the sea at low tide. This area was heavily polluted though the exposed section of the spit has been virtually cleaned by wave action whilst the beach in the lee of the spit remains paralyzed.

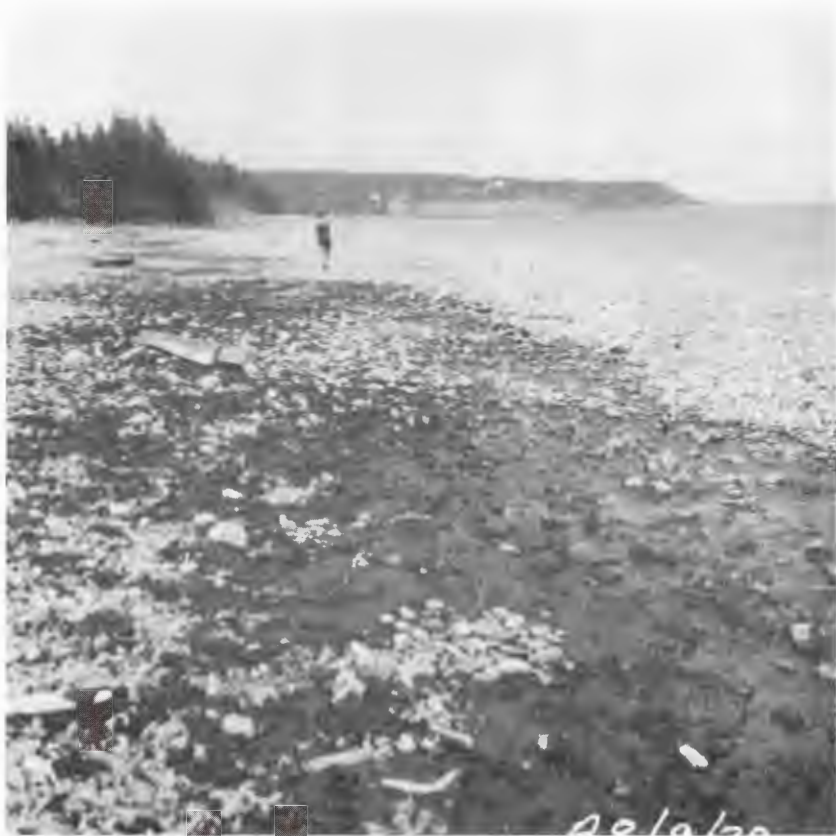
Photograph 6

The central section of the beach was characterized by a thick, continuous layer of oil ten to fifteen feet wide, above the high water line. This upper part of the beach, rarely affected by waves, remained paralyzed while the intertidal zone was cleaned by wave processes.

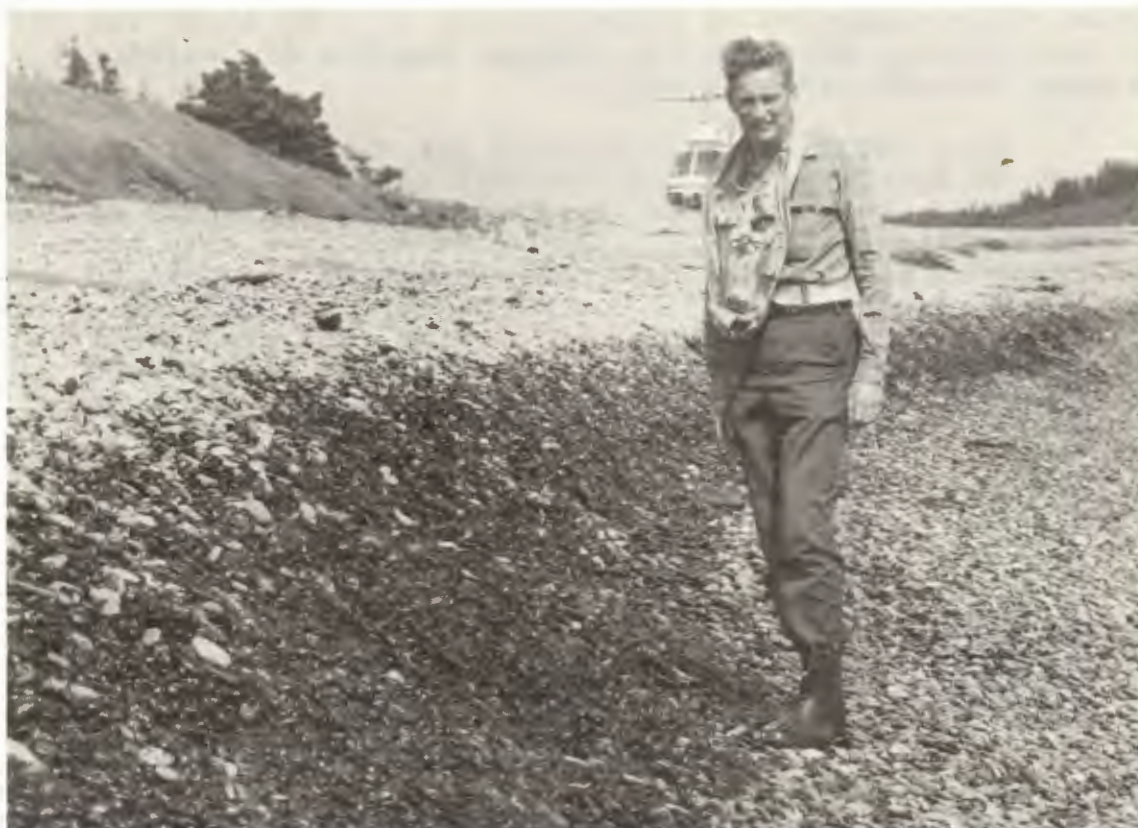
Photograph 7 JERSEYMAN ISLAND June 21, 1970

A badly contaminated cobble beach near the high water mark. Although this beach has been partially immobilized, wave action has begun to clean the area below the high water line by abrasion and burial. With storm waves the remainder of the beach will be combed down and the cleaning process will be extended to include all the contaminated material.

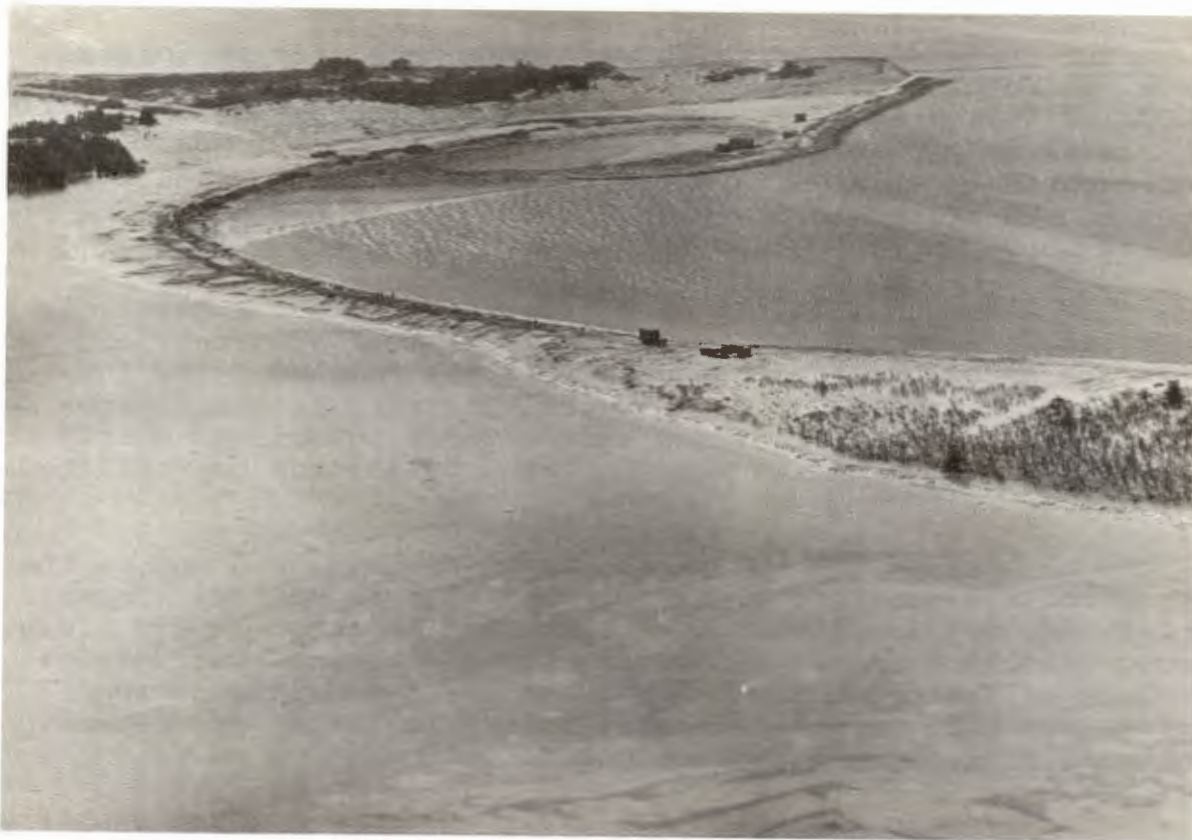
Photograph 8

DEEP COVE

In mid-February, shortly after the sinking of the "Arrow", the Canadian Armed Forces bulldozed part of the bar at Deep Cove in an attempt to clean this beach (Photograph 8). It was estimated that some 3,000 cubic yards of sediment were excavated and removed during this operation (Asthana and Marlowe, 1970). This trial was not successful as oil and sediments were thoroughly mixed and not all the contaminated material was removed. This operation was also ineffective in terms of recontamination as this area was reoiled within a few tidal cycles and on several occasions subsequently.

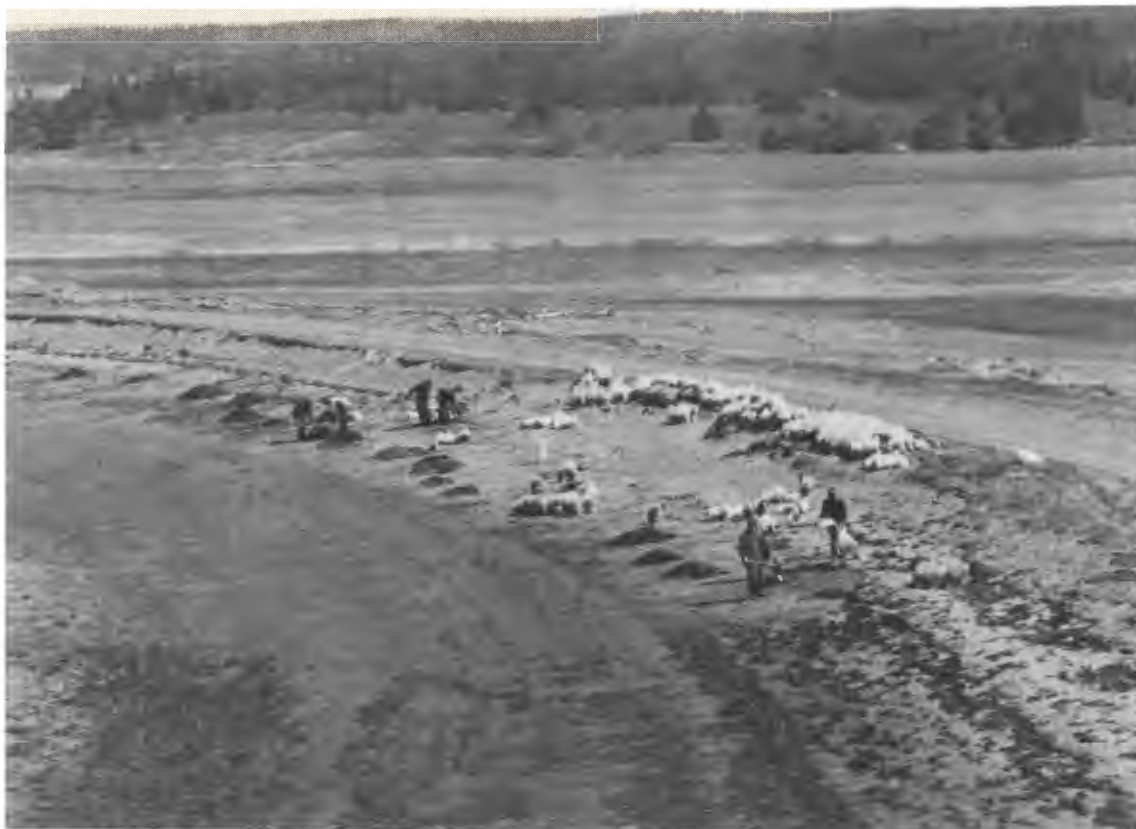
Photograph 9

SLICK PICKERS

Those sections which were designated for restoration but which were only lightly oiled were cleaned effectively by squads of "slick pickers". These units, local labour under the Department of Public Works supervision, removed oil and contaminated material with shovels and rakes (Photograph 9). The material was placed in plastic bags which were collected and removed to an approved dump site.

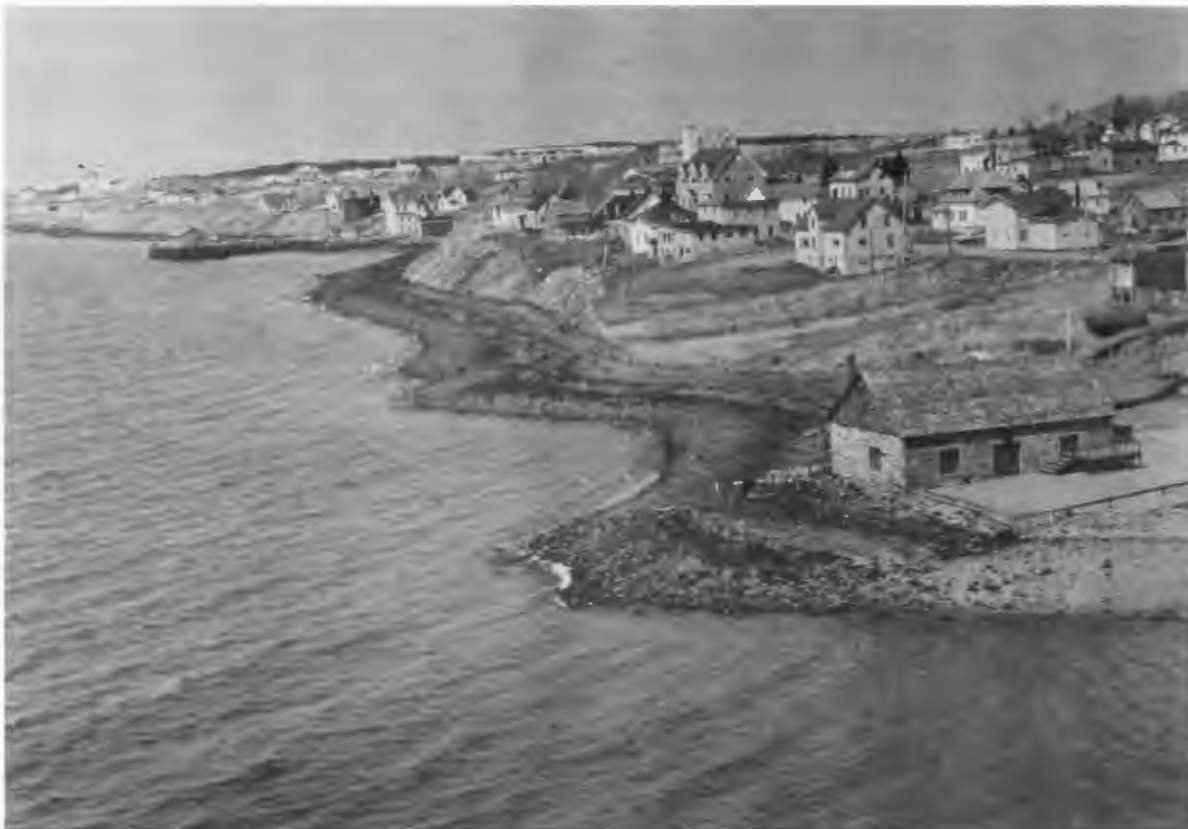
Photograph 10

ARICHAT

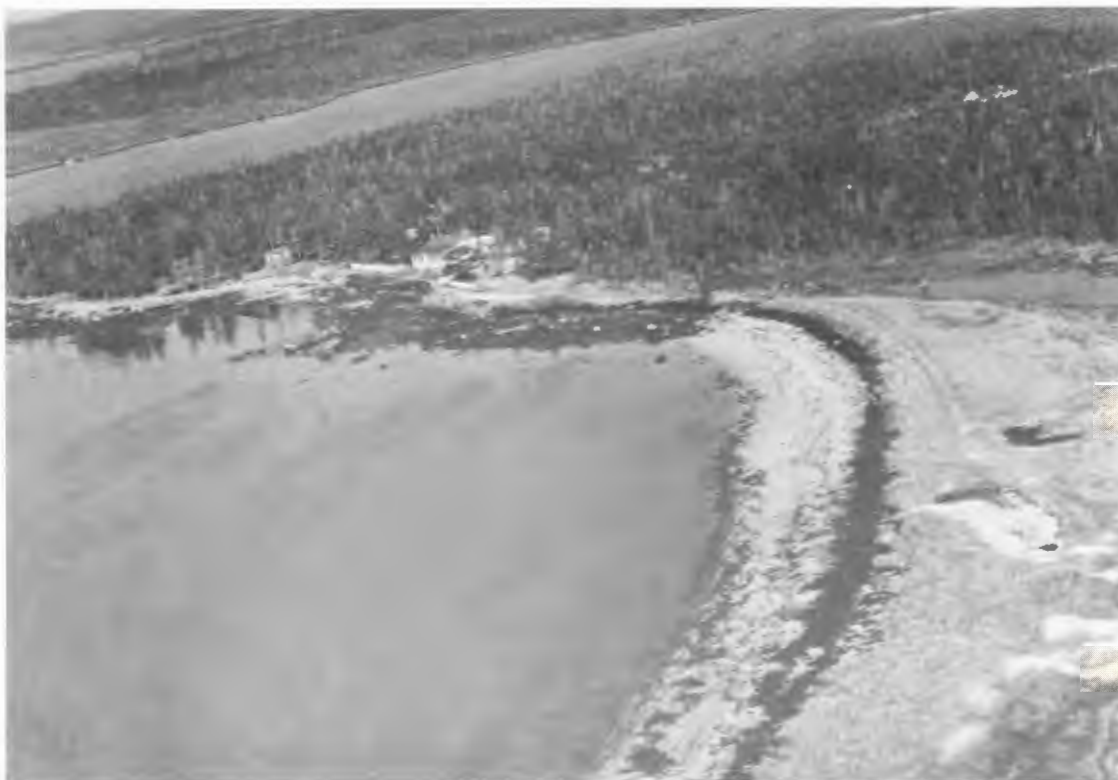
Photograph 11

Air view of sand beach at the east end of the cove near high tide. Oil is present as a thick, continuous layer along the high water mark and along the edge of the vegetation. Thick patches of oil and seaweed "cakes" cover much of the intertidal zone but the beach is still mobile. The cobbles and boulders along the north shore in front of the cottages are also heavily polluted but this section is paralyzed.

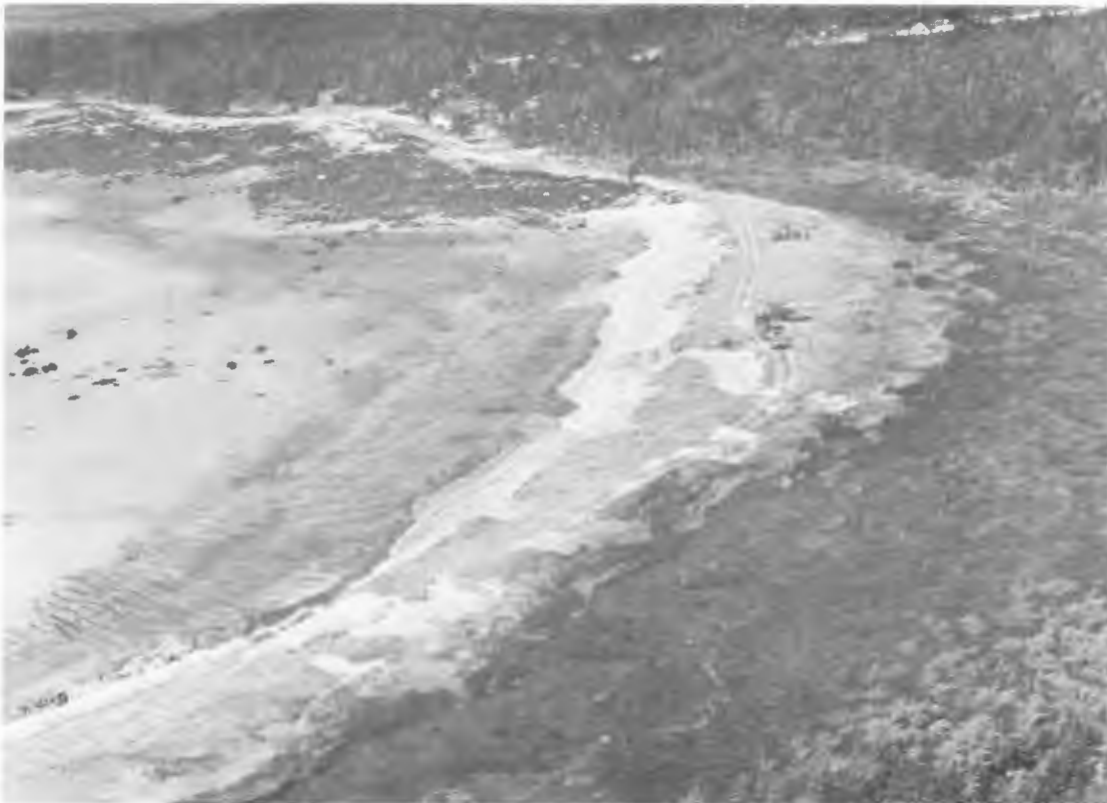
Photograph 12

Air view of beach restoration work at low tide. A bulldozer has pushed the contaminated sediments above the high water mark for subsequent removal by a front-end loader. The contaminated material along the edge of the vegetation was removed by the bulldozer scraping backwards down the beach in order to minimize damage to the backshore. For the same reason, access to the beach from the backshore was carefully controlled to prevent the development of blow-outs.

- b) Controlled access to the beach by the trucks using only one track resulted in damage to only one area of vegetation rather than wide-spread disturbance. Where contaminated material was found near the edge of the berm vegetation, the bulldozer was used to scrape down, rather than dig or push up the material. This again helped to minimize damage to the vegetated zone, (the destruction of the vegetation could have led to blow-outs).

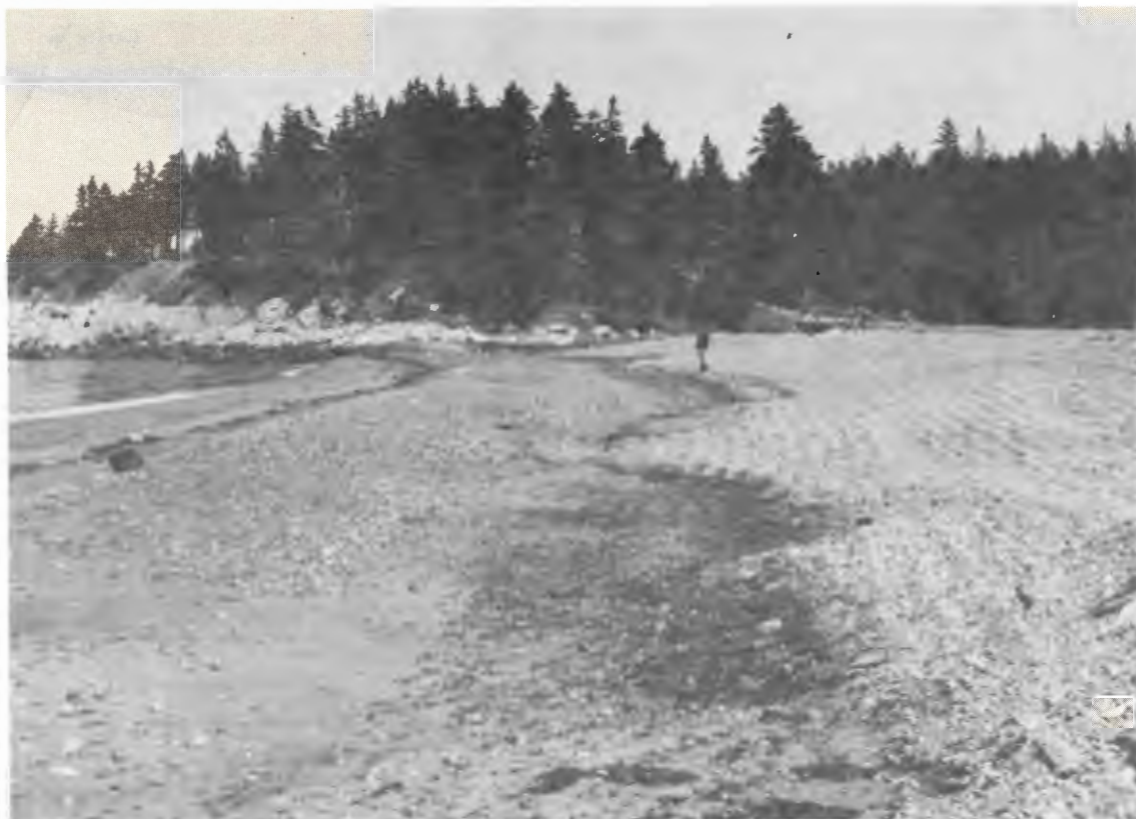
Photograph 13

The east section of this pocket beach at low tide, four days after completion of the contract work. Before restoration, a thick continuous layer of oil, six to ten feet wide, covered the length of the beach above the high water line. (see photograph 11). The figure is standing near the high water line. Recontamination was from alongshore and the oil concentrated in the upper part of the intertidal zone.

- e) Reoiling of the eastern section took place (within 4 days) during a period of spring tides as oil was released from pools and cracks in the adjacent rock areas (Photograph 13). High temperatures during the preceding week had encouraged

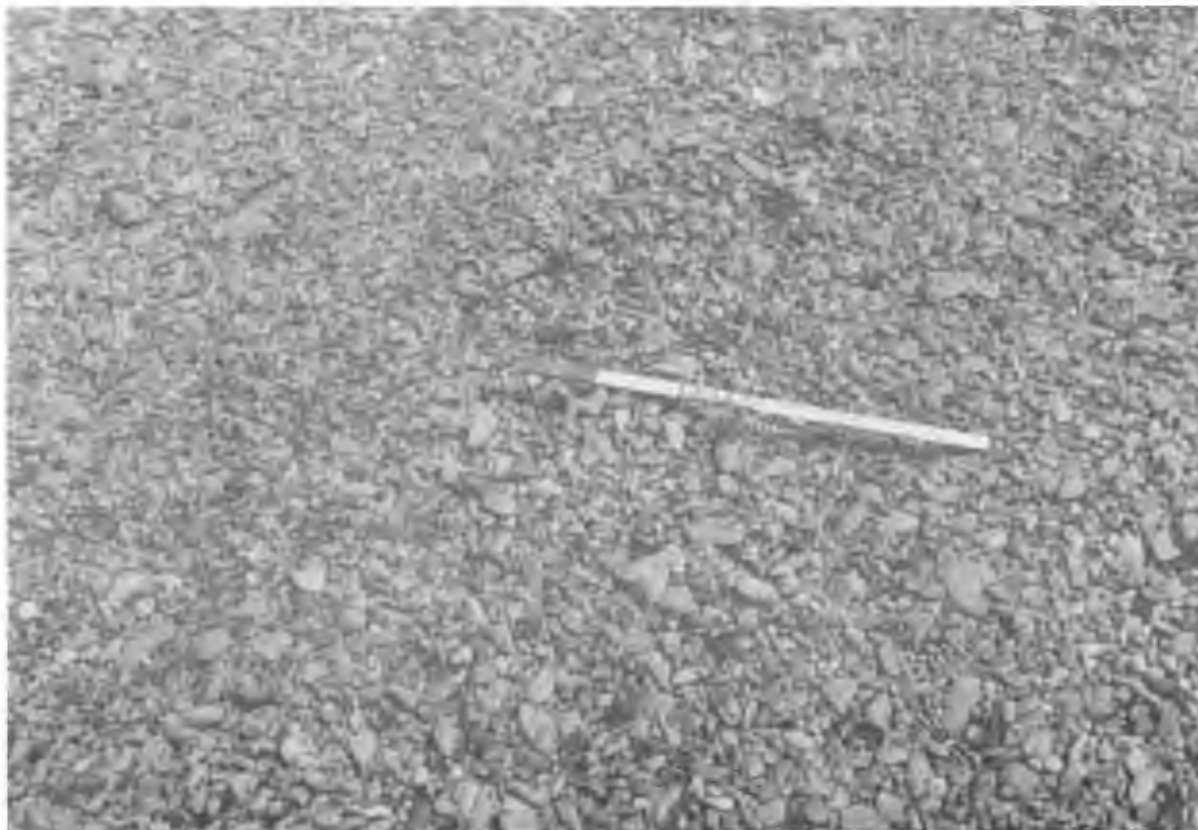
Photograph 14

HALF ISLAND COVE

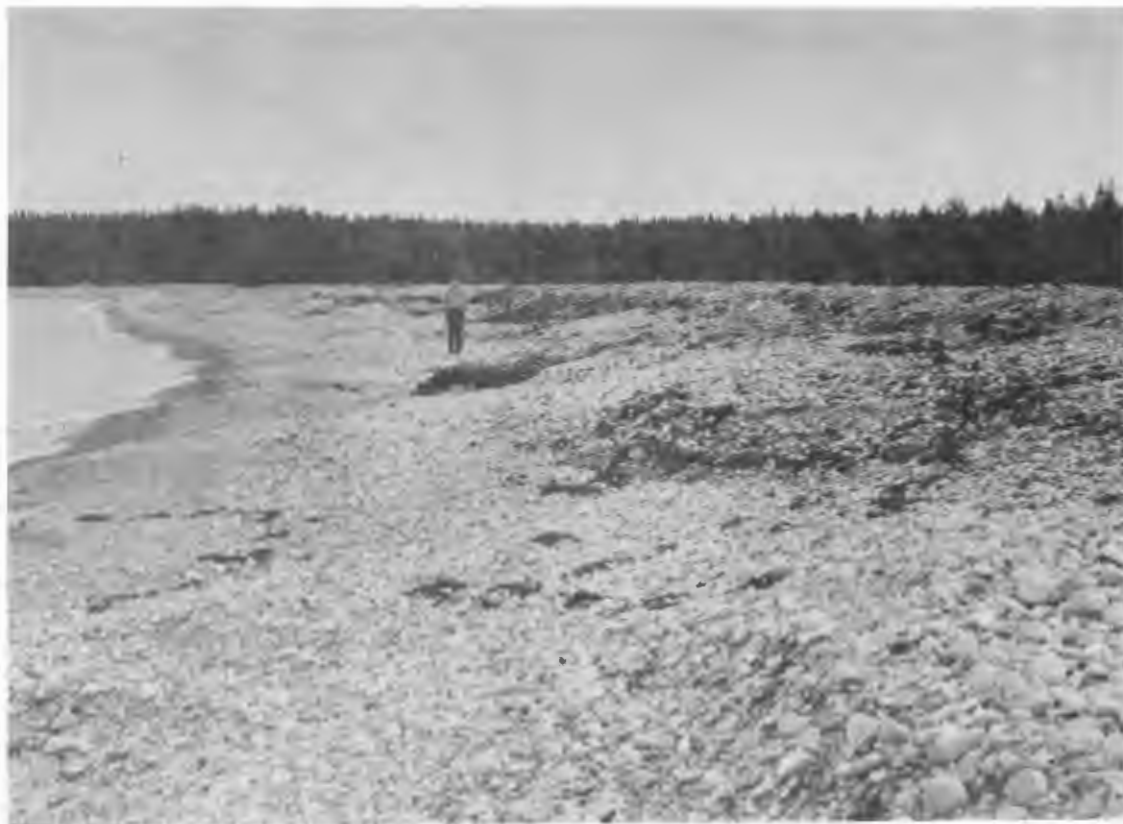
Photograph 15

This was one of the worst parts of this beach, in the west section at low tide. Contaminated material has been buried and subsequently exposed as layers in the beach face slope. This well developed beach is backed by a series of vegetated swales and former ridges.

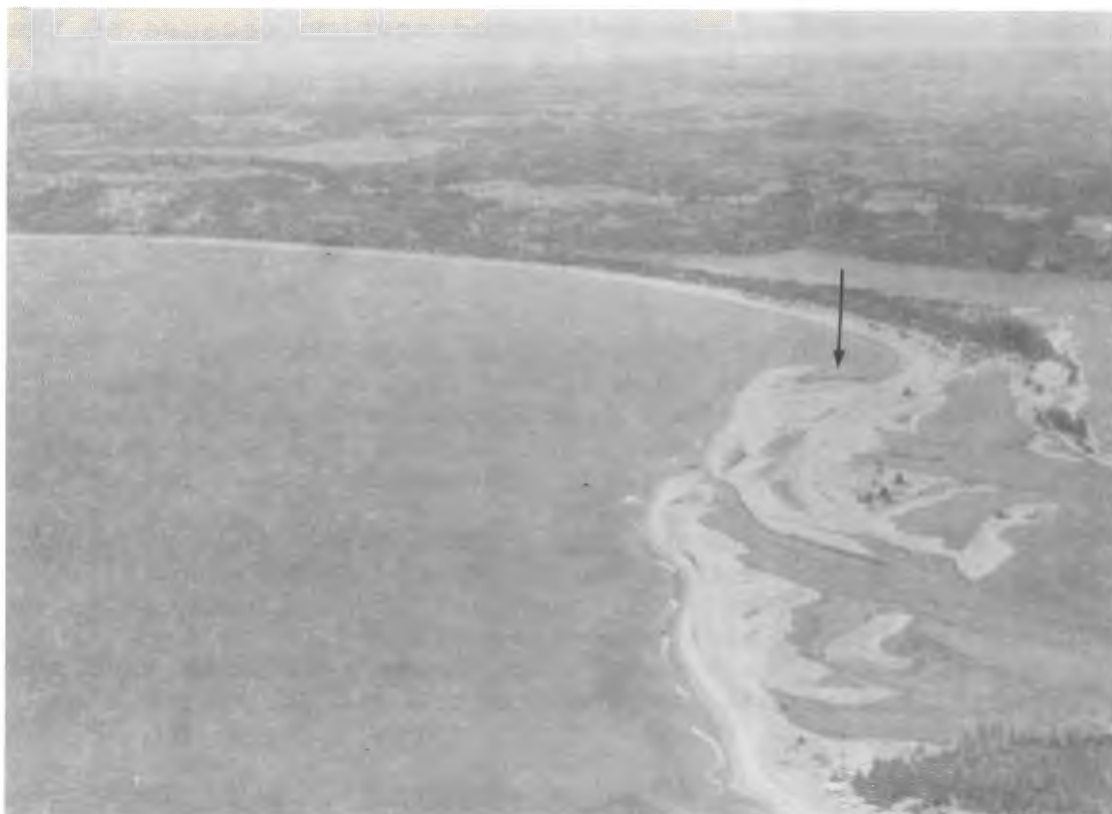
Photograph 16

MOOSE BAY

This large cobble beach and spit complex on the west coast of the Bay is one of the most impressive coastal features of the area (Photograph 16) (Johnson, 1925). The west half of this beach was restored manually (Photograph 2) while the eastern 5,000 feet were put out to contract for machine work.

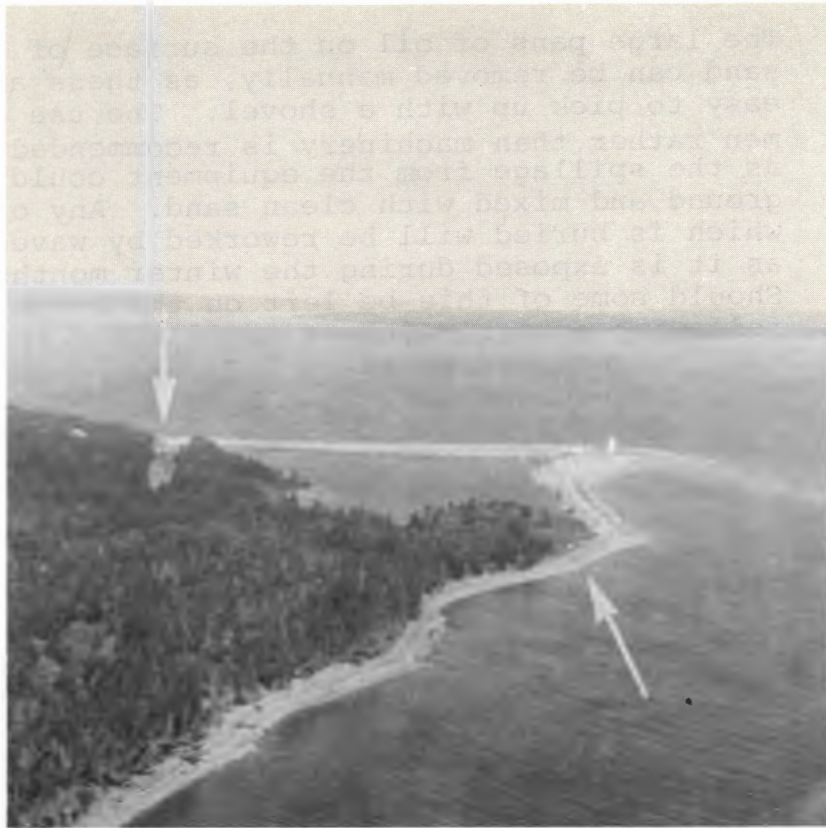
Photograph 17

Air view looking north. The lagoon is fresh water and rarely breached by the sea. The contract limits are given by the arrows.

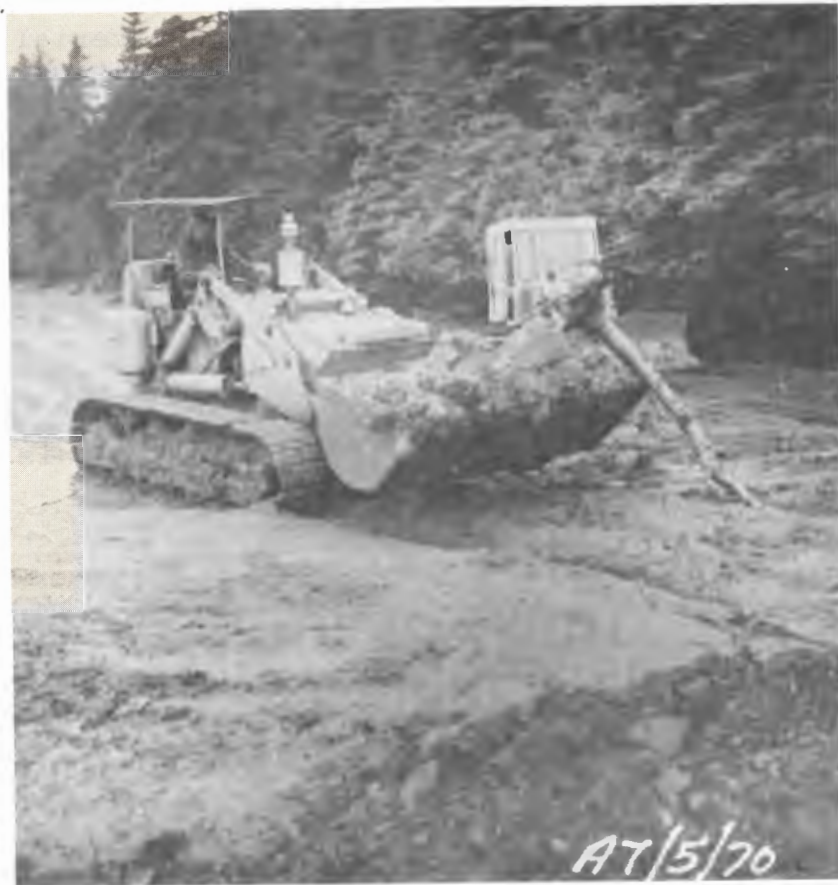
Photograph 18

WALKERVILLE

This beach section near Walkerville on the north coast of Inhabitants Bay is in this sheltered area and has a very thin sediment cover which overlies a till platform and is backed by low till cliffs. The surface layer of cobbles was paralyzed by the oil and was removed by a bulldozer and a tracked front-end loader. This action exposed the fine, till-derived, sediment which overlay the bedrock and clean and contaminated material were mixed by the churning of the tracked vehicles (Photograph 18). With the removal of the surface layer of large material, the fines were removed by wave action.
