A VOLUMETRIC ANALYSIS OF EROSION

Using Photogrammetric Contour Maps
Scarborough Bluffs, Lake Ontario

R. K. Weaver

November, 1979

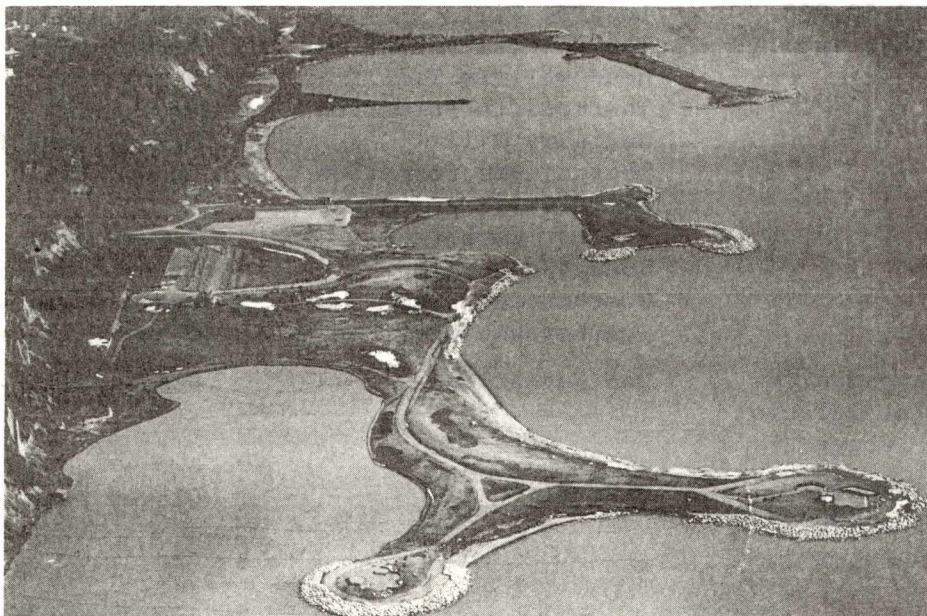
Figure 2: Bluffer's Park, offshore landfill development site

The landfill site influenced Sections 4 to 9 at the 250 ft contour line by showing definite accretion. This accretion is not regarded as being part of the natural process of erosion-accretion cycles and was taken into account in the analysis. The moderation of the slope in the Brimley Road ravine was another specific area in which the data reduction required some discretion.

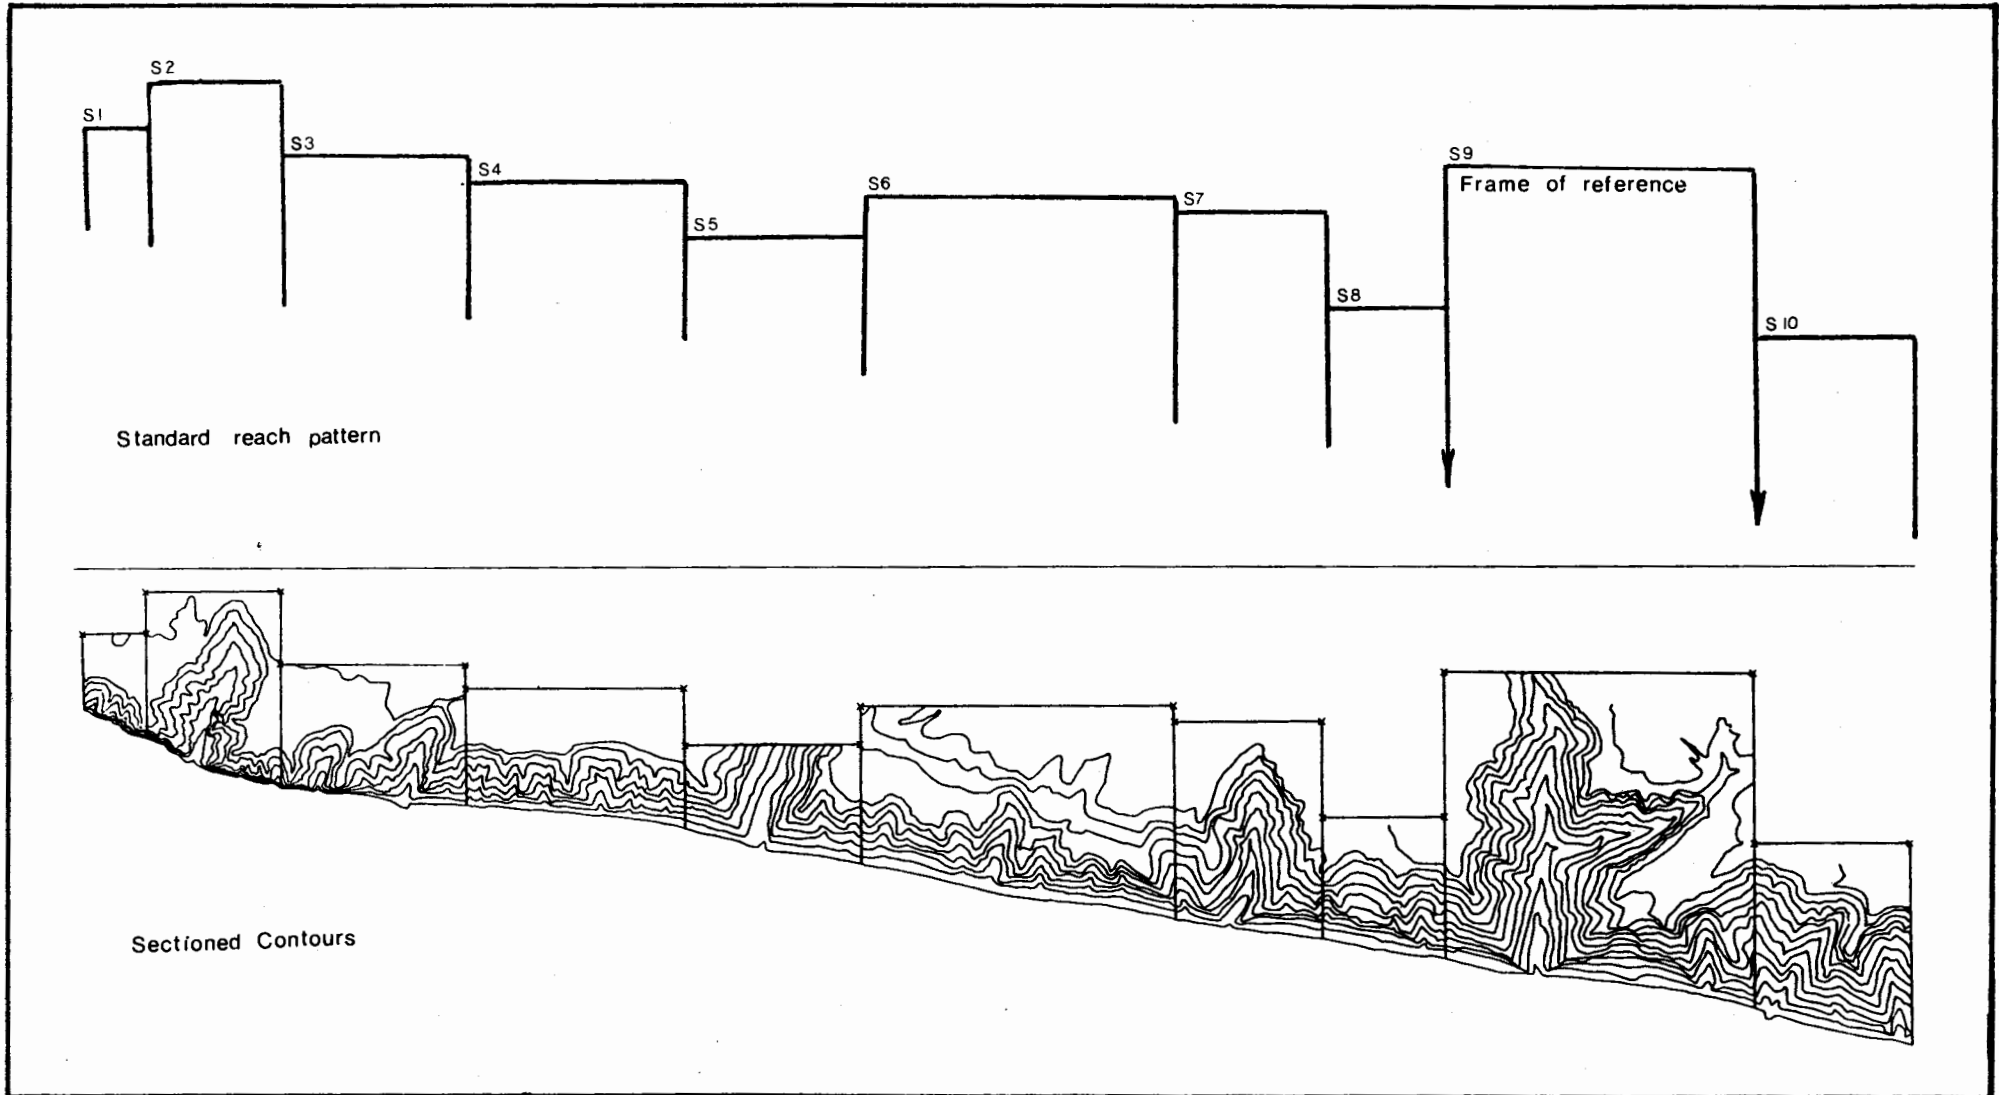
Figure 3: a) Standard reach pattern, b) Bluffer's Park 1956 (sectioned)

The study area was divided into ten sections of varying length, each section delineating significant shoreline characteristics. Figure 3 illustrates the geographical position of these sections and Table 2 summarizes the characteristics of each of the ten sections.

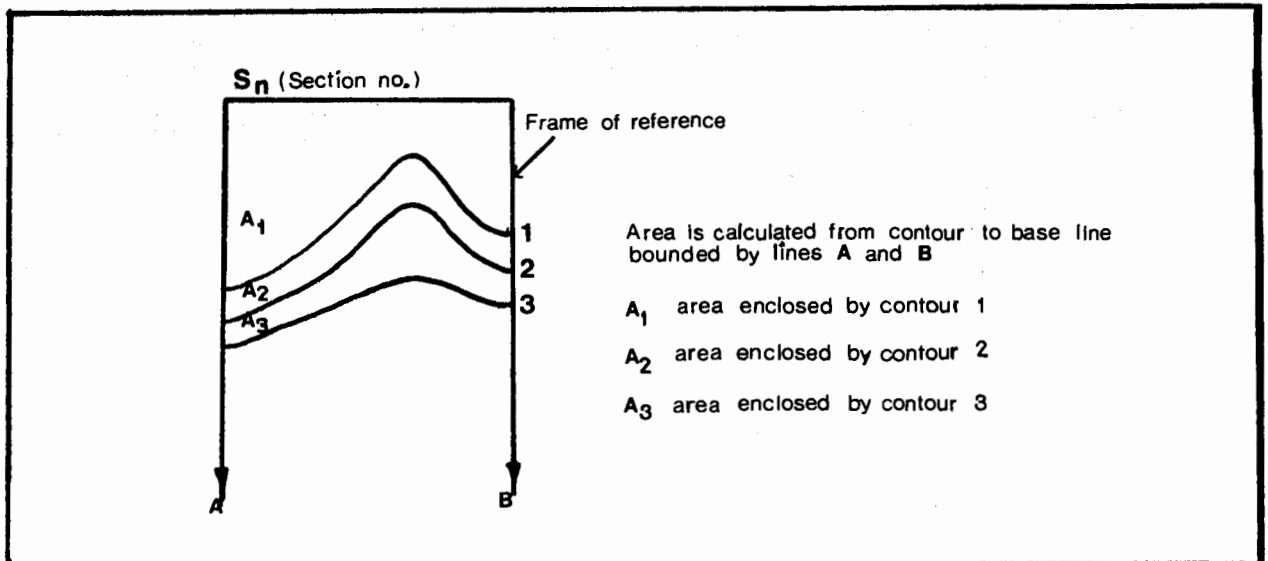
Figure 4: Section and frame of reference configuration

1. Contour maps: Establish maximum contour interval at which data will be reduced.
2. Specify a standard reach pattern: This is a collection of standard frames of references established to section off the reach into specific and prominent shoreline characteristics (Figure 3b). The frame of reference allows three of the four sides to be consistently represented at all times for all maps with the contour line forming the final closure needed to calculate the relative area at that contour.

3. Use each frame of reference and digitize all contours within its bounds: Digitizing is a process used to convert continuous (analog) information to discrete (digital) information so that the resulting transformed data will be compatible for computer processing. Digitizing a contour (analog or continuous information) is essentially the representation of the contour using a number of discrete points having x and y coordinates, (x_i, y_i) ; where $i=1,N$. The distance between points is user specified, but is typically 0.03 in, $x_i - x_{i-1} = 0.03$.

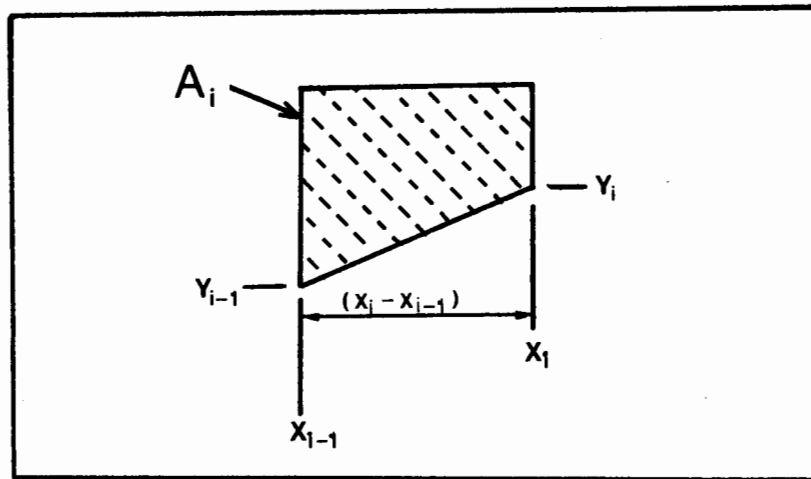
Figure 5: Increment of Area: A_i

4. Calculate the relative area: A straight line simulates the contour over the distance of 0.03 in and forms a small trapezoid, the area of which is calculated using the following equation:

$$A_i = \frac{1}{2}(Y_i + Y_{i-1}) * (X_i - X_{i-1}) \quad (1)$$

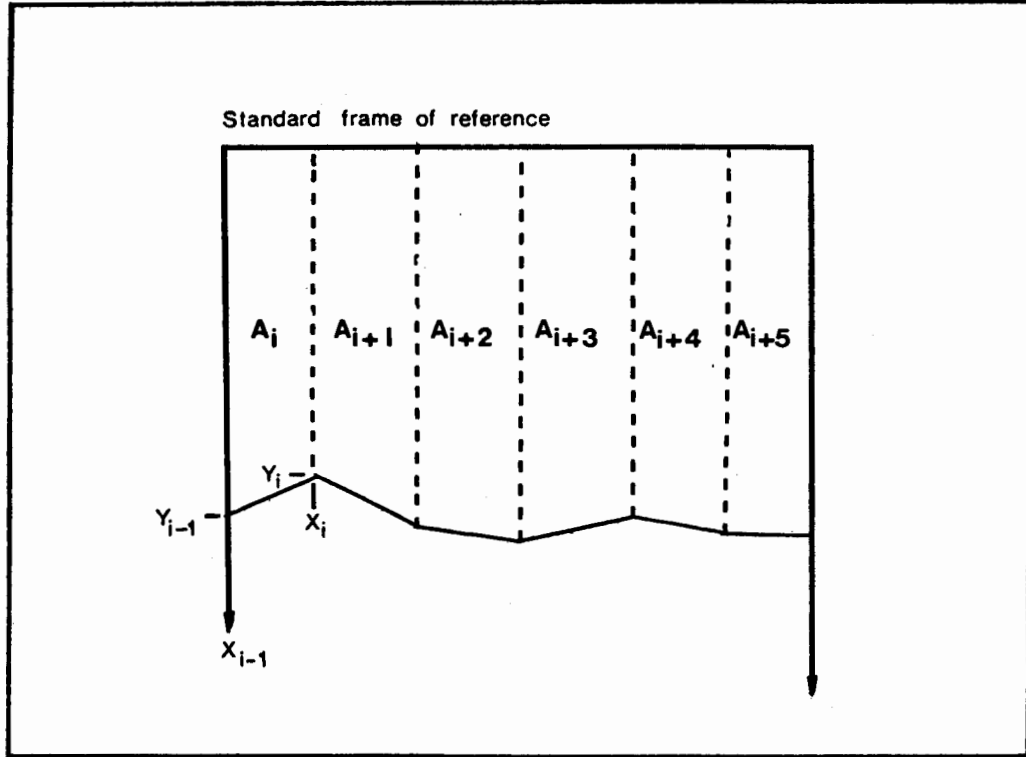
Figure 6: Area within a frame of reference

Each area is summed over the length of the section which is bound by the frame of reference.

The result is an approximated area for the contour line being considered, calculated numerically by the technique known as "the trapezoidal rule for integration".

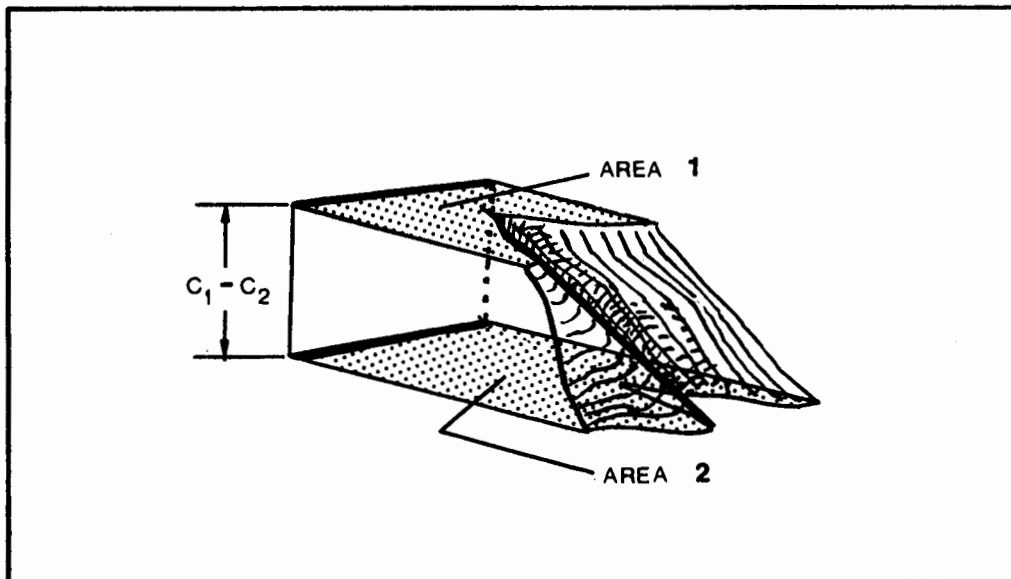
Figure 7: Volume between contours

5. Calculate the volume between contour intervals.

$$\text{VOL} = \frac{1}{2}(A_2 + A_1) * \text{FACT}^2 * \text{ABS}(C_2 - C_1) * \text{METRE} \quad (2)$$

- METRE = 0.305
- FACT = 60.96
- A_1 = Area 1
- A_2 = Area 2
- $C_2 - C_1$ = contour interval.

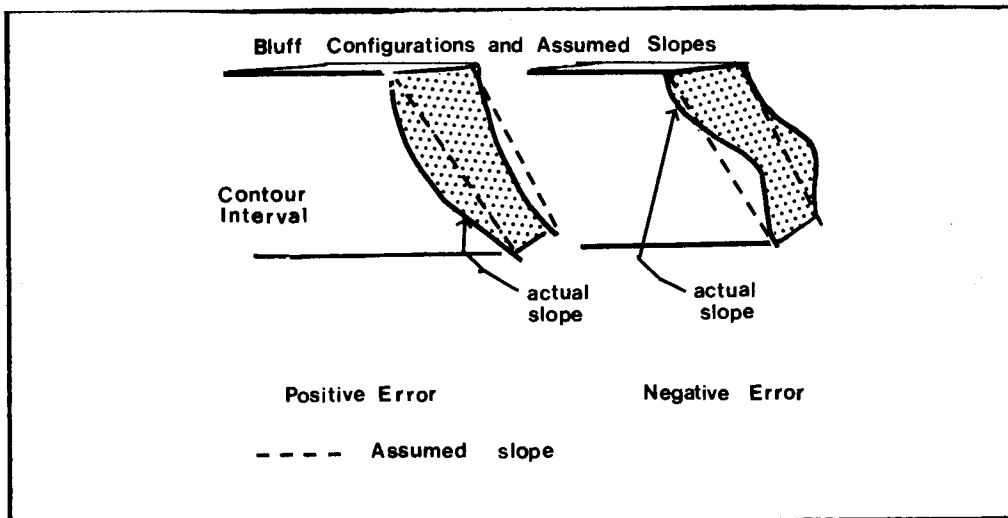
Figure 8: Straight line slope

Calculating volumes may result in either a positive or negative error depending on the configuration of the actual bluff between the contours. Over the 7.63 m (25 ft) contour interval, a straight line slope is assumed. If the actual slope is concave to the assumed straight line slope, calculations will yield an overestimate of the volume for that bluff configuration. A convex slope will result with an underestimate of the volume. This relationship is shown in Figure 8.

However, over the length of the reach the slope may vary between the two configurations many times. The assumption of a straight line slope is an approximation of the mean. If an error is present, it may be decreased by increasing the number of contour lines to be digitized, thereby decreasing the contour interval.

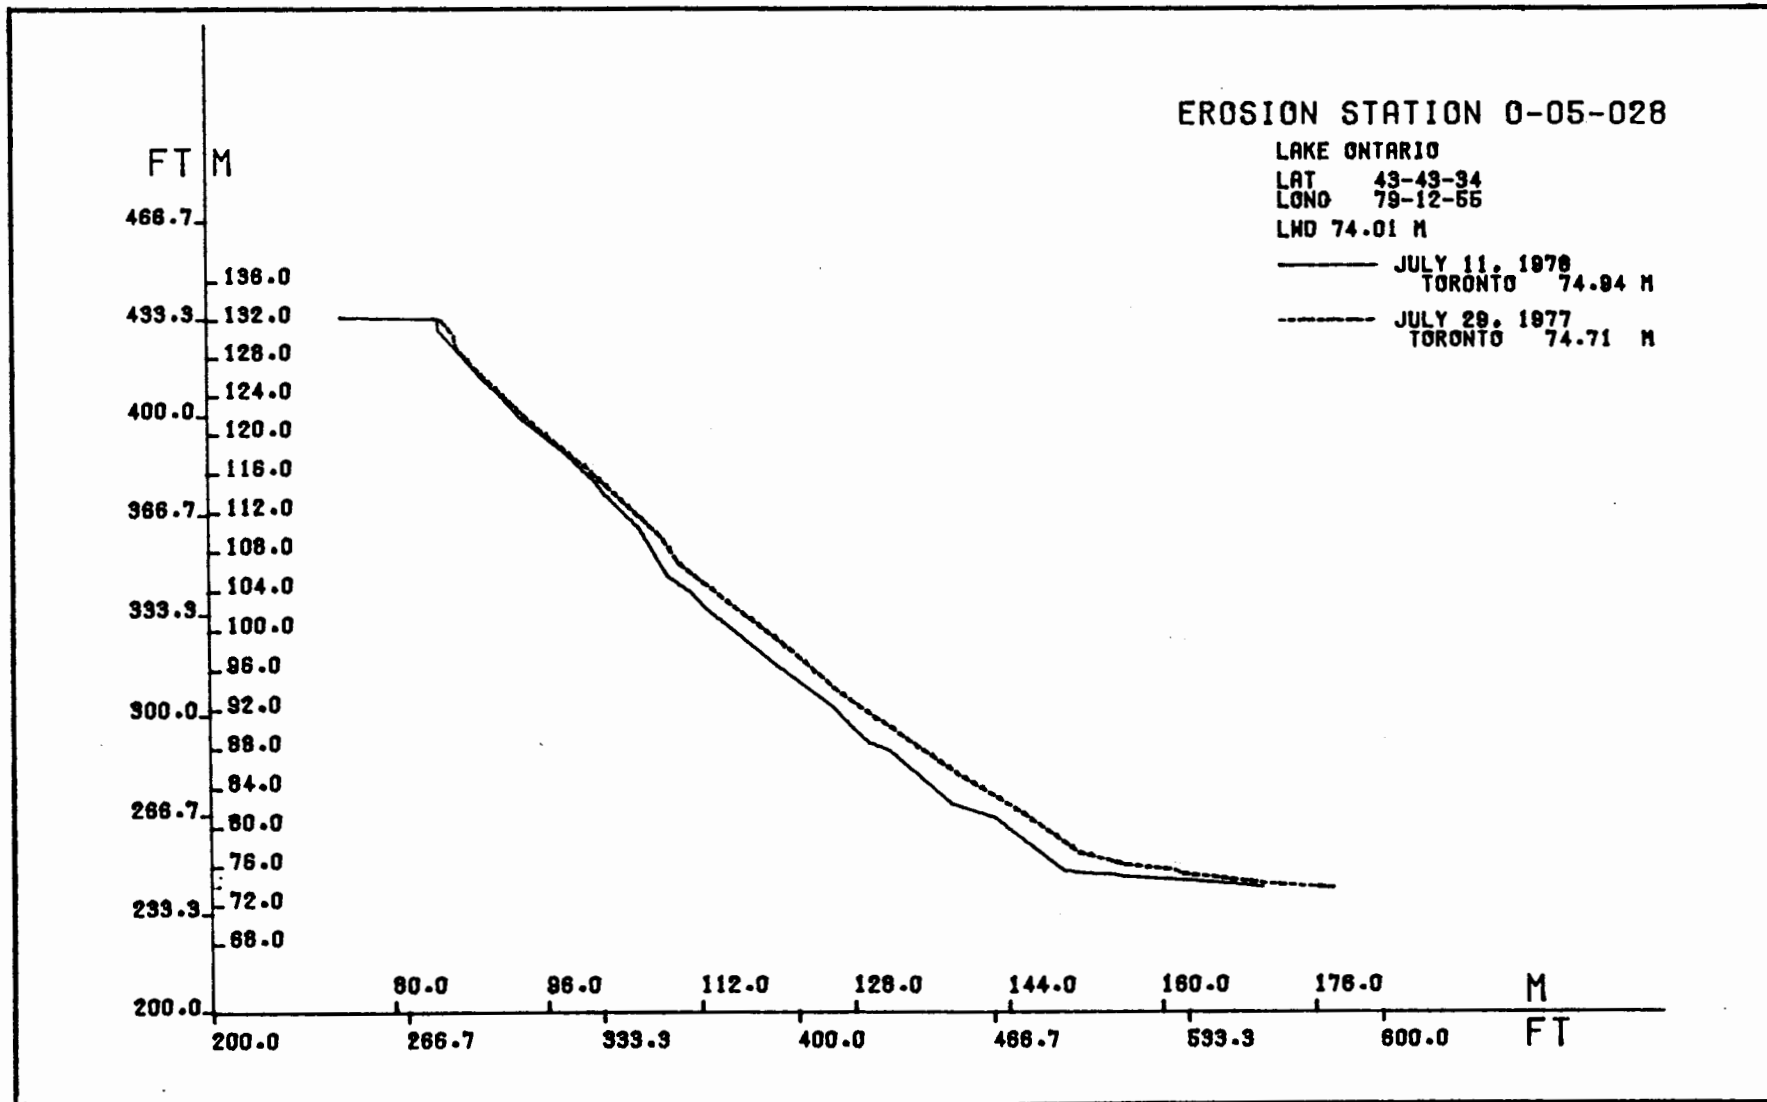
Figure 10: Erosion Station Profile

Presently there are erosion monitoring stations in the Scarborough reach (Figure 9) which are used to measure shoreline changes. Figure 10, a plot of cross-sectional profiles, illustrates the apparent differences between ground surveys for two consecutive years (1977-78).

For a volumetric comparison, assume the profile line represents a one metre reach. The associated volume lost over the height of the bluff (57 m) is 140 m^3 and can be reduced to an average annual recession rate of $2.45 \text{ m}^3/\text{m}/\text{yr}$. Similar rates are reduced from other erosion stations within the Bluffer's Park reach. They are $3.06 \text{ m}^3/\text{m}/\text{yr}$, and $1.88 \text{ m}^3/\text{m}/\text{yr}$ for stations 0-05-025 and 0-05-023 respectively. In comparison to these short term rates (1 yr period), other studies over a longer period (up to 30 yr) have been done.
