Environmental Engineering Studies associated with the Aishihik River Hydroelectric Development

by
R.A. Robertson and B.R. Eliassen

PAC/T-74-18

September, 1974

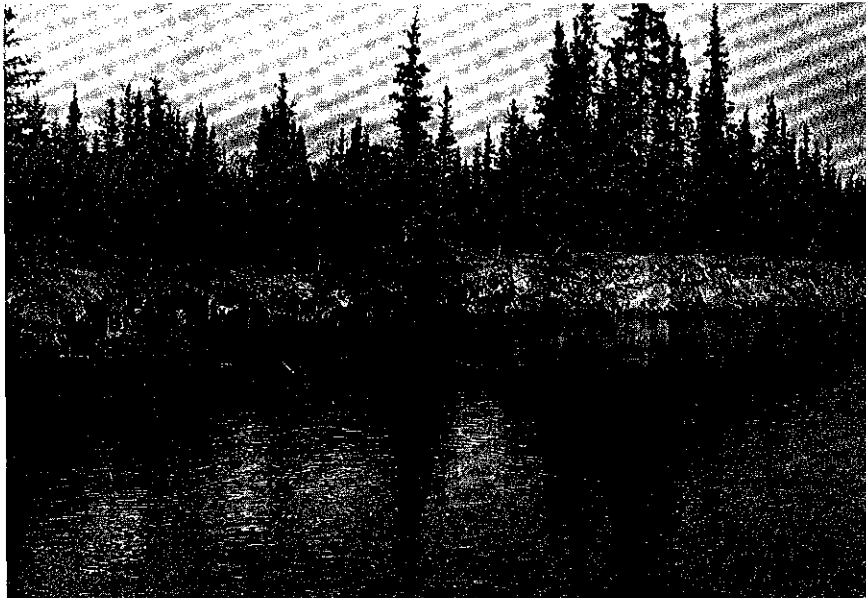
Left bank of Sekulmun River between hubs P10 and P11. Note block slumping which is believed to be caused by frost melt.

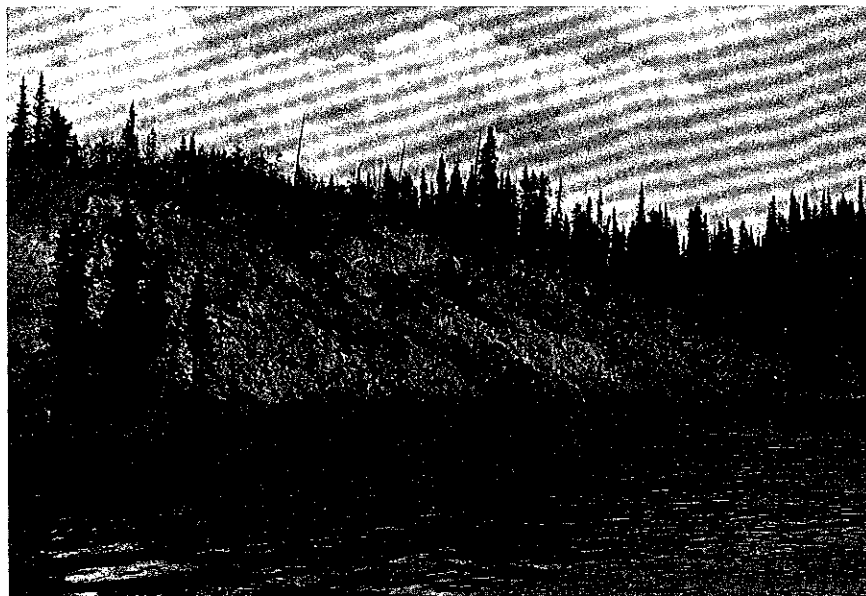
Left bank of Sekulmun River near hub P23. Clay cut banks sometimes rising to more than 80 feet in height are common to the central reaches of the river.

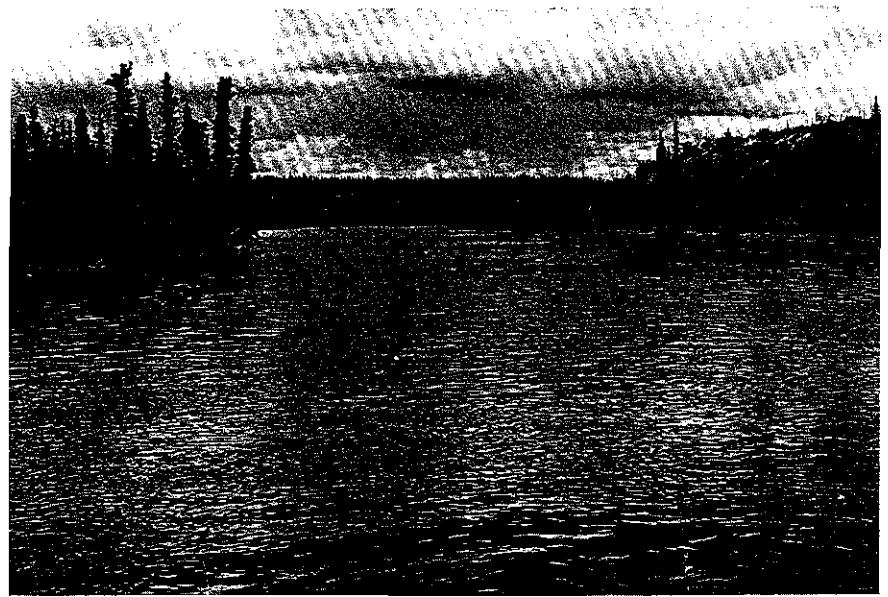
Sekulmun River looking upstream
from hub 1C

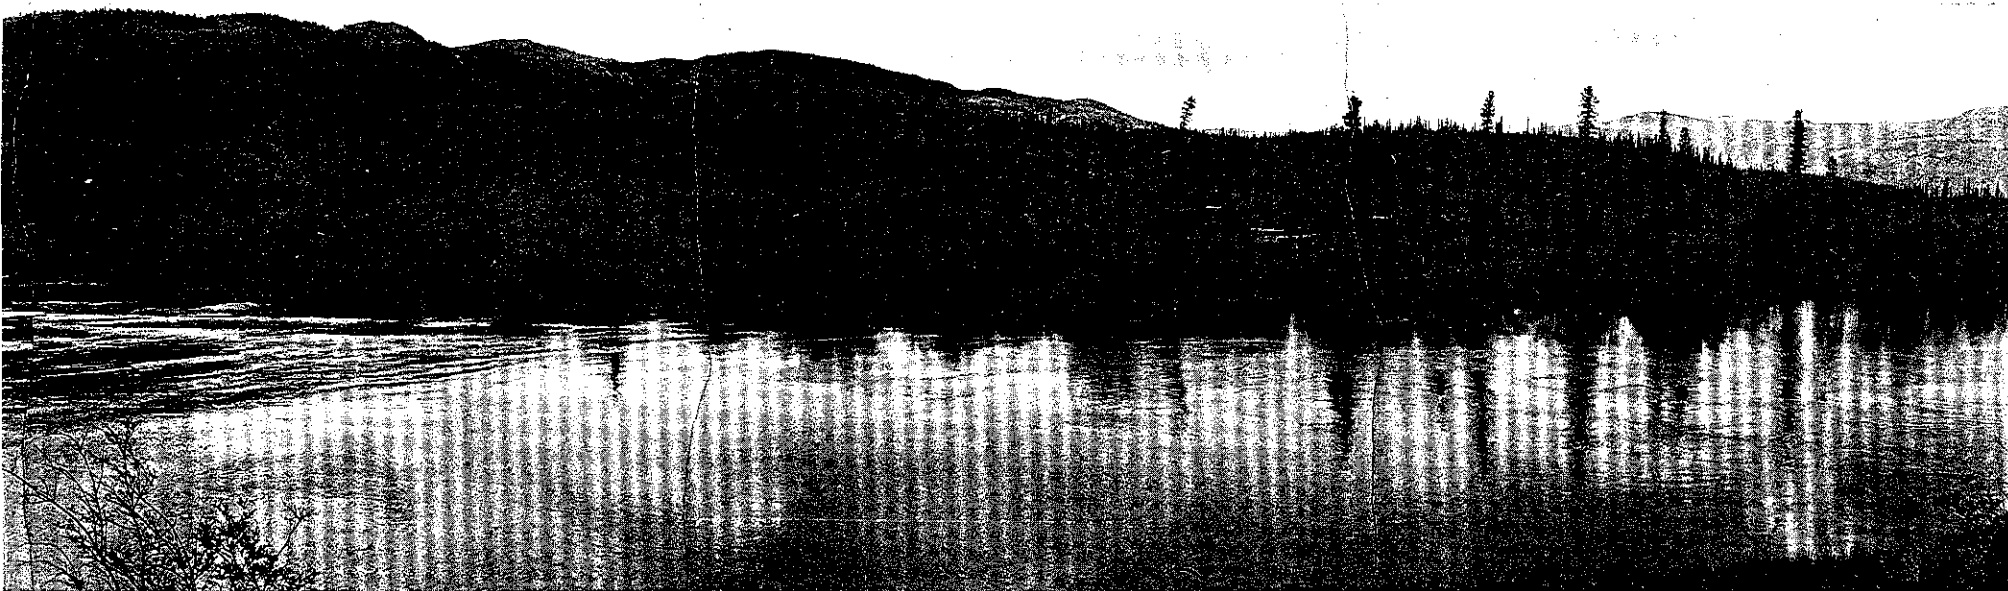
STUDY AREA NO. 1

Sekulmun River looking downstream
from Sekulmun Lake

This area lies in very flat terrain. Banks are low and the river is generally quite shallow. The stream is approximately twice as wide and has a steeper gradient than the remainder of the river. The riverbed is composed of fine, clean gravel due to the higher velocity throughout this area. Stunted willow, white spruce, shrubs, and grasses tend to stabilize the fine soil composition of the banks.

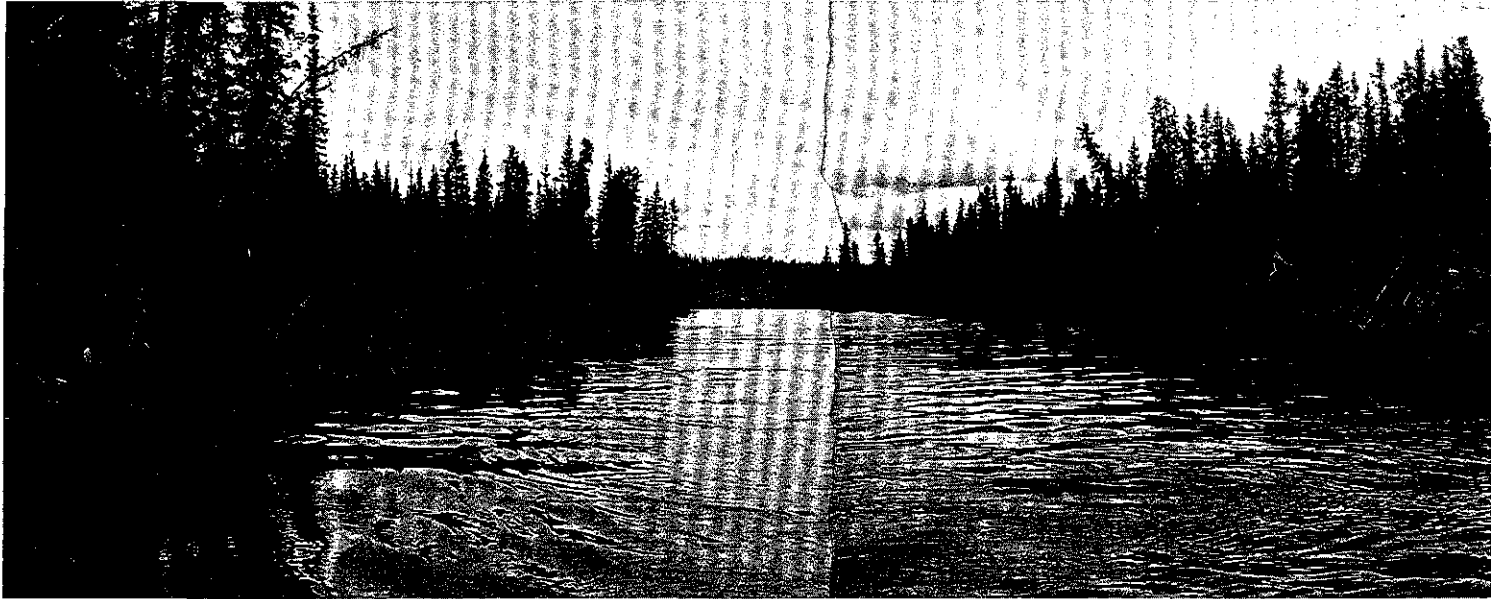
STUDY AREA NO. 2

Sekulmun River looking at right bank from opposite hub P19

Riverbanks are low and the surrounding terrain is generally quite flat between this point and Sekulmun Lake. Steep clay banks begin to occur a short distance downstream. The stream is narrower than in study area No. 1 and the gradient is much flatter. The riverbed is composed of sandy clay material and velocities are low.

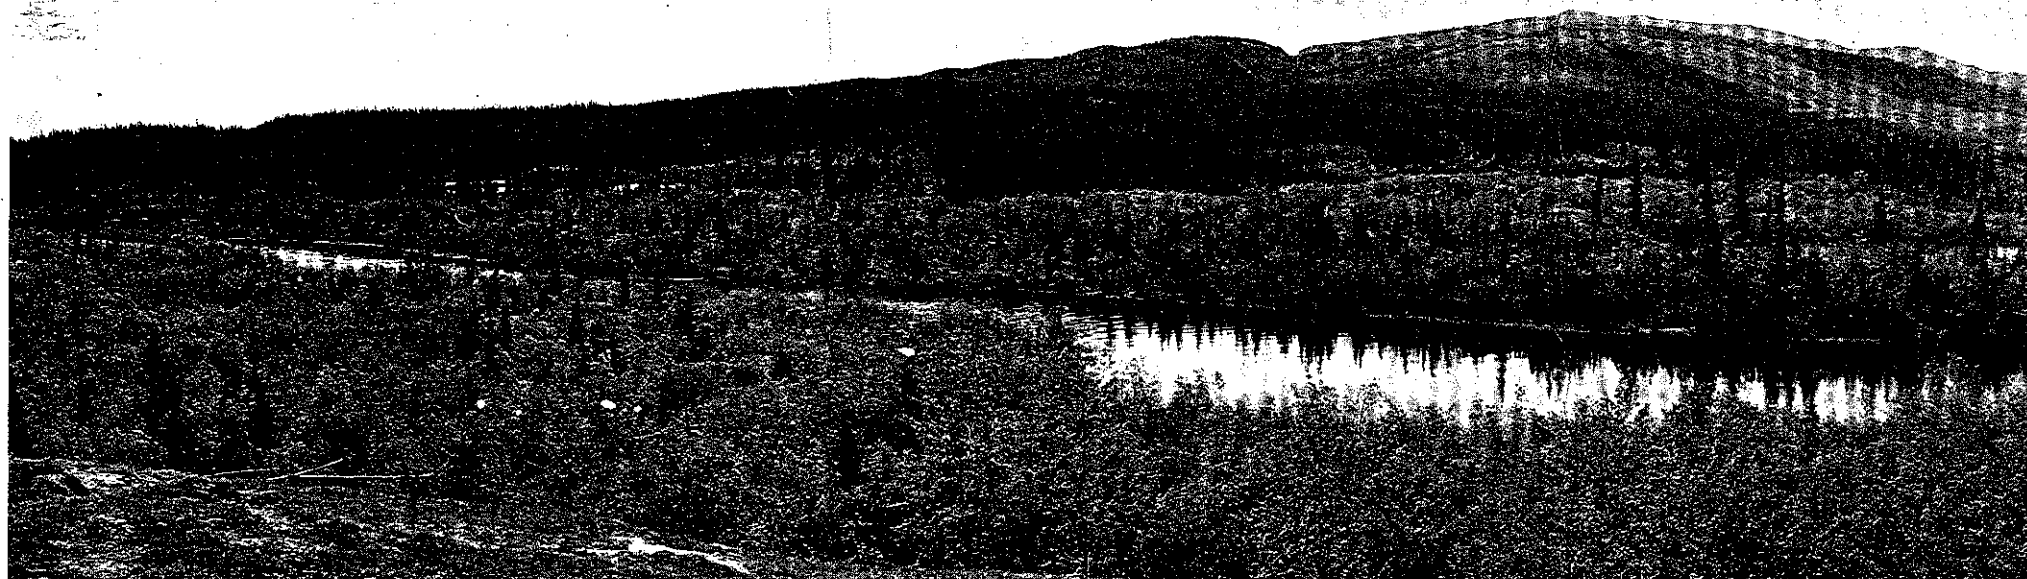
STUDY AREA NO. 3

Sekulmun River looking downstream
adjacent to hub P32

This area has banks rising 8 - 12 feet from the water surface and an undulating terrain. Dense stands of mature white spruce and stunted willow crowd the riverbanks. Gradient and velocity is low, resulting in a sandy, clay river bottom. Signs of bank sloughing is very common throughout this area.

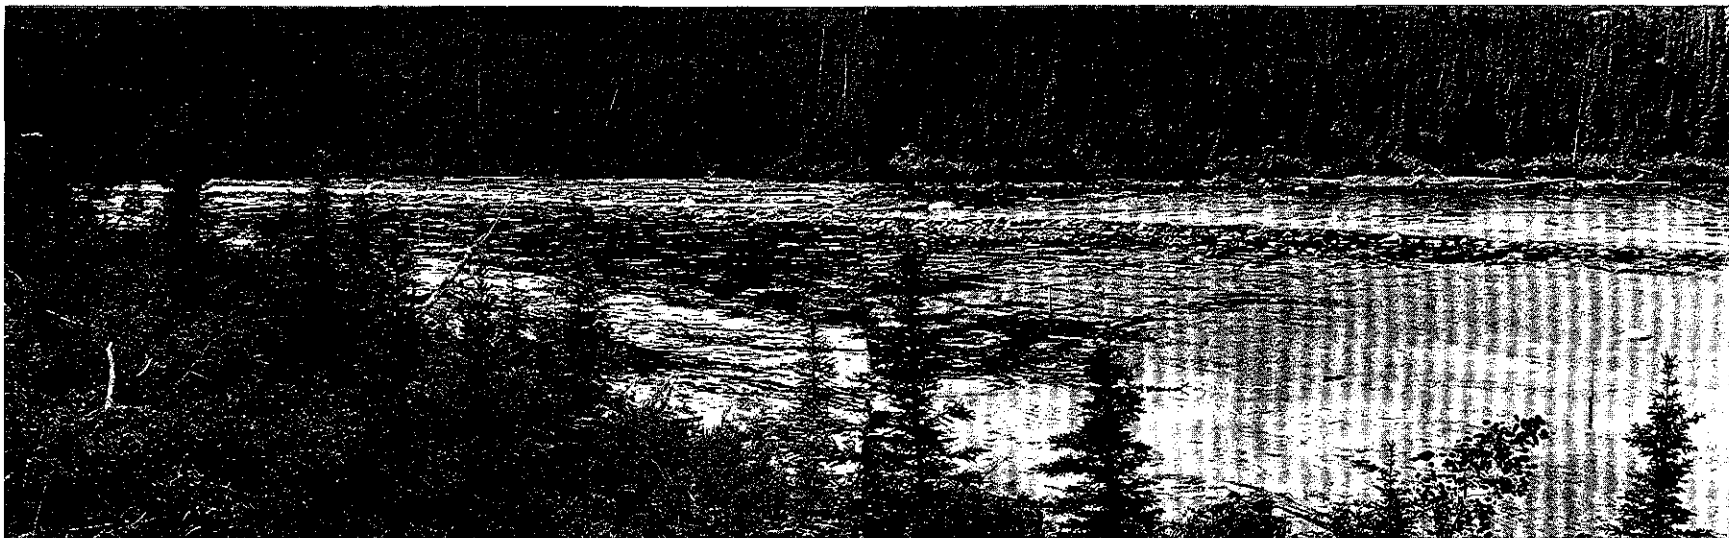
Upper Aishihik River immediately below Canyon Pond.

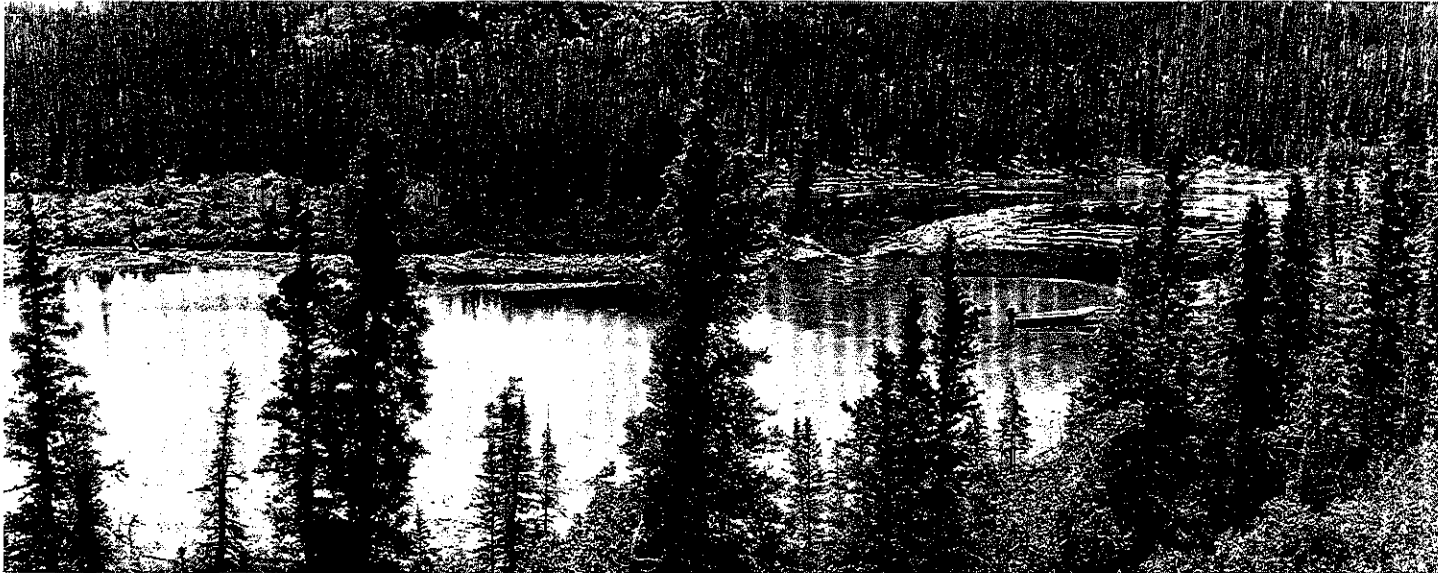
Upper Aishihik River - Pool 1 in background, Pool 2 in foreground.
(See Figure 7)

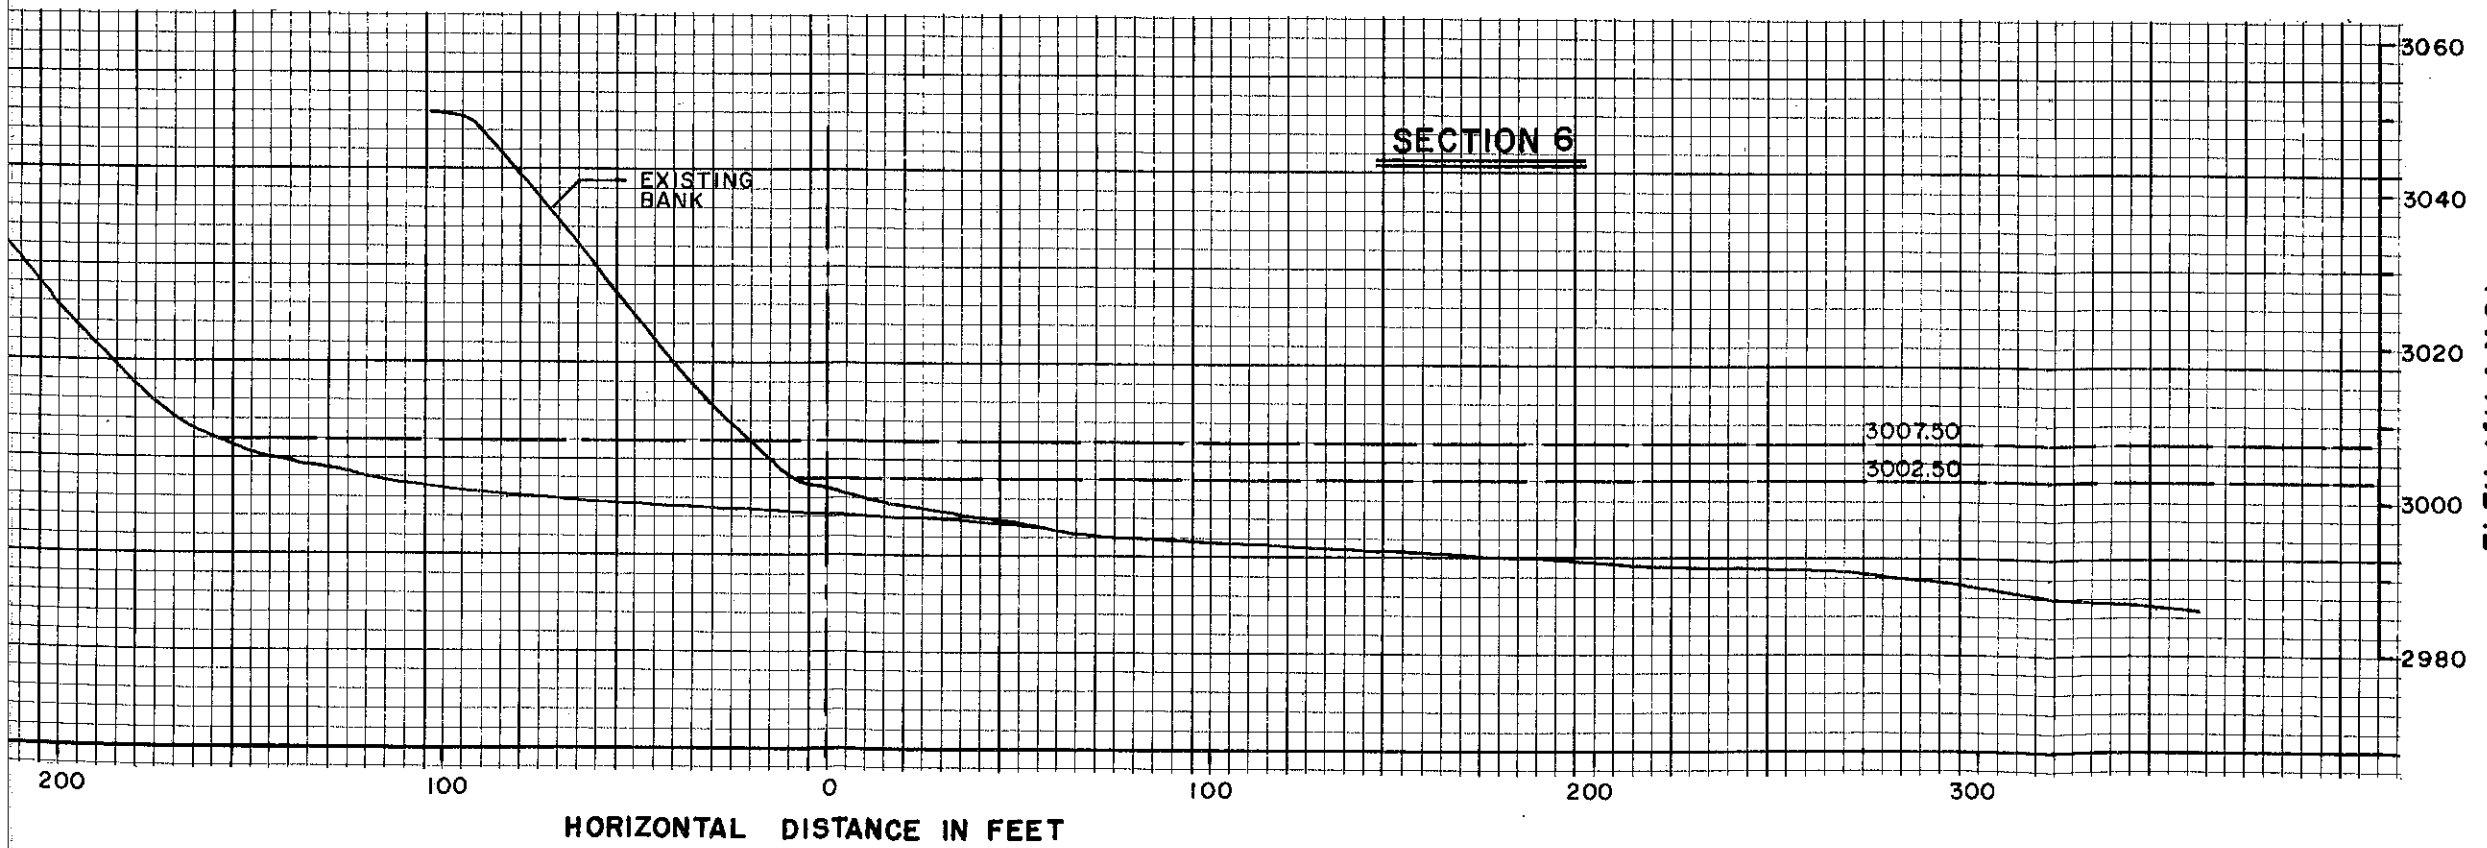
PROBABLE BANK RECESSION RESULTING FROM INCREASED STORAGE LEVELS AT SECTIONS I AND 6.

Extensive erosion will, however, occur along the Class A shoreline with flooding to elevation 3007.5. This includes the 3 miles of steep clay banks along the north end of the lake, as represented by Section 1, and the 1 mile of steep gravel banks at Section 6. The instability of the clay banks is apparent by the large cracks and slumping occurring near Section 1. Wide beaches have formed at the toe of the banks but a certain amount of erosion probably occurs
