Research Document 2002/026

Impact of a standard conduit fish counting fence on water quality of Campbellton River, 2001

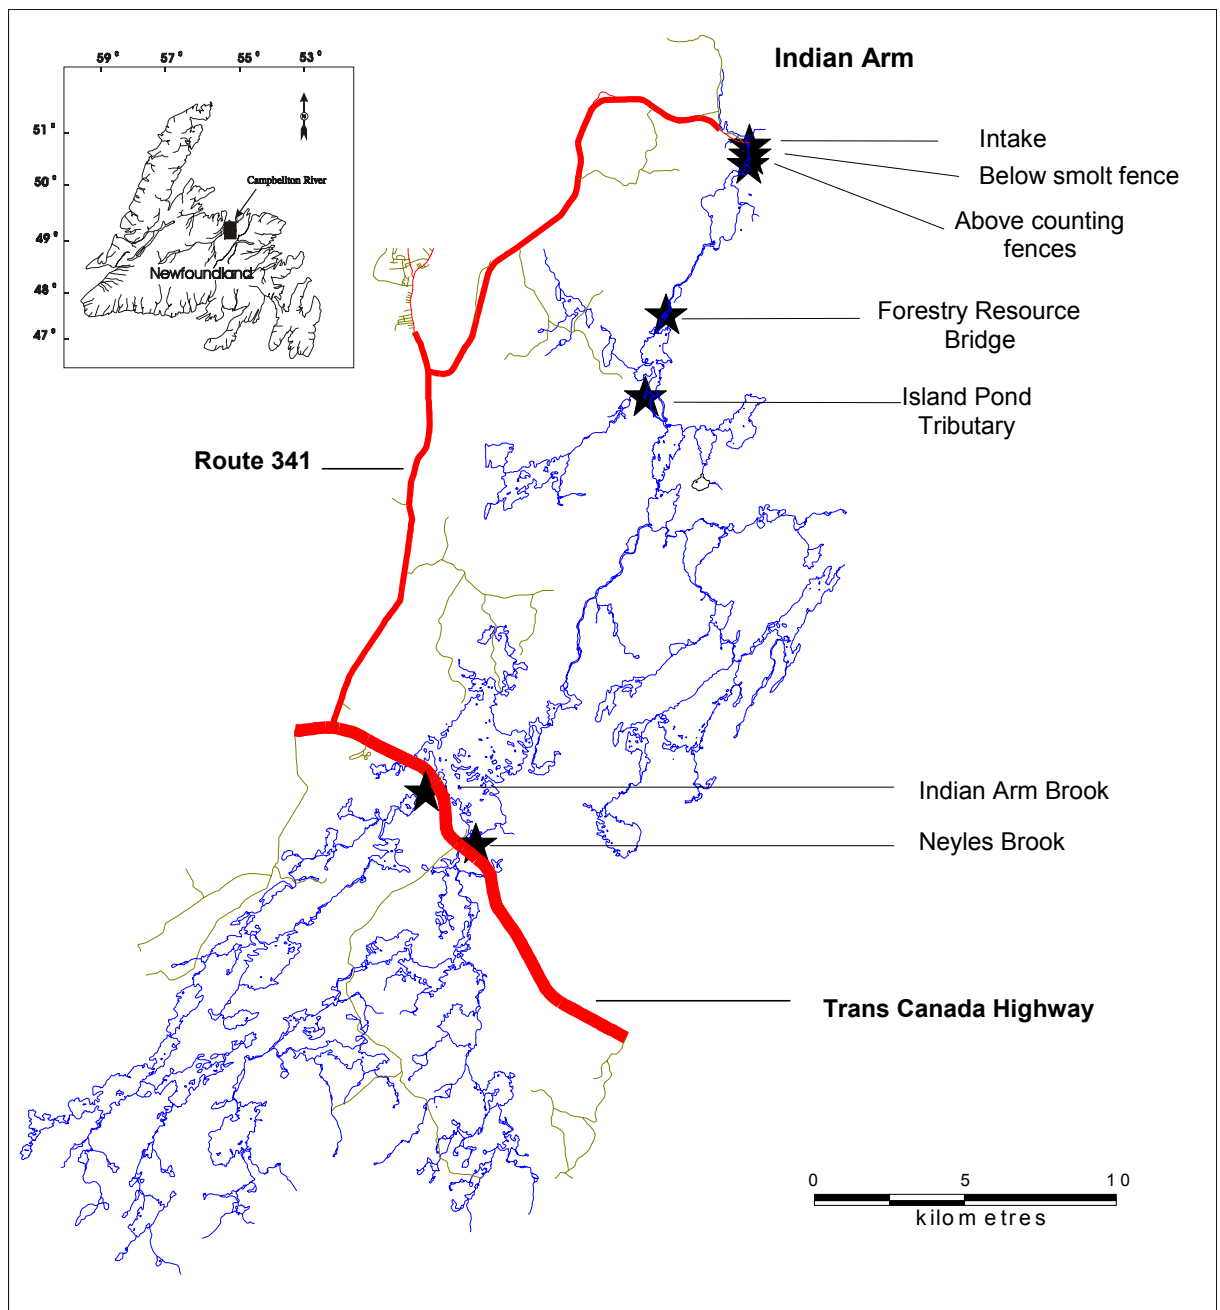
Figure 1. Water collection sites for Campbellton River from selected years from 1987 to 2001.

Campbellton River (Indian Arm River) flows in a north-easterly direction emptying into the sea at Indian Arm, Notre Dame Bay (Fig 1). The river is located in the Central Newfoundland Ecoregion characterised by gently rolling to hilly topography, underlain mainly by acidic bedrock with the absence of limestone (Damman 83). Campbellton River has a drainage area of approximately 296 km² with an axial length of 40.22 km with a mean width of 7.4 km (Porter et al. 1974). The drainage area is situated in a low relief basin on the north-east coast that generally has elevations less than 200 m, giving the river a moderate gradient when compared to rivers in other parts of Newfoundland. The Campbellton watershed is densely wooded, comprised mainly of black and white spruce with scattered patches of balsam fir and white birch, with string bogs that are mainly on the eastern side of the river. Throughout the waterway are many interlocking small lakes, some of which are quite shallow, with mean depths less than three meters. Habitat studies done at mid-summer during moderate water levels from 1993 to 1997 (DFO, unpublished data), indicate water flows through the system quite slowly at less than one meter per second. Salmonid rearing areas for both the fluvial and lacustrine habitats are 5,960 units (unit=100 m²) and 4,037 ha respectively (Downton et al. 1998).

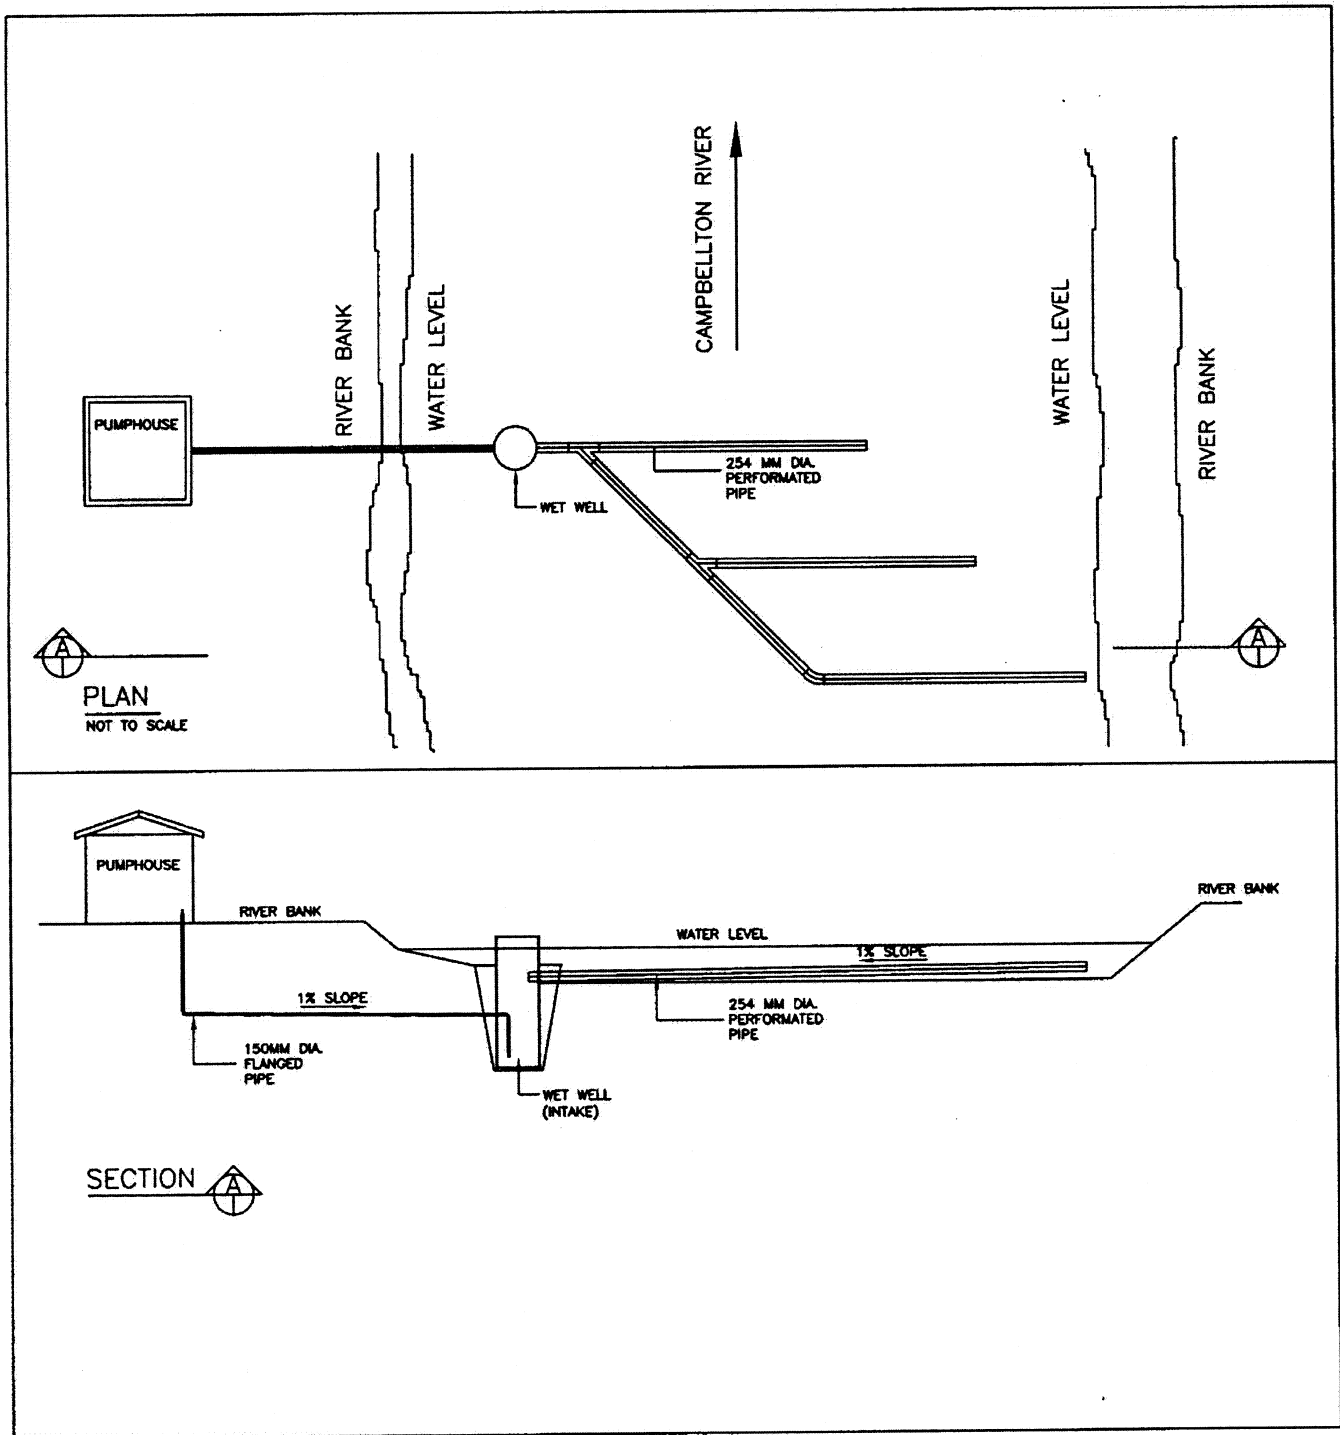
Fig. 2. Plan and section view of the intake at Campbellton River which supplies water to the Community of Campbellton.

The protected water supply area was extended on October 12, 1999 from 7.15 km² of the lower section of the river to include the entire drainage basin. At present under the Environment Act, SN 1995 cE-13-1, Department of Environment and Labour of the Province of Newfoundland and Labrador, an approval must be obtained from the Province prior to any development activity in a protected public water supply. This only applies, if the development activity in the river is 100 m below or above the water intake. Campbellton River provides the town of Campbellton with its municipal water supply, except for the lower end of the community which draws its water from local wells. Water is removed from the river by an infiltration gallery constructed in 1973 in the streambed just approximately 15

meters above tidewater. The water is then gravity fed into a culvert intake and pumped to a building located onshore several meters away for chlorinating (Fig. 2).

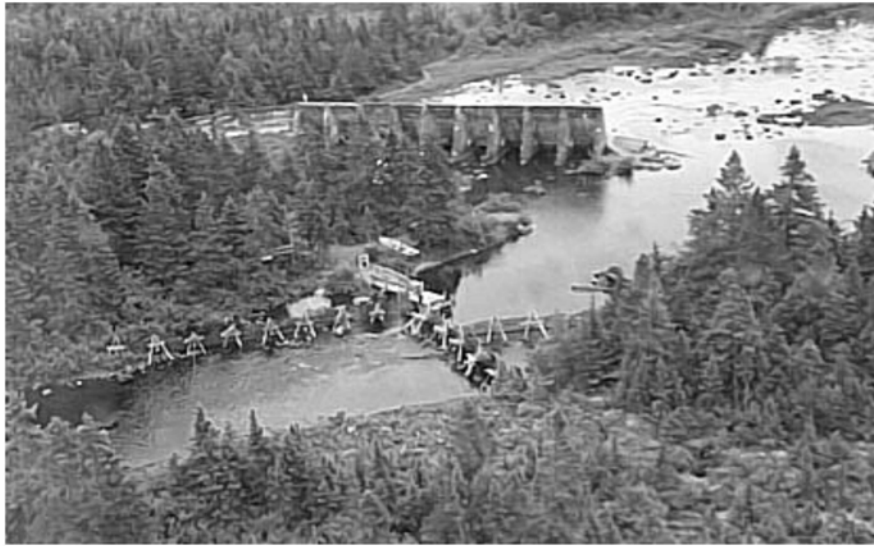
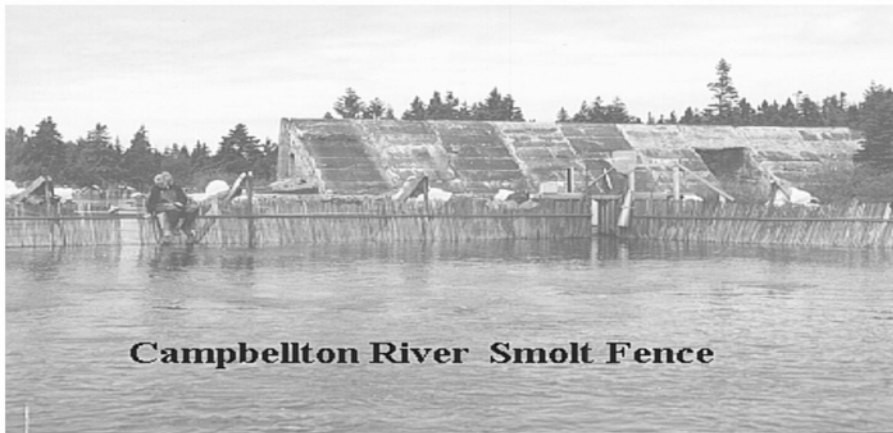
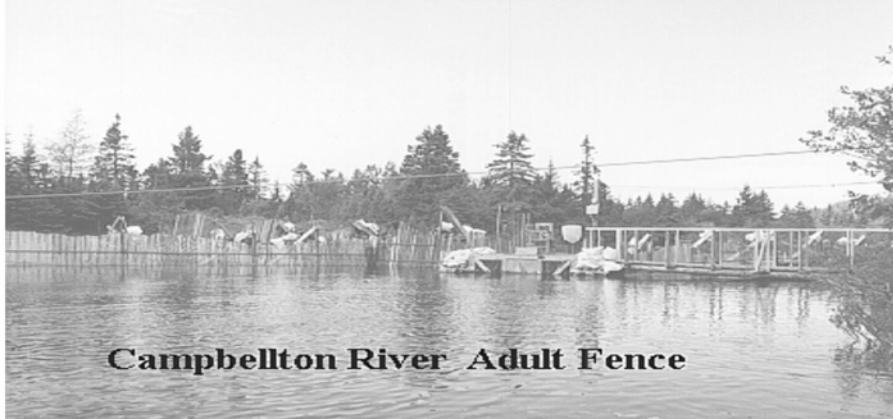
Figure 3. Adult and smolt counting fences used in Campbellton River.

The adult fence is smaller but of similar construction as the smolt fence and located just below the Horwood Dam (Fig. 3). The river is approximately 25 m in width at the site of the adult fence. This fence is installed mainly on bedrock with the east wing over large and small boulders. The installation time is approximately three days with very little disturbance to the bottom substrate. The adult fence is generally in place by the beginning of June and remains in operation until late September. The period of time that the adult fence and smolt fence are in operation can overlap depending on the end of migration of downstream smolts with the beginning of upstream adults. Generally, the overlap between the two fences is less than a week. After the smolt run is finished the fence is removed from the river and stored on shore near the riverbank. The adult trap is 2.1 X 2.1 m and the sides are constructed of conduit pipe. The fence has two wings forming a V-shape into the trap and a guide wing to keep fish out of a pool located just above the west wing of the fence. Overall the fence is comprised of 20 sections. Inside the trap, a see-through enclosed tunnel is placed on the floor of the trap with an overhead underwater camera that will videotape fish as they pass through the fence. After use, the fences are completely removed from the river and stored on shore.

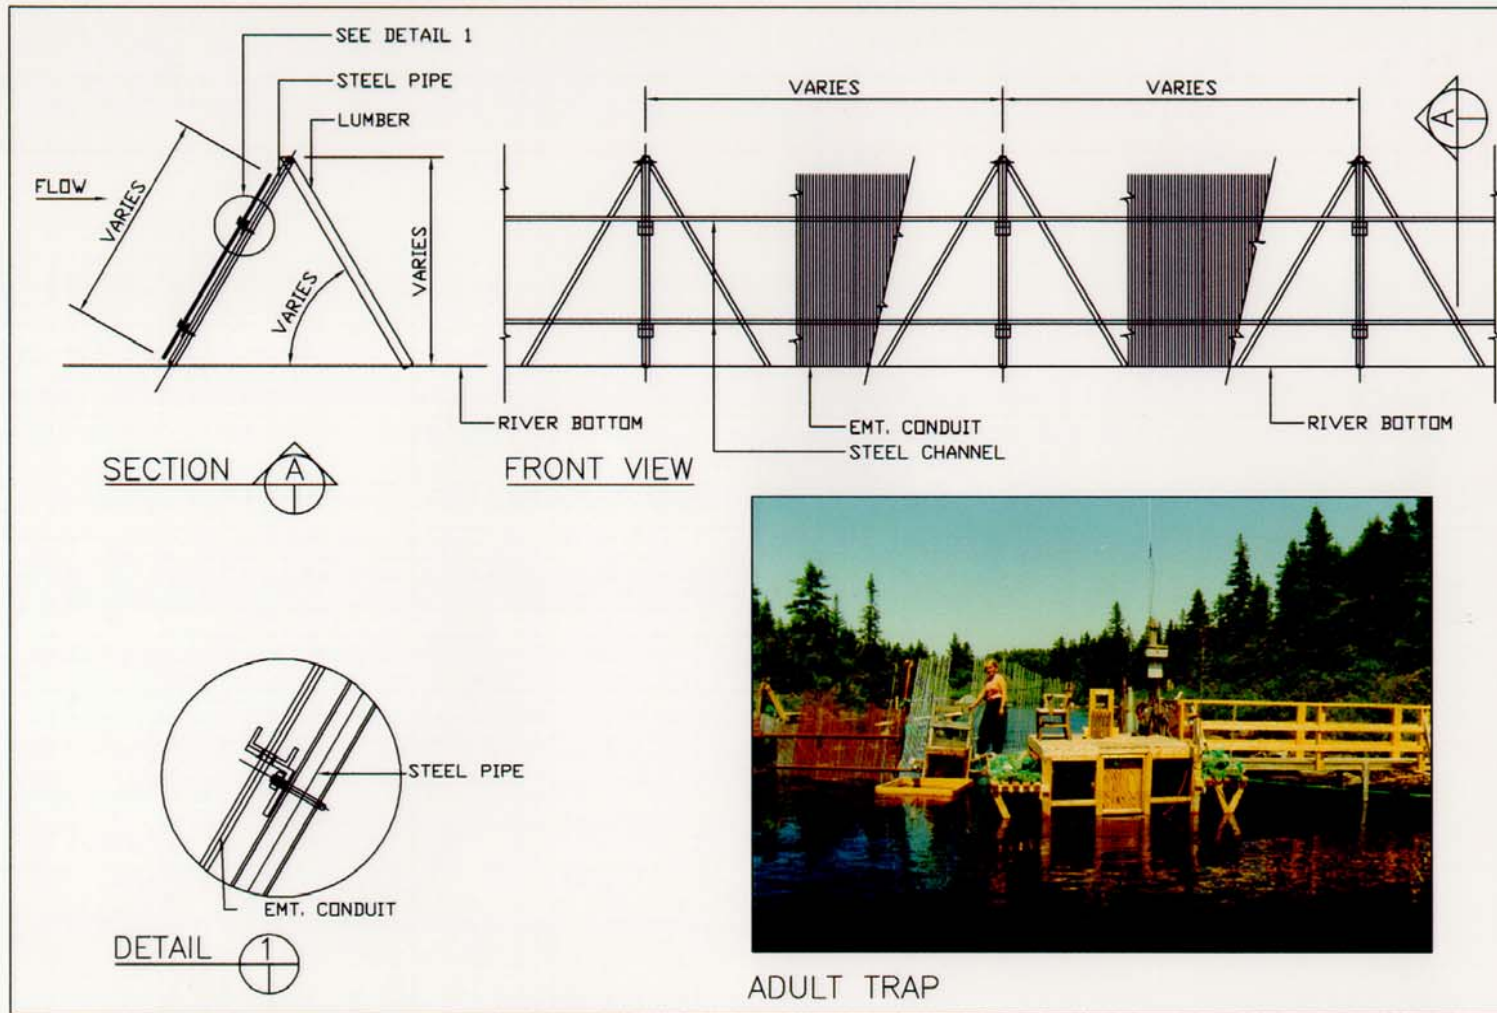
Fig. 4. Basic components which comprise the fish counting fence at Campbellton River.

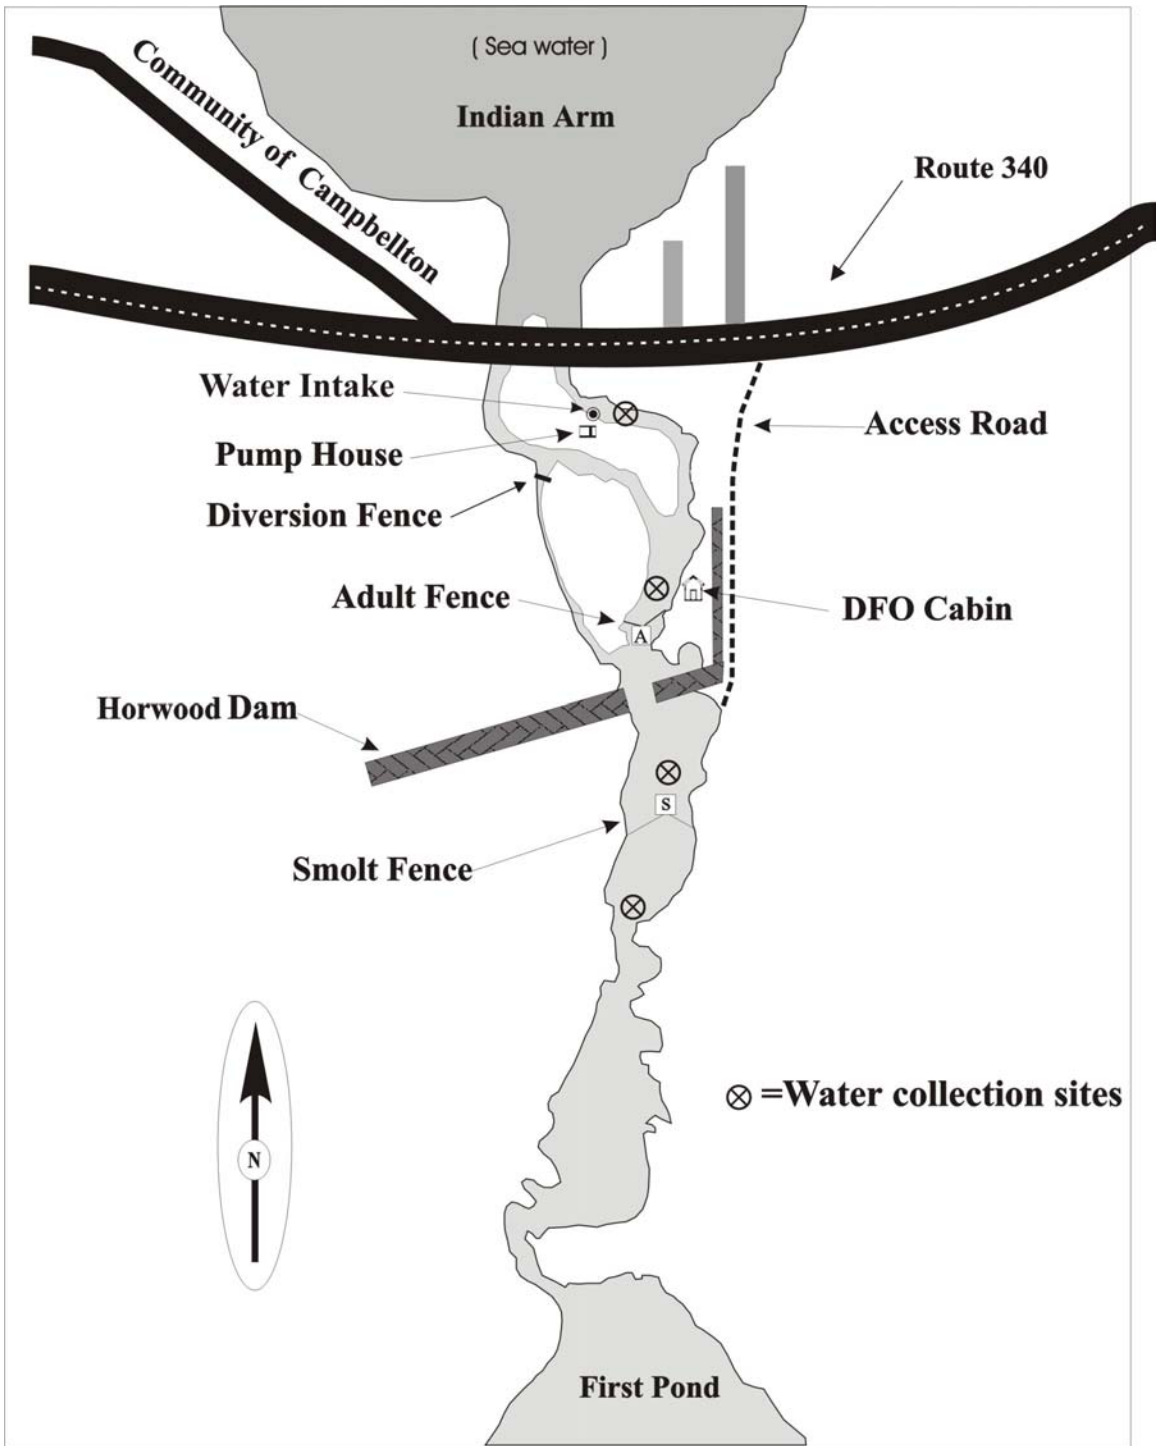
Figure 5. Locations of smolt and adult counting fences showing water collection sites for Campbellton River, 2001.

In 2001, three water collection sites were selected, one located 50 m above the smolt fence, a second several meters below the fence and the third at the water intake for the community. The sampling site just below the fence was dropped after it was determined that the test results were very similar to those above the fence and at the intake. Both the smolt and adult fences were situated between these sample sites (Fig. 5). Water samples were collected as per techniques outlined by Shelton (1994). During each sampling period three, one litre water samples were collected at evenly spaced intervals between riverbanks for the upper site and three samples were taken near the intake for the lower site. All samples were immediately placed on ice and kept cool until transported to DFO laboratories in St. John's. Within 24 hours of arriving at DFO laboratories, the water samples were acidified with two ml of trace metal clean nitric acid. Without further processing, the water samples were then analyzed for a suite of elements by ICP-MS. Several other water quality parameters were done on site with a LaMotte Freshwater field testing kit (AQ-2). These samples were collected at a site in mid river just above the DFO field camp located near the mouth of the river. In total, water samples were collected from seven sites during the period from 1987 to 2001 with the furthest site from the counting fences at Neyles Brook, 22.3 km upstream from the mouth of the river.

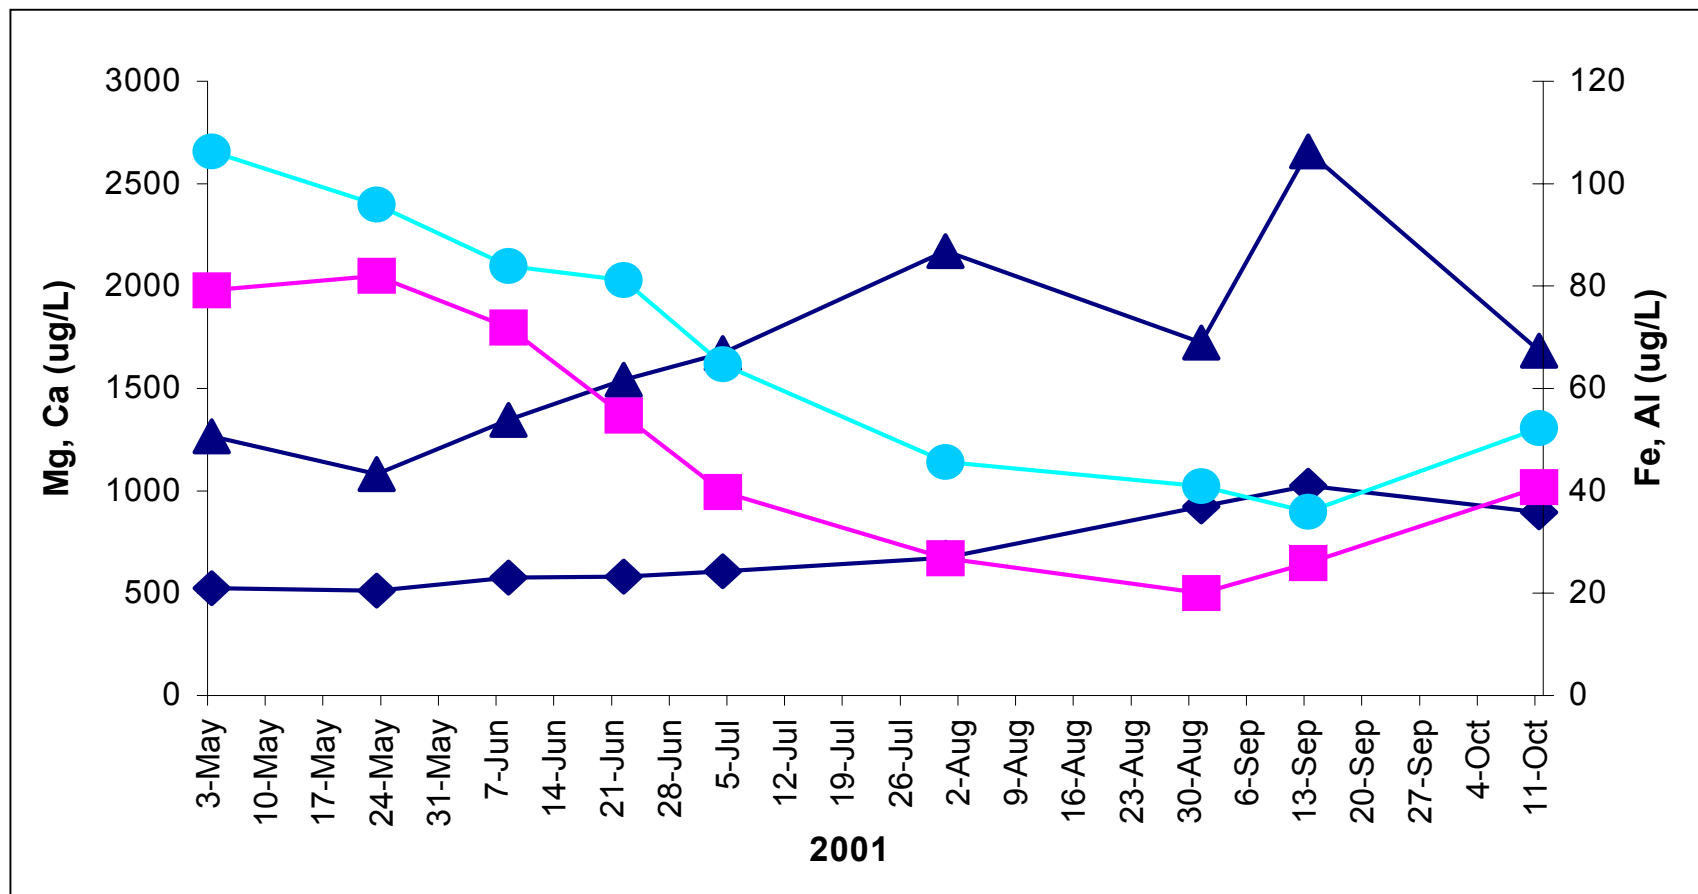
Figure 6. Average concentrations of Mg (diamonds), Ca (triangles), Fe (circles) and Al (squares) in Campbellton River water, 2001.

Seasonal trends were observed in the water chemistry data (Fig. 6). Concentrations of Mg, Na, K, Ca, Mn, As, Li, and Sr increased as spring progressed into summer, while Al, Si, and Fe decreased over the same time period. These trends appeared to be related to water levels in the Campbellton River (Fig. 7 & 8). Cameron (1996) attributed similar trends in the Fraser River to the phase in which the constituents were found. Concentrations of elements in the dissolved phase increased as water levels dropped (spring to summer) whereas

the concentration of elements in the suspended or particulate phase decreased as water levels dropped.

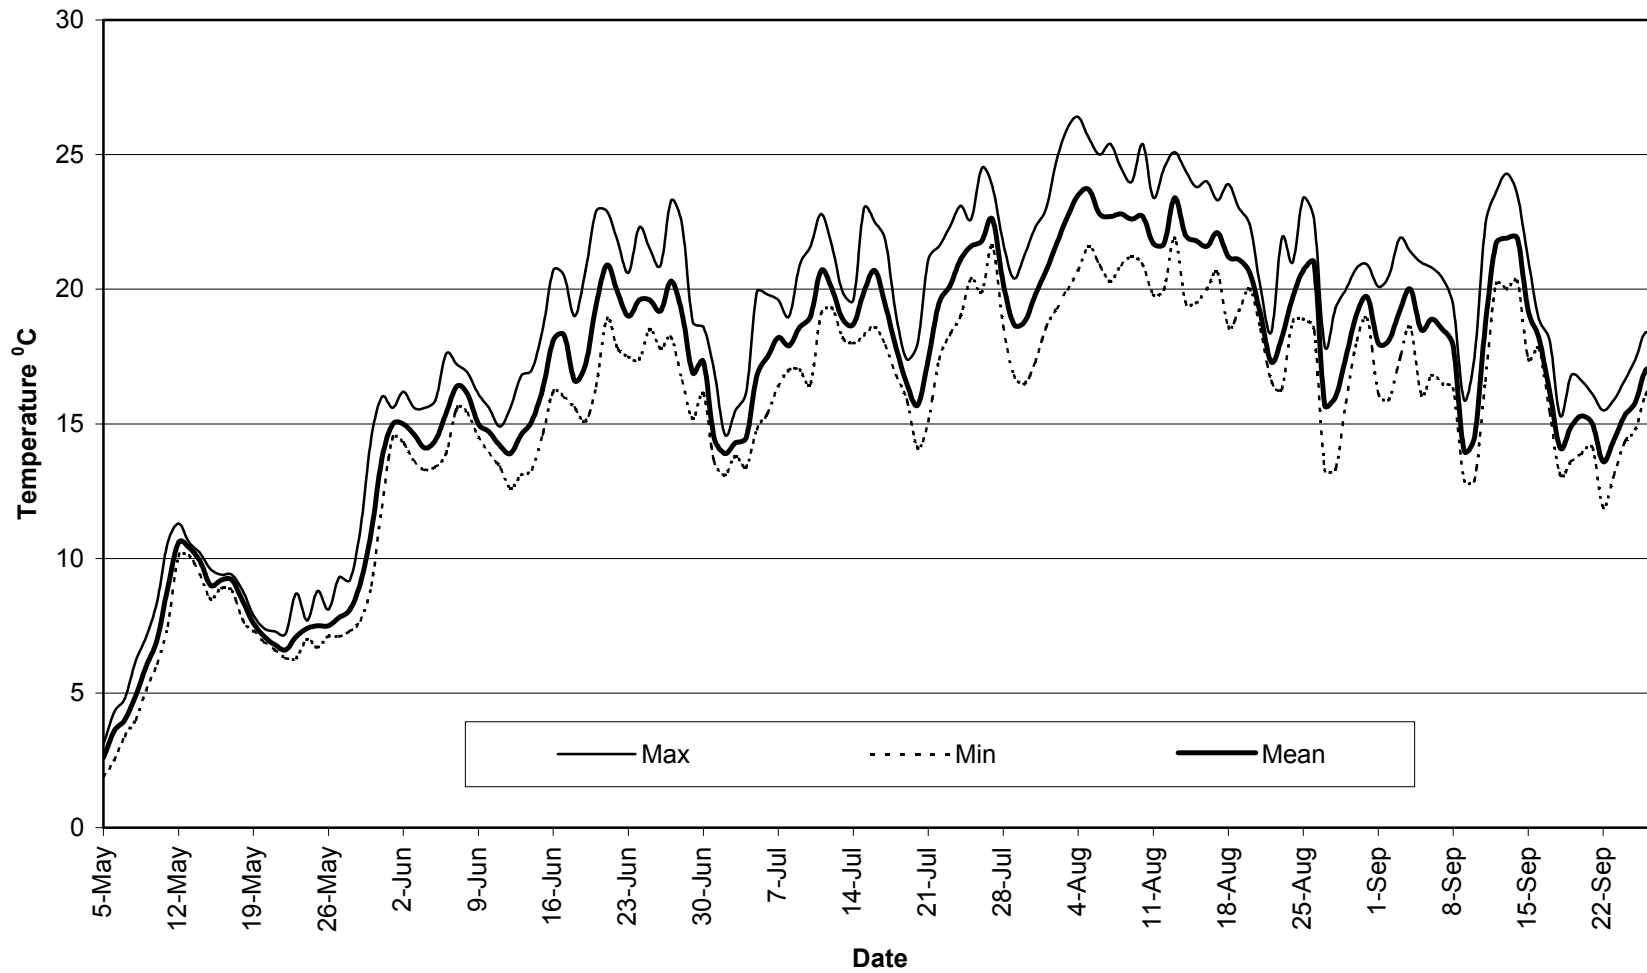
Figure 7. Water temperatures recorded at 1 meter depth near the adult counting fence for Campbellton River, 2001.

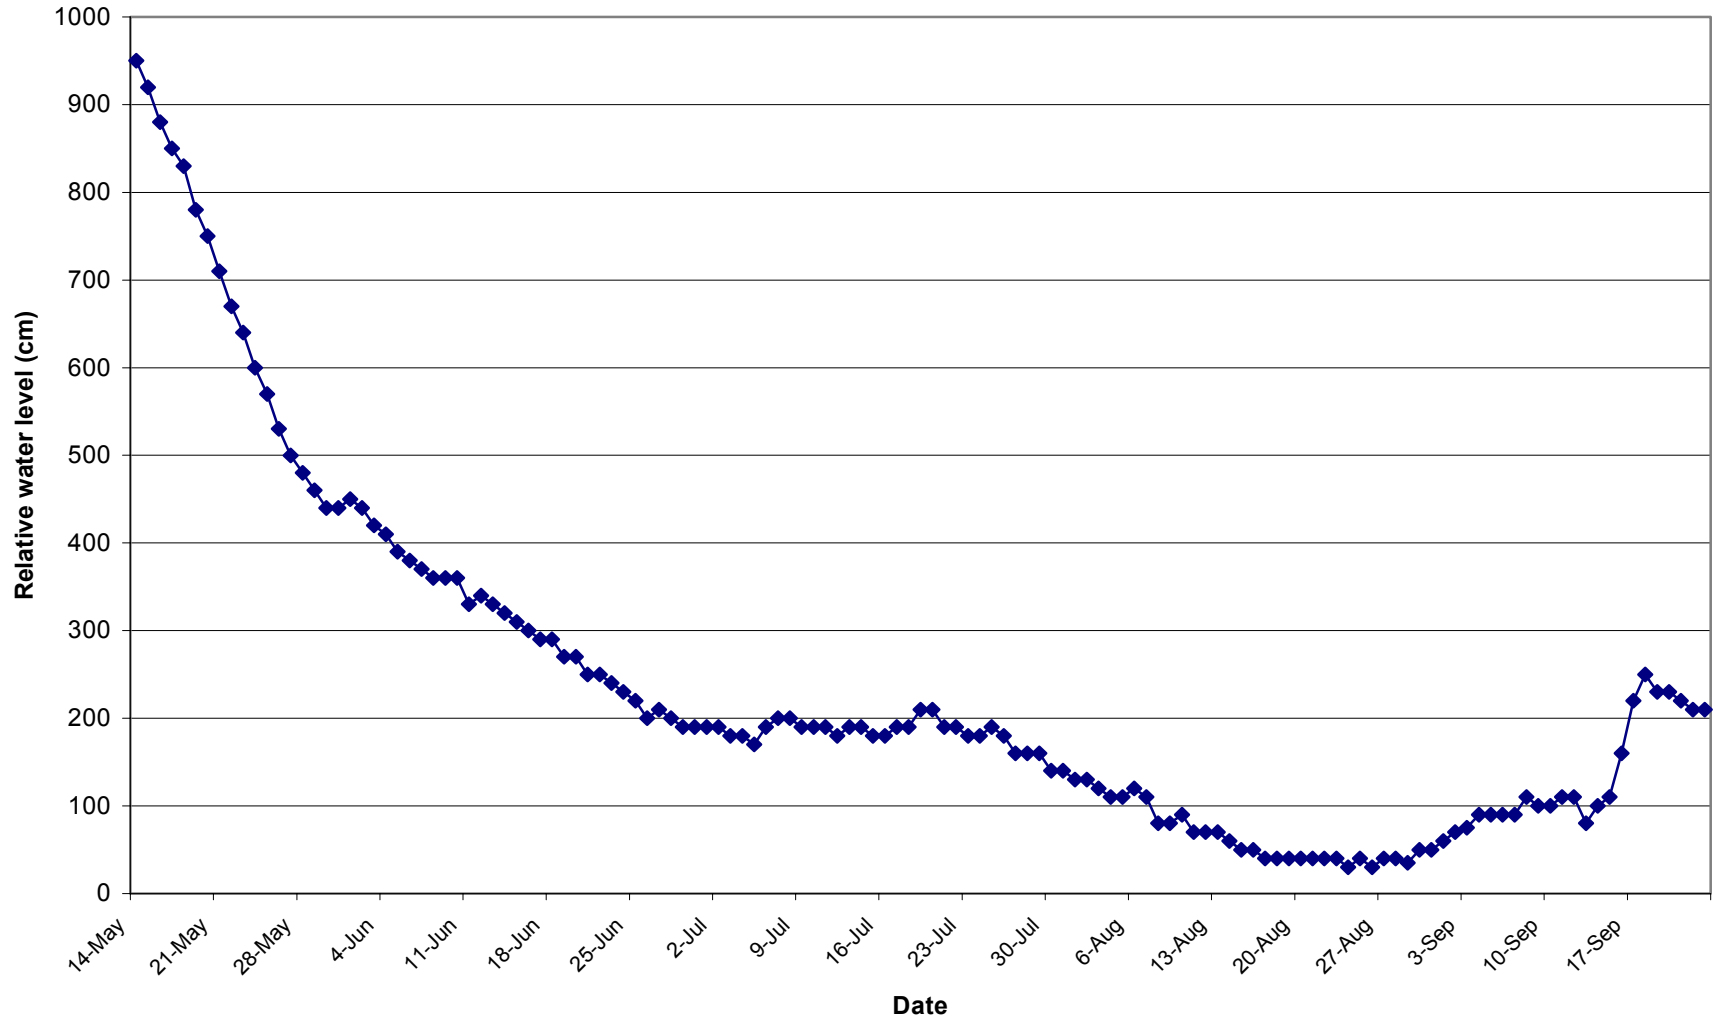
Figure 8. Relative water levels taken near the adult counting fence at Campbellton River, 2001.
