**SOUTH THOMPSON RIVER
WATERSHED MANAGEMENT STUDY**

DRAFT FINAL REPORT

**Northwest Hydraulic Consultants Ltd.
2 - 40 Gostick Place
Vancouver, B.C. V7M 3G2**

March 1, 1996

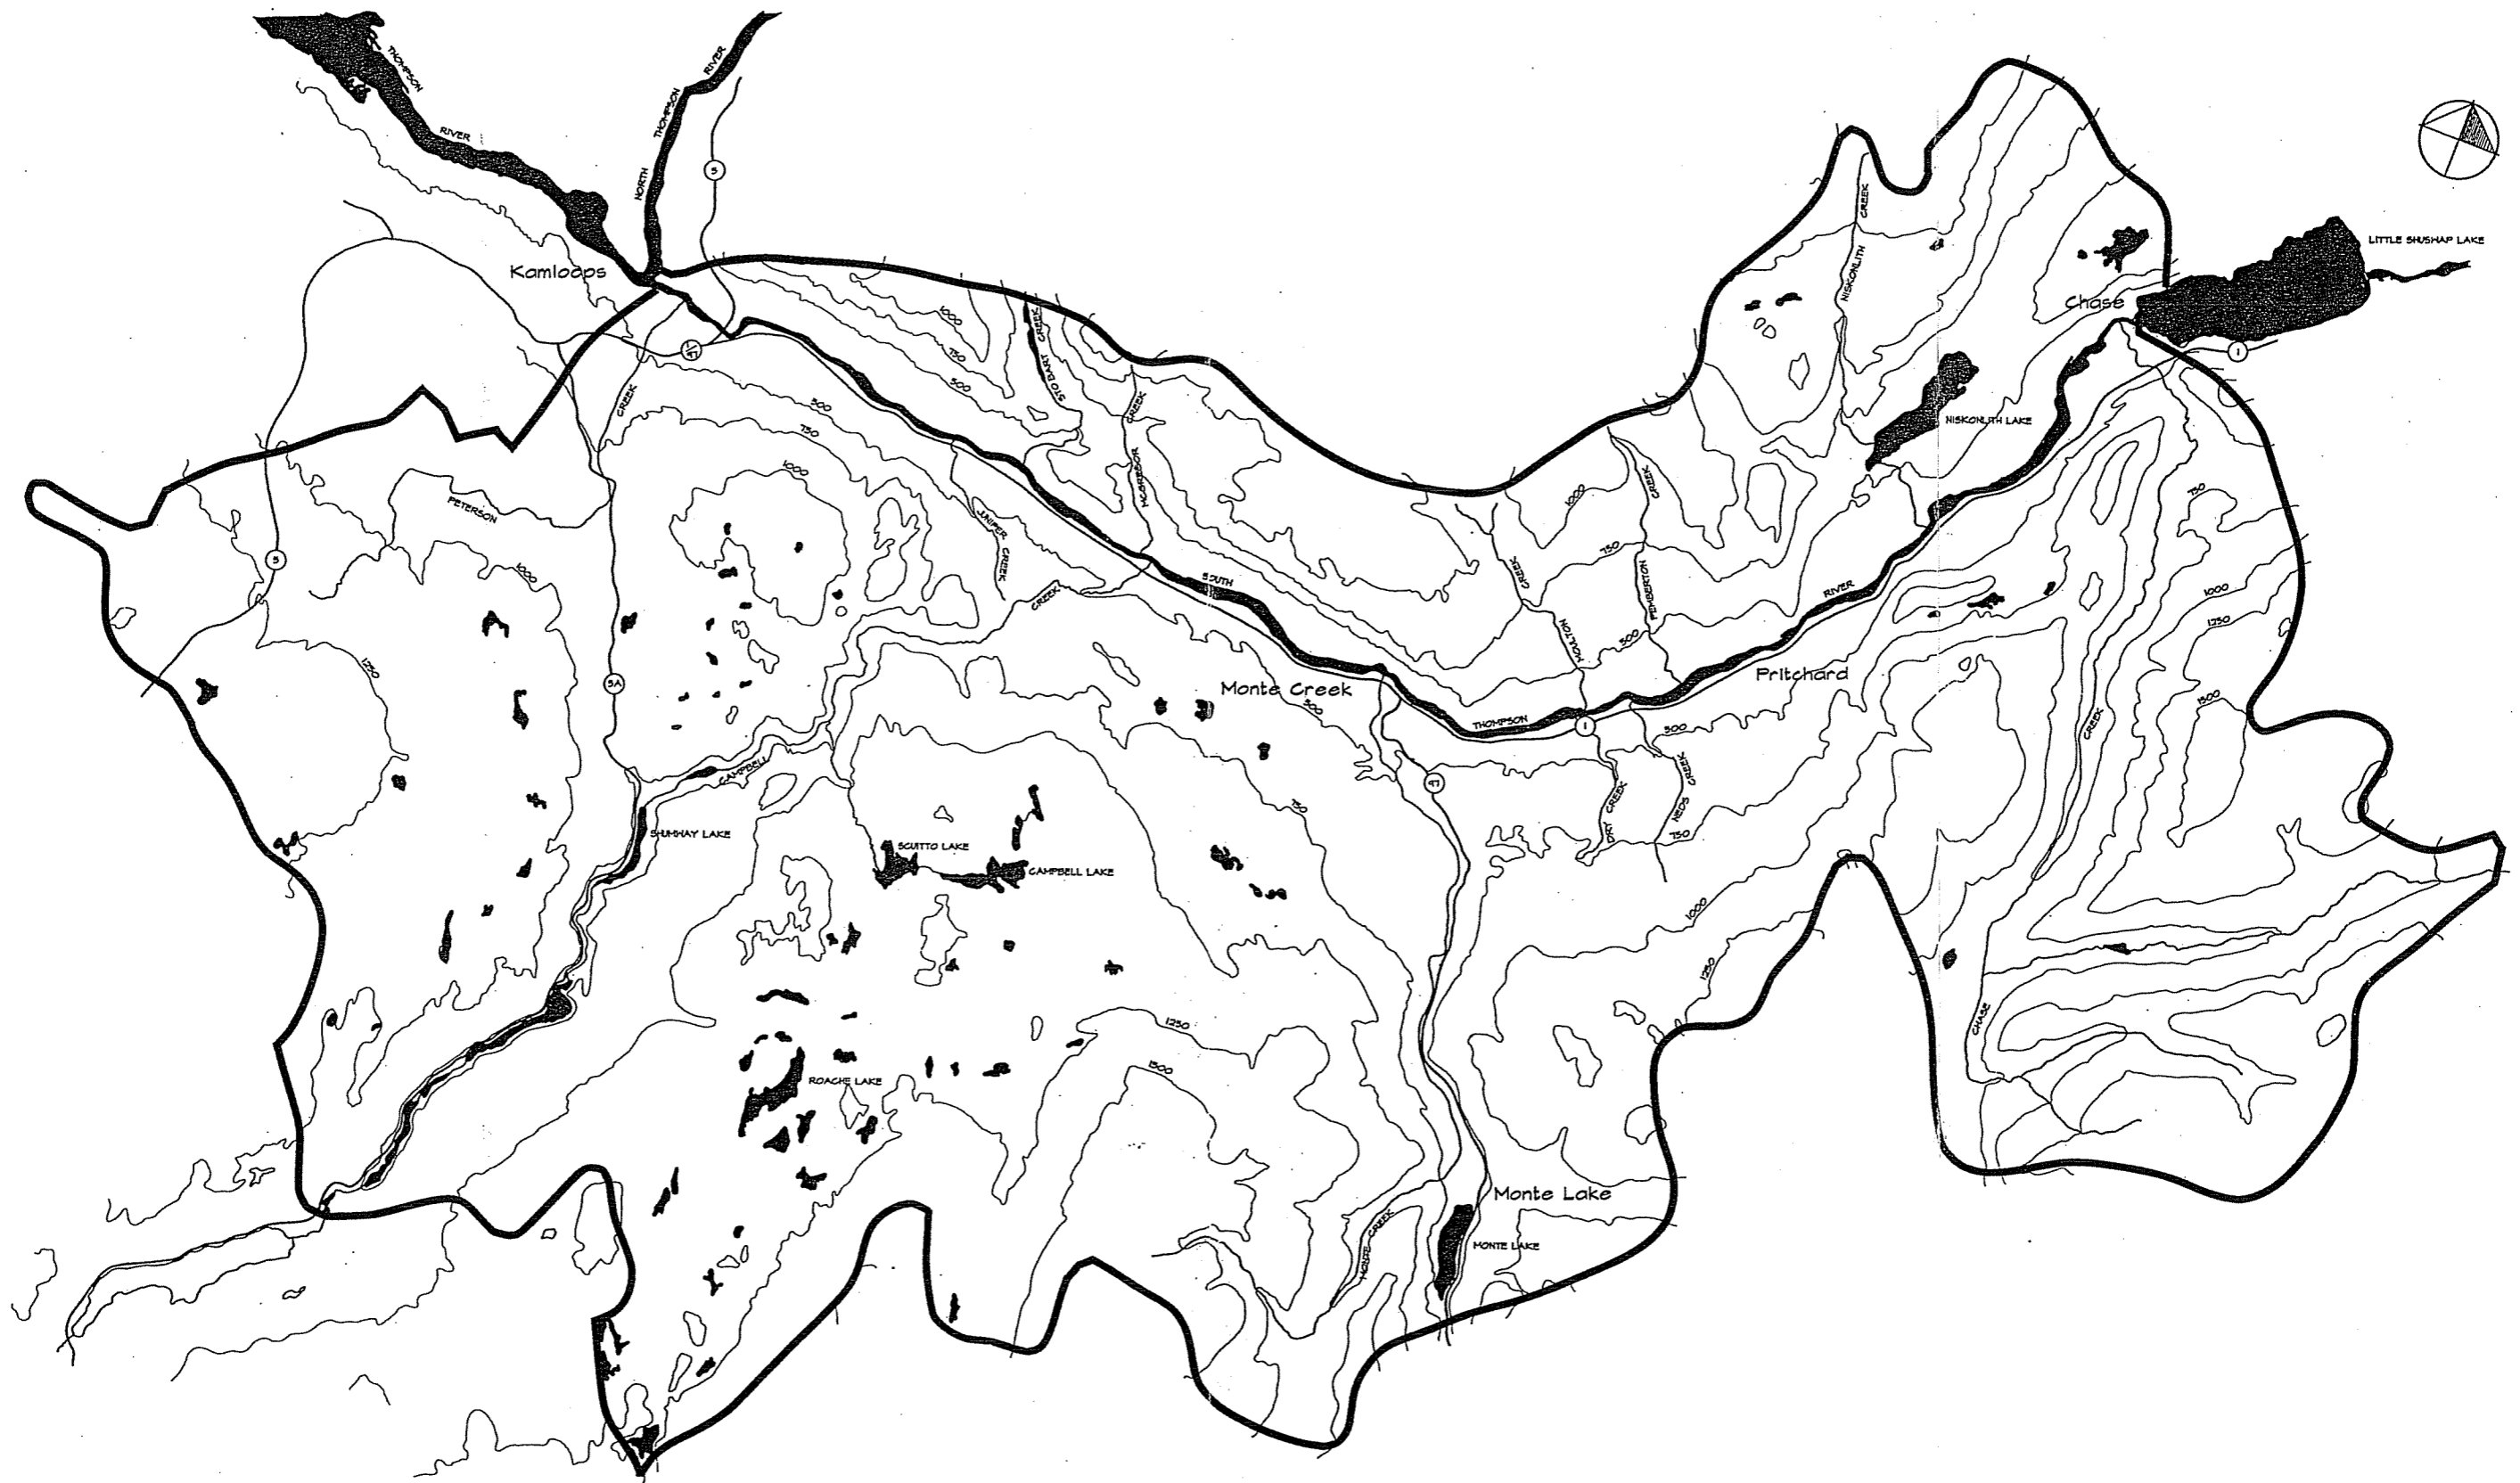
FIGURE 1

study area
SOUTH THOMPSON RIVER WATERSHED MANAGEMENT STUDY

The South Thompson River has a total watershed area of about 18,000 km². A little over 2,000 km² of this drainage area lies between Shuswap Lake and Kamloops and contributes fine sediment to the South Thompson River at Kamloops. This is the study area for this report (Table 1; Figure 1).

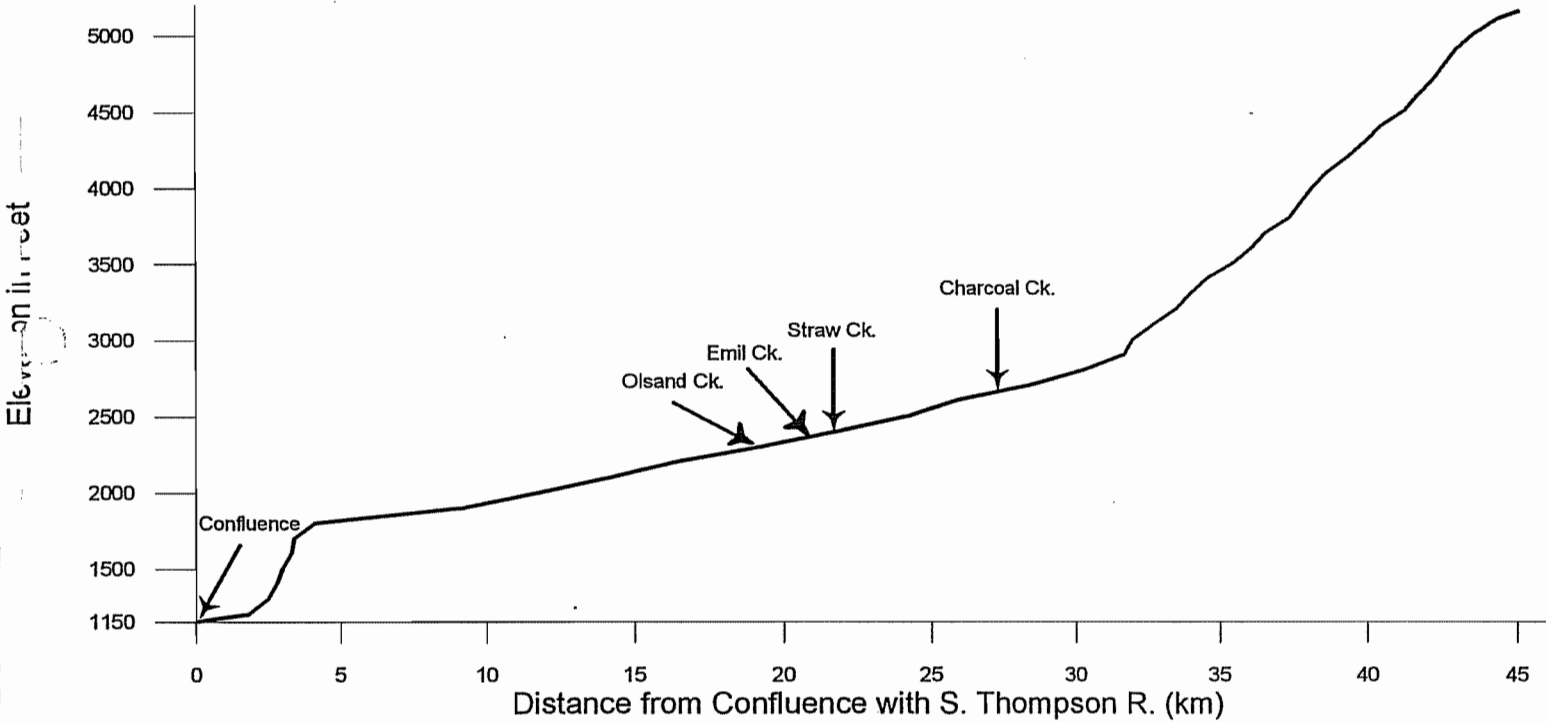
Long Profile of Chase Creek

Long profiles of Campbell, Monte and Chase Creeks are included in Appendix A. These three creeks all have similar profiles, with a steep section near their mouths where they leave the uplands to join the South Thompson River. a relatively flat middle section, and a steep upper reach that extends to the upper limit of their watersheds. The steep upper reaches of both Monte and Campbell Creeks drain to large lakes which intercept their sediment load.

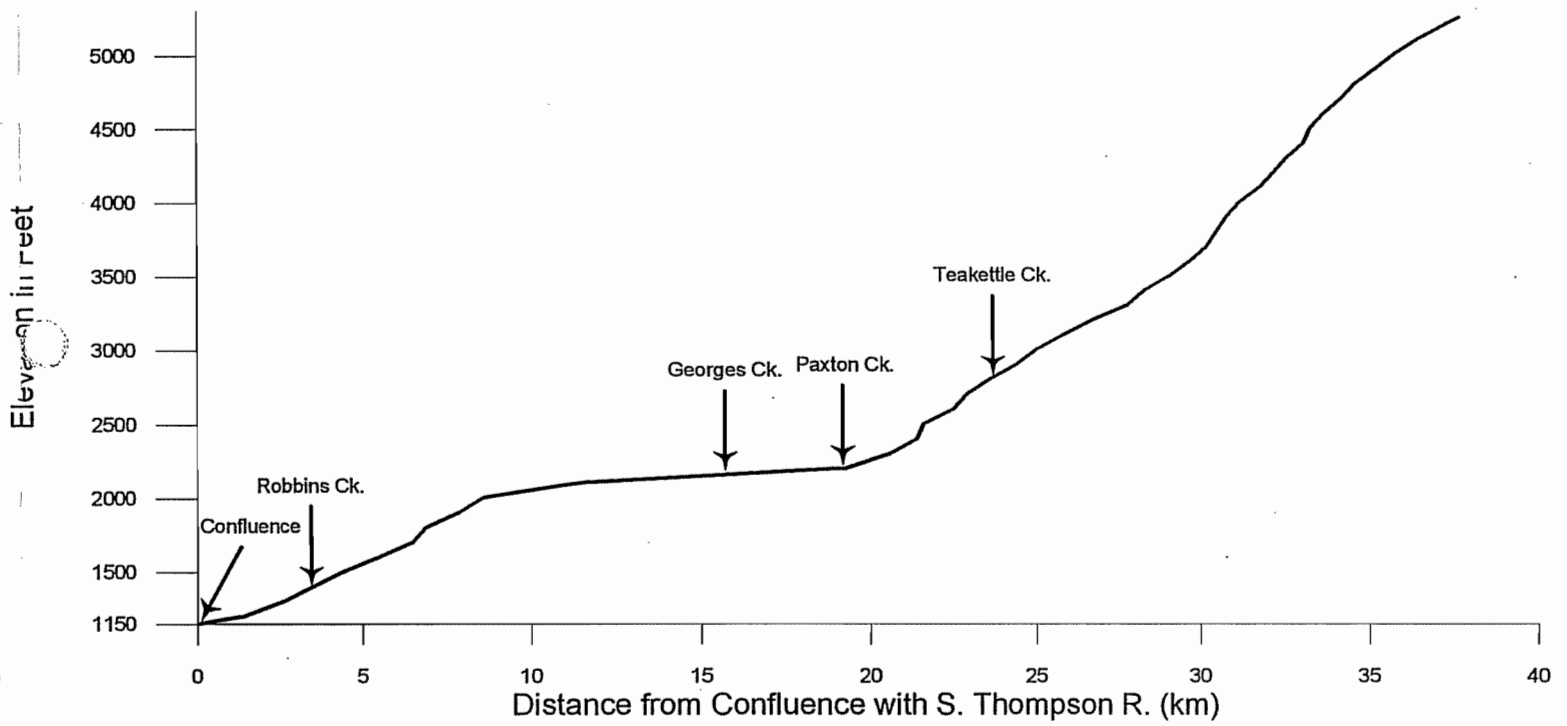
Long Profile of Monte Creek

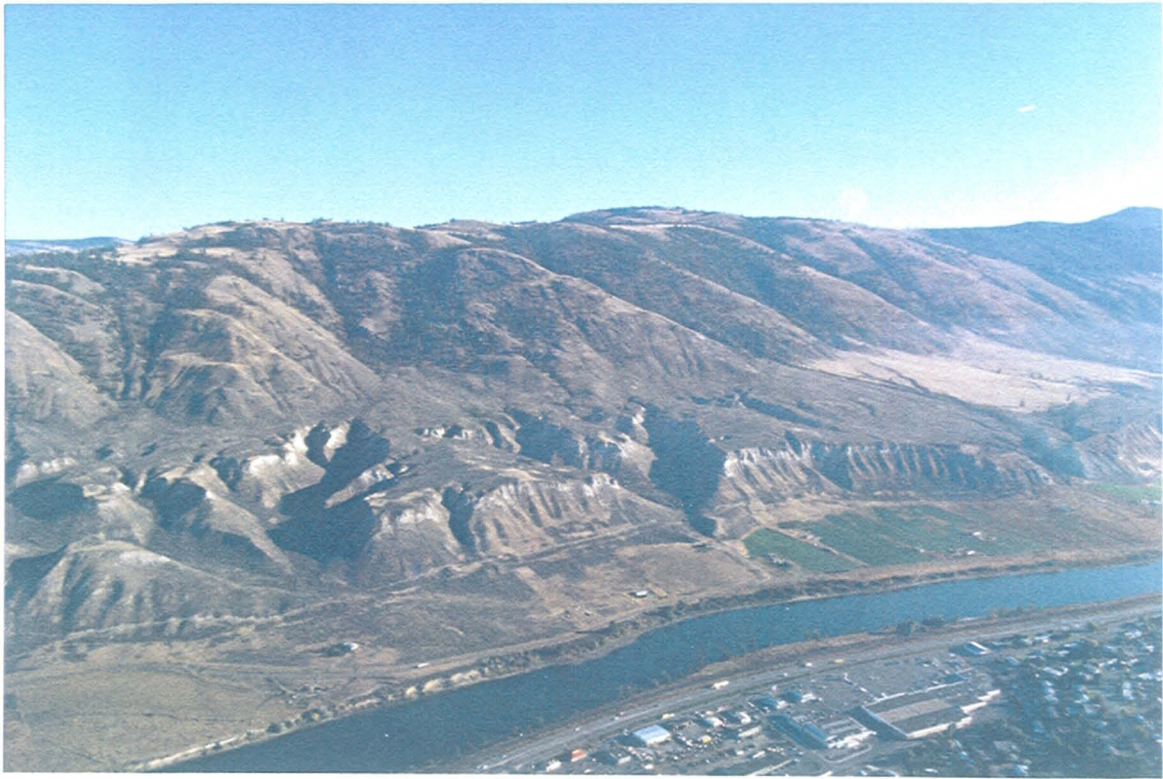
Photo 1

North shore of the South Thompson River.

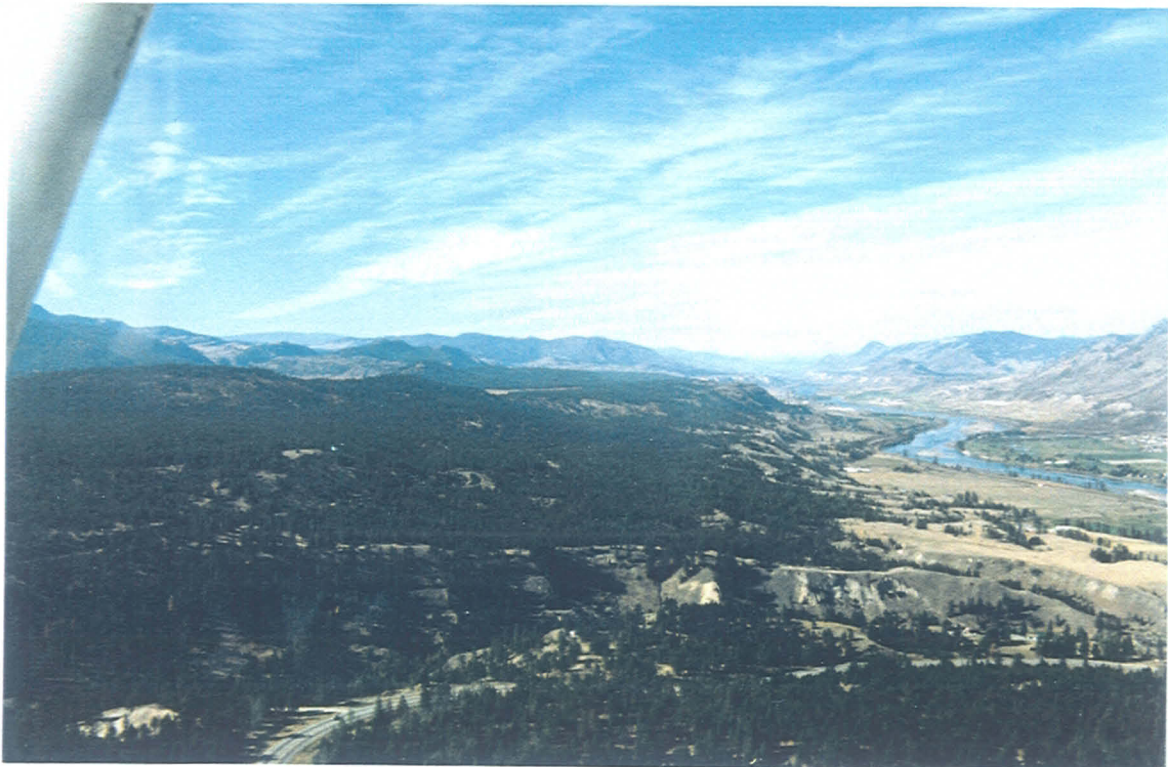
Photo 2

Monte Creek -- left valley wall near the mouth.

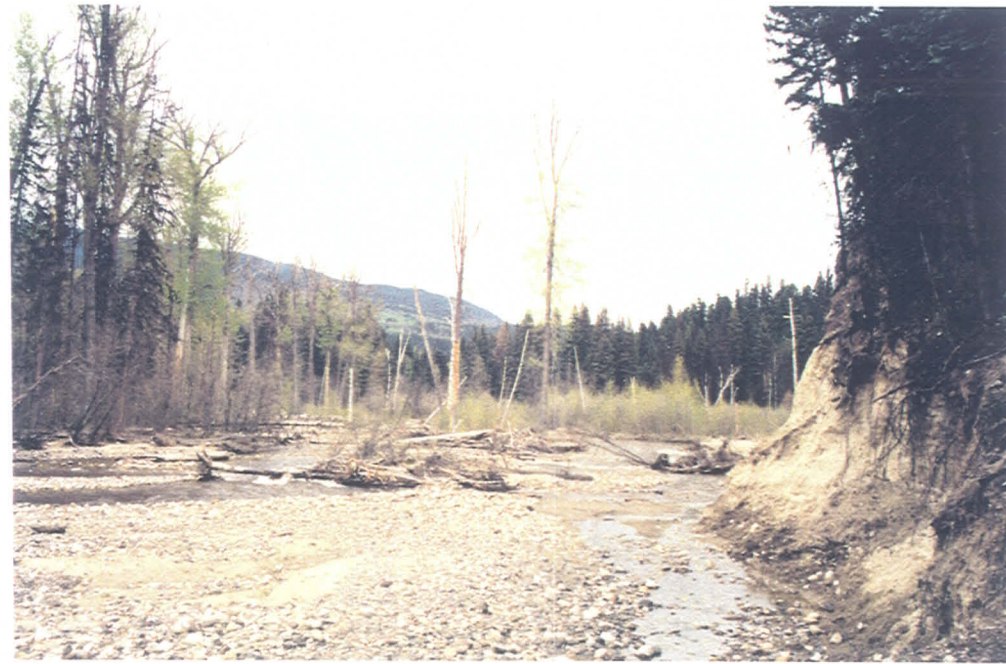
Photo 3

Chase Creek -- lacustrine sediments downstream of Charcoal Creek.

During 1994 and 1995, most turbidity was generated in the reach between Charcoal Creek and the Turtle Valley Bridge by erosion of lacustrine deposits and of channel banks (Photos 3 and 4). However, during large rainstorms floods it is thought that sediment generated by landslides and road failures (Photo 5) in the upper Chase Creek watershed (upstream of Pillar Lake) assumes more importance.

Glacial Deposits near Charcoal Creek: Charcoal Creek, downstream of China Lake, is deeply incised into glacio-fluvial sediments, likely as a result of an unusual release from China Lake though this has not been confirmed. These sediments seem to be stable at present and do not contribute fine material to Charcoal Creek (Photo 6). Downstream of Charcoal Creek, Chase Creek flows in a broad channel over gravel deposits and is in contact with lacustrine sediments (Photo 3). Through this reach, Chase Creek appears to be degrading or incising into its deposits and may be reasonably stable. We do not recommend any in-channel works but recommend continued monitoring of this section of the river.

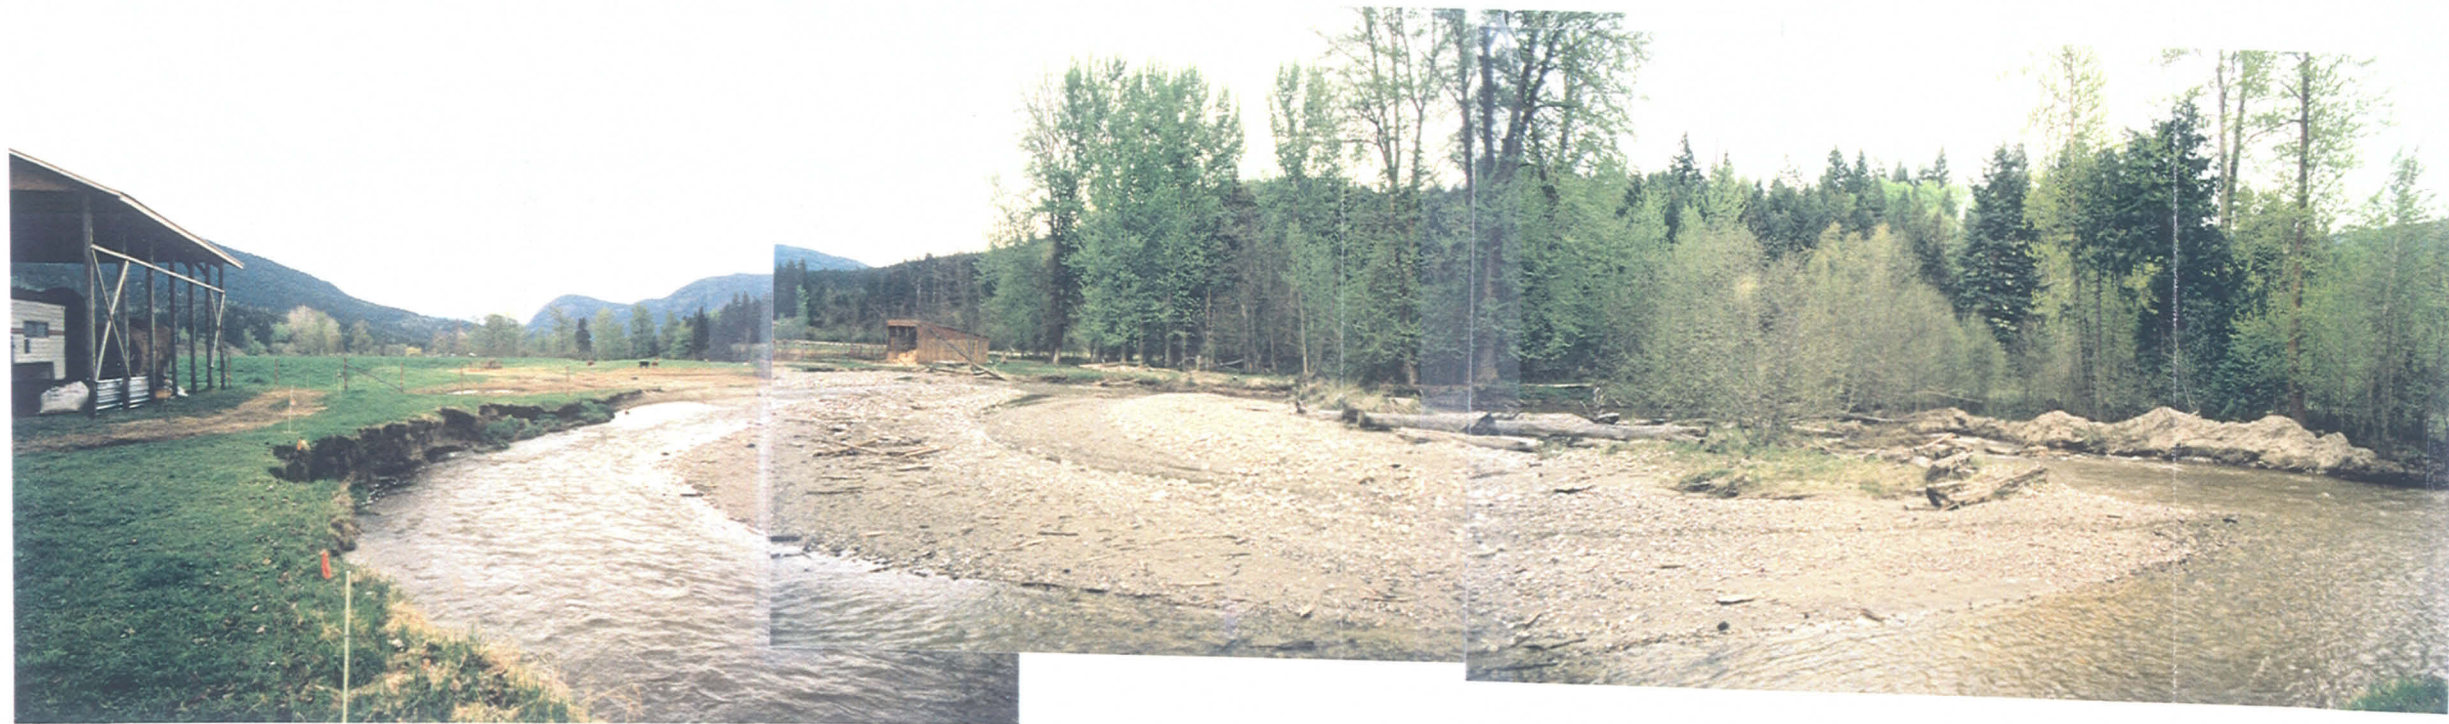
Photo 4

Chase Creek -- bank erosion downstream of Charcoal Creek.

Instead, we recommend long-term erosion control through re-establishment of riparian vegetation. A corridor of trees should be established to a distance of 10 to 20 m from the river banks and a covenant established so that this land will remain as a riparian corridor. Part of the erosion problems have resulted from enhancement of flood peaks as a result of harvesting in the upper watershed and the Watershed Restoration Program could perhaps fund planting of appropriate species.

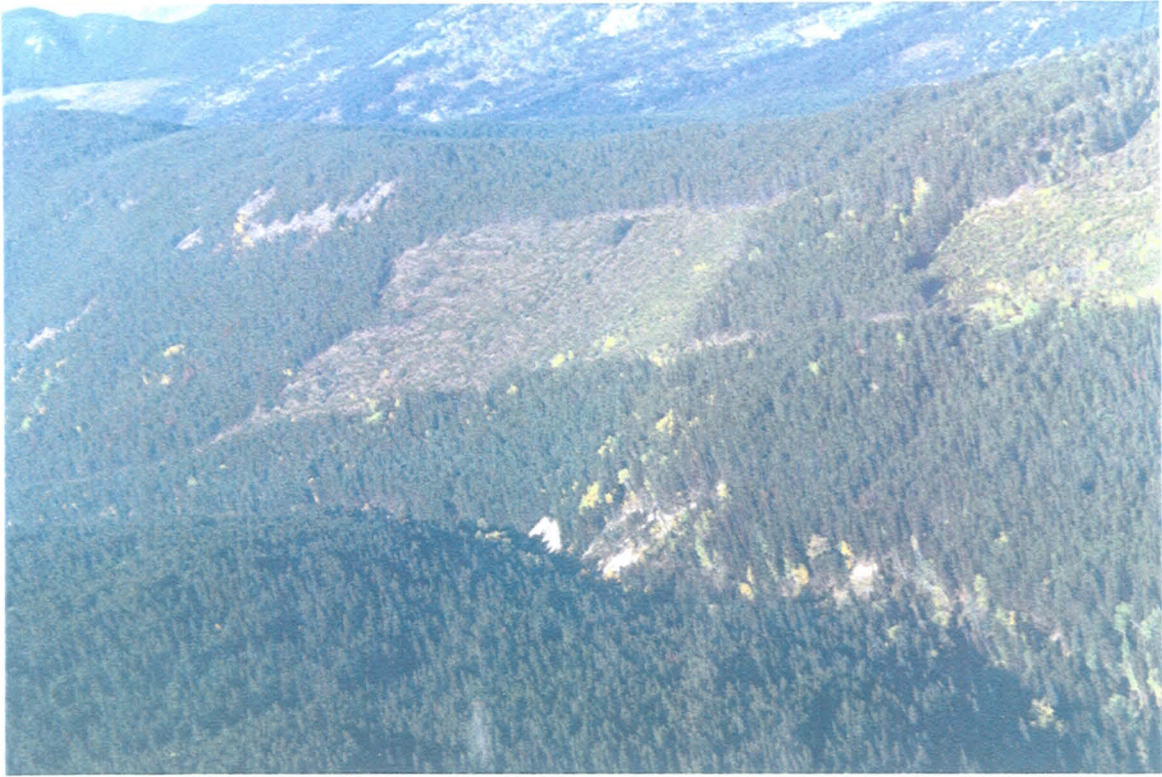
Photo 5

Upper Chase Creek -- natural landslides on the left valley wall.

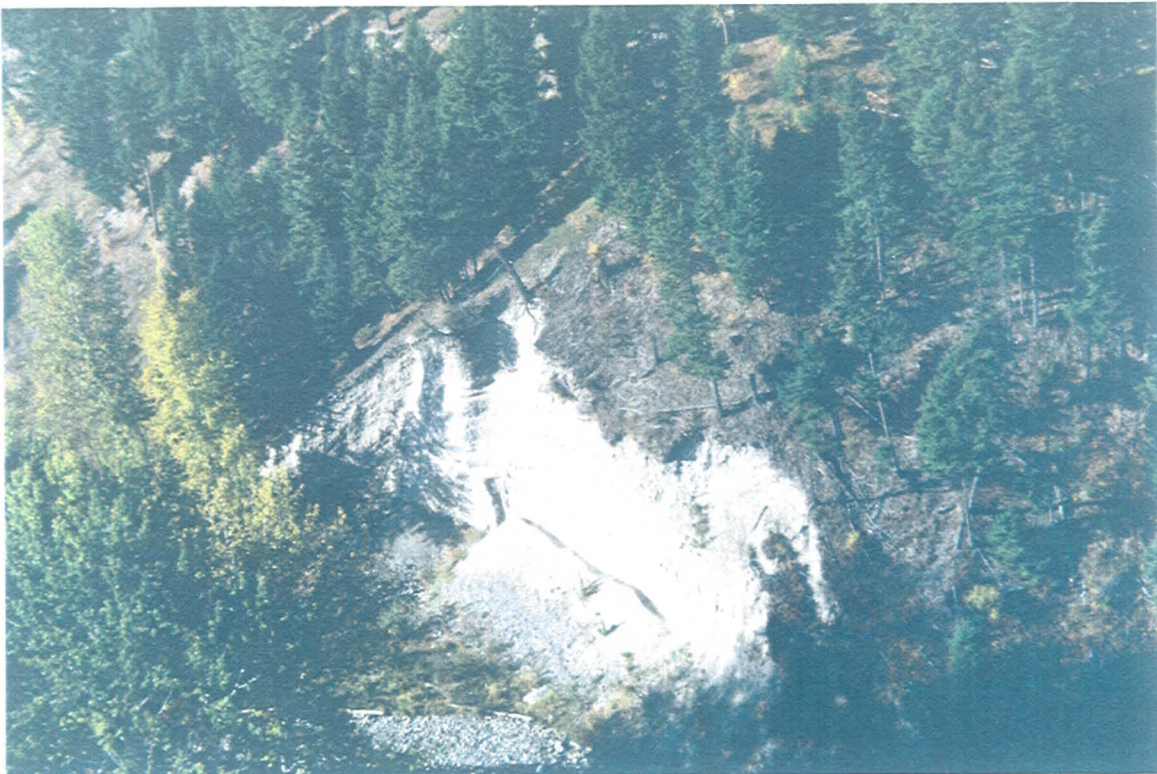
Photo 6

Charcoal Creek -- erosion downstream of China Lake.
