MANUSCRIPT REPORT

Preliminary Biological Survey of
Medway River, Queens County, N.S.

C.L. Dominy

May 1966

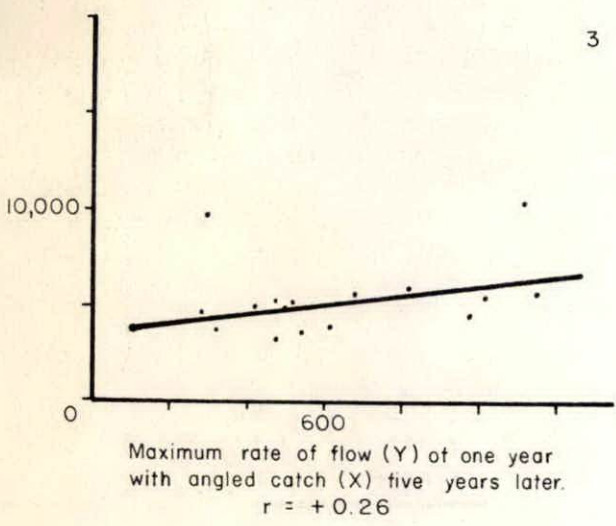
FIGURE 2: Correlations between rate of flow and angling catch on the Medway River, Nova Scotia. 1946-1960

The highest correlation coefficient found was that between the mean rate of flow during the angling season of May to July and the corresponding annual angling catches ($r=+0.57$). The next best coefficients were those between the angling catch of one year correlated with minimum ($r=+0.31$) and maximum ($r=+0.26$) rates of flow five years previous. These correlations indicate that salmon eggs and fry may be the stages that are most affected by extremes of water flows.

Finally, poor coefficients were found when angling catches of one year were correlated with minimum ($r=+0.17$) and maximum ($r=+0.17$) rates of flow three years previous. The indication here is that large parr are not greatly affected by extreme water levels.

Generally speaking, it was found by inspection that extremely low angling catches usually resulted from poor water conditions during the fry year combined with poor water for angling in the year that the fish were caught. Conversely, high angling catches usually resulted from good water conditions for fry survival one year combined with good water for angling five years later.

It must be emphasized that natural fluctuations in angled catch caused by factors other than changing water levels are probably too great to be able to demonstrate that these water level fluctuations by themselves will seriously affect future salmon stocks.

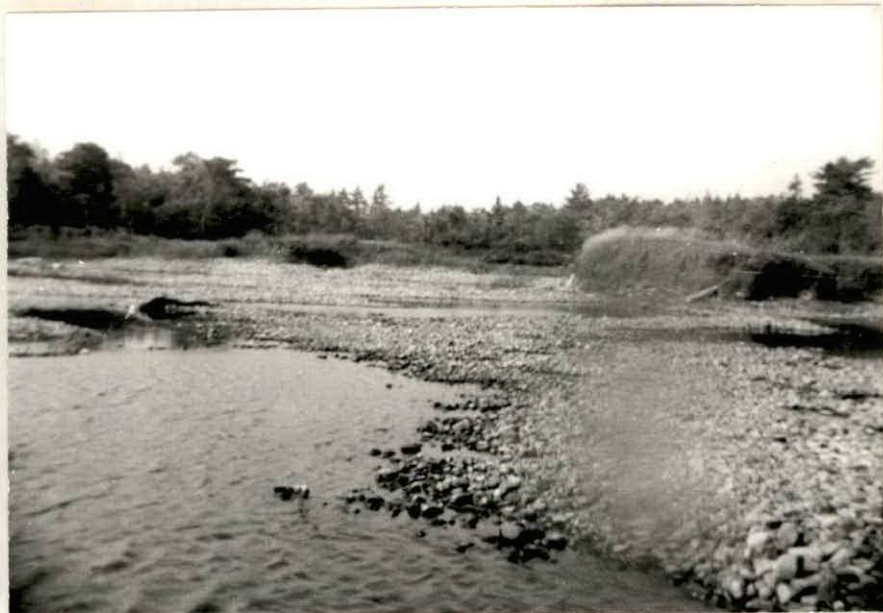
Photo 1. Wide portion of river 6.7 miles upstream.
Just below Poltz Falls. Coarse gravel.

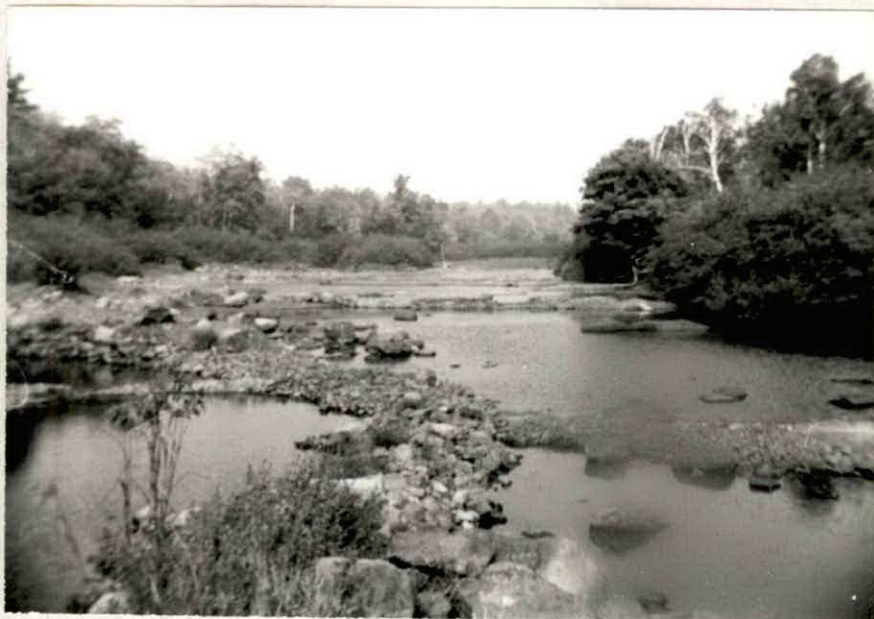
Photo 2. Right side of Bear Island, 9.5 miles from
mouth, looking downstream. Near Two Inch
Brook tributary. No flow at survey time.

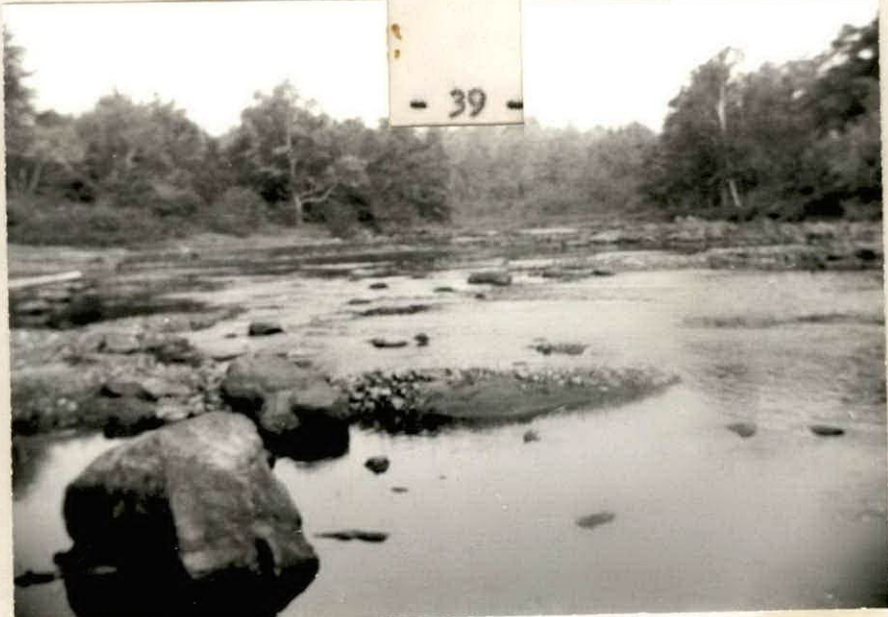
Photo 3. Left side of Bear Island, 9.6 miles from mouth, looking upstream. Little flow.

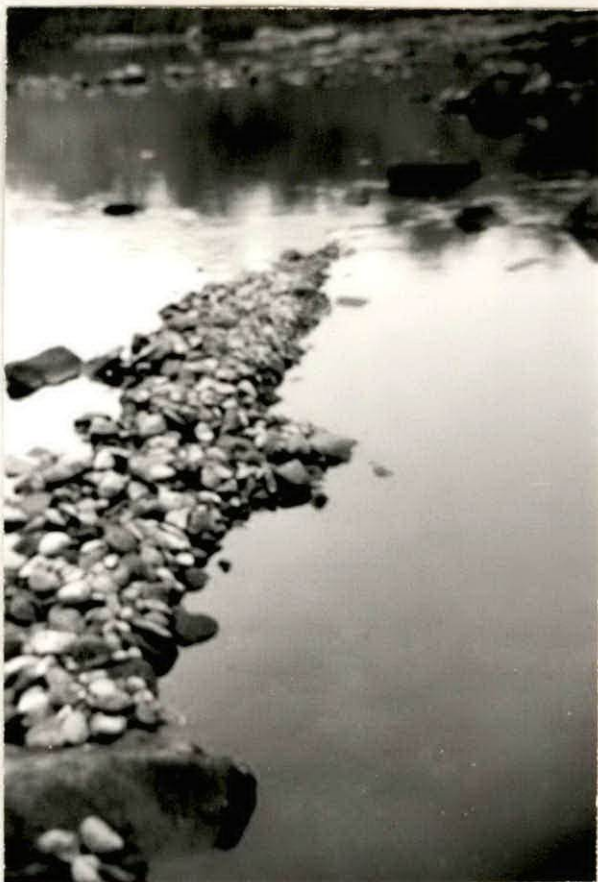
Photo 4. Close-up of gravel mound at the foot of Glode Falls, 9.8 miles upstream.

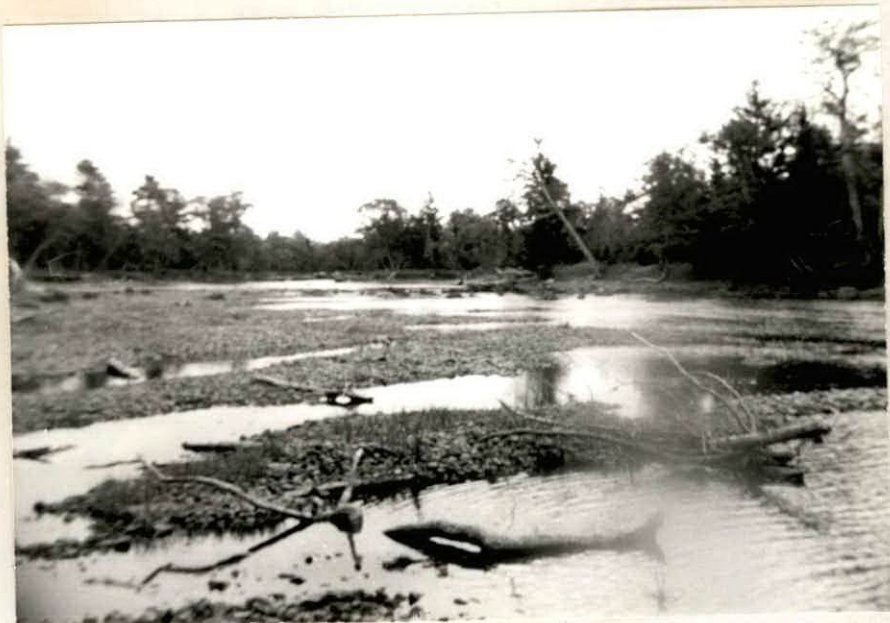
Photo 5. Wide portion of river in front of Medway Lodge, 12.0 miles from the mouth. Abundance of gravel, few boulders. Looking downstream.

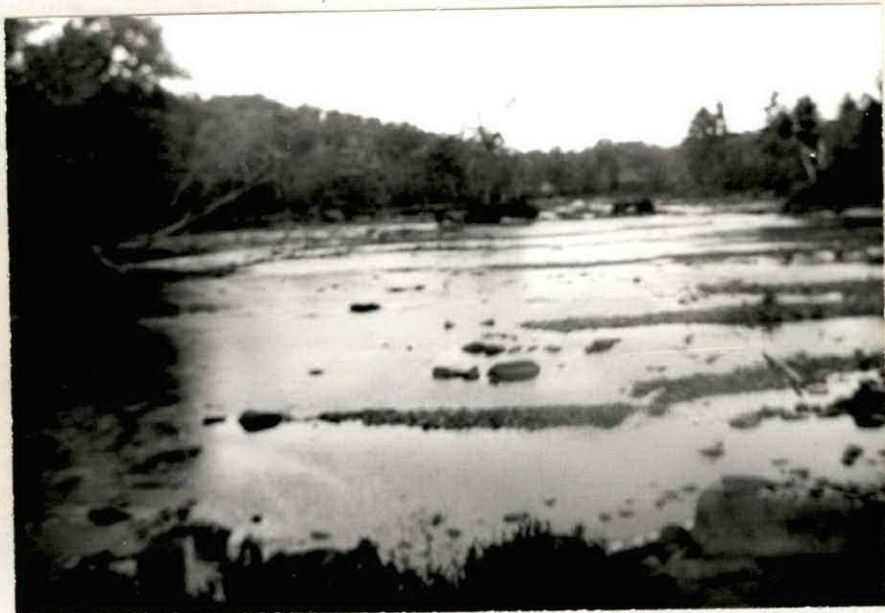
Photo 6. Rearing area near Eel Weir Pool, 12.4 miles from the mouth, looking upstream. Approximately 400 feet wide.

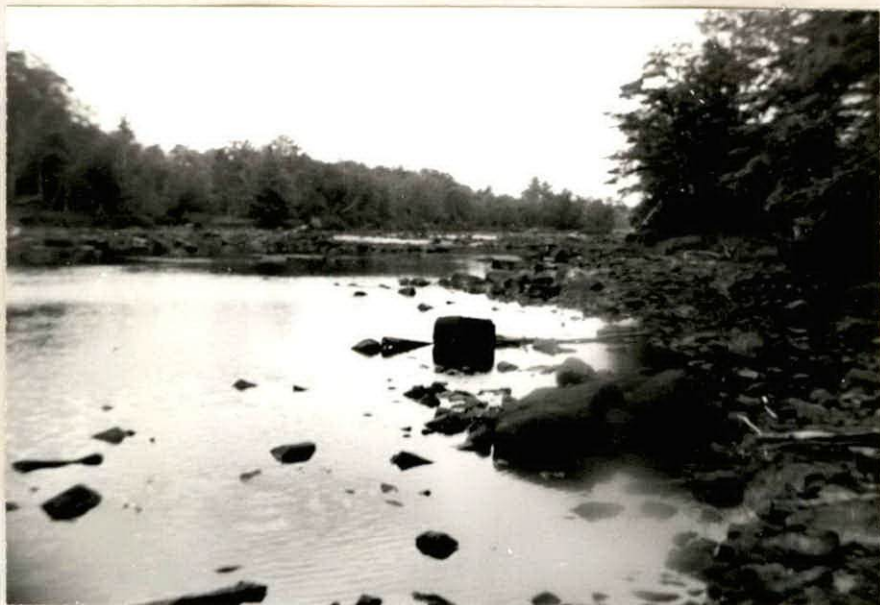
Photo 7. Rearing area near Diving Rock Pool, 12.8 miles from mouth, looking upstream. Very little water flowing.

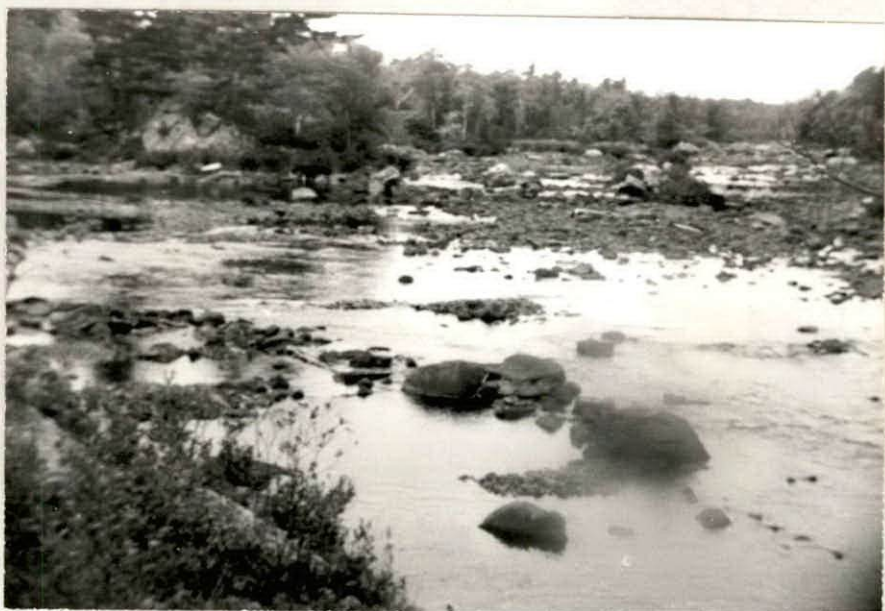
Photo 8. Good rearing area near Boggy Hole Brook tributary, 13.0 miles upstream, looking upstream. Boulders provide excellent cover for small fish.

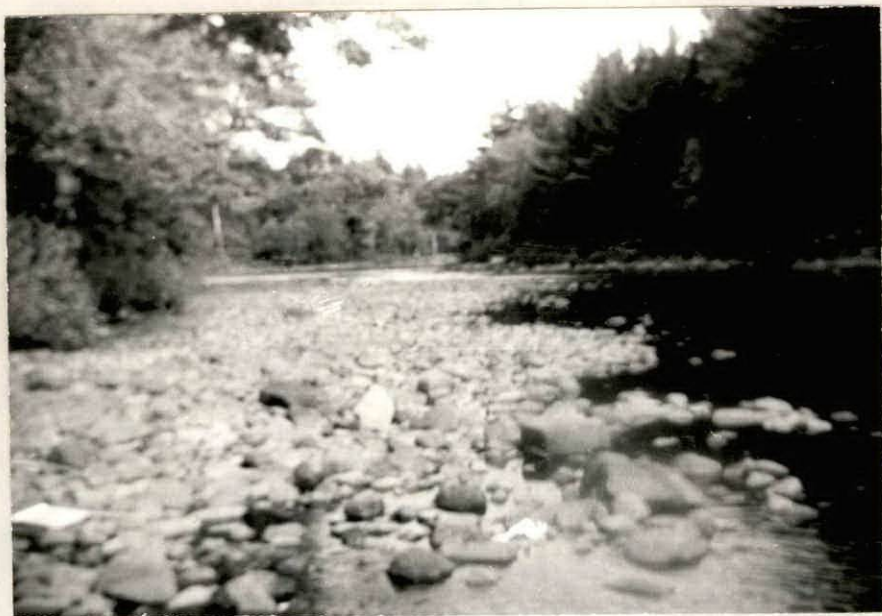
14.8	Below Bangs Falls Road Bridge	20,000	excellent	excellent	Boulders scattered. (Photo 9). Located around small island.
15.1	Above Bangs Falls Road Bridge	11,250	excellent	excellent	Also found around small island.

Photo 9. Right side of island below Bang's Falls Highway Bridge, 14.8 miles from mouth, looking downstream. Boulders few and scattered.

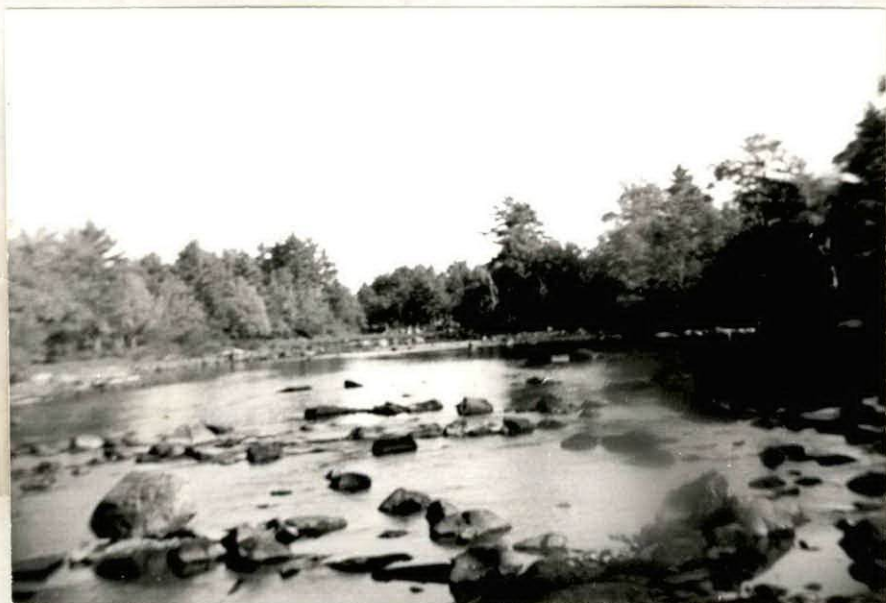
Photo 10. Good rearing area on main river at Fifteen Mile Brook, 15.5 miles from mouth, looking downstream.

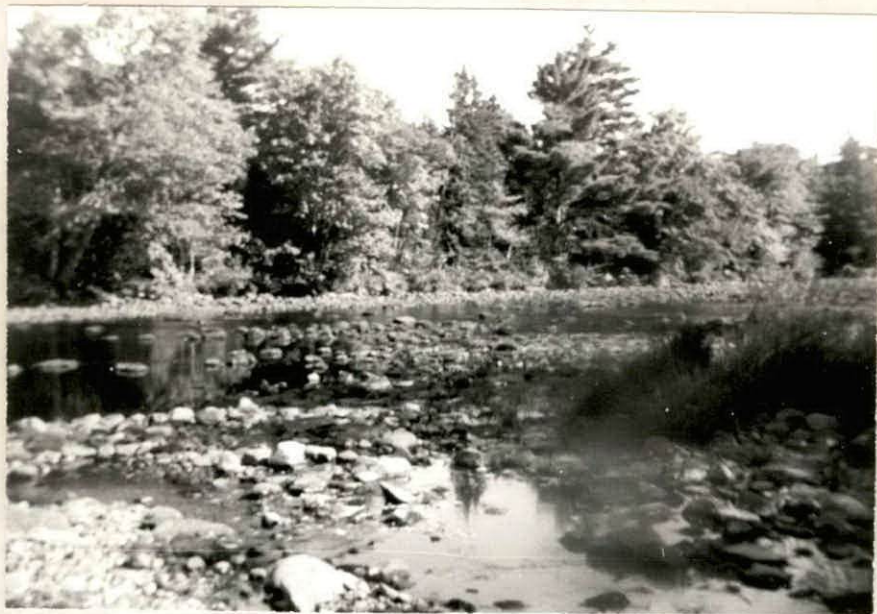
Photo 11. Good rearing area on main river at Fifteen Mile Brook, 15.5 miles upstream. Rate of flow when photograph taken: 45 c.f.s. approximately.

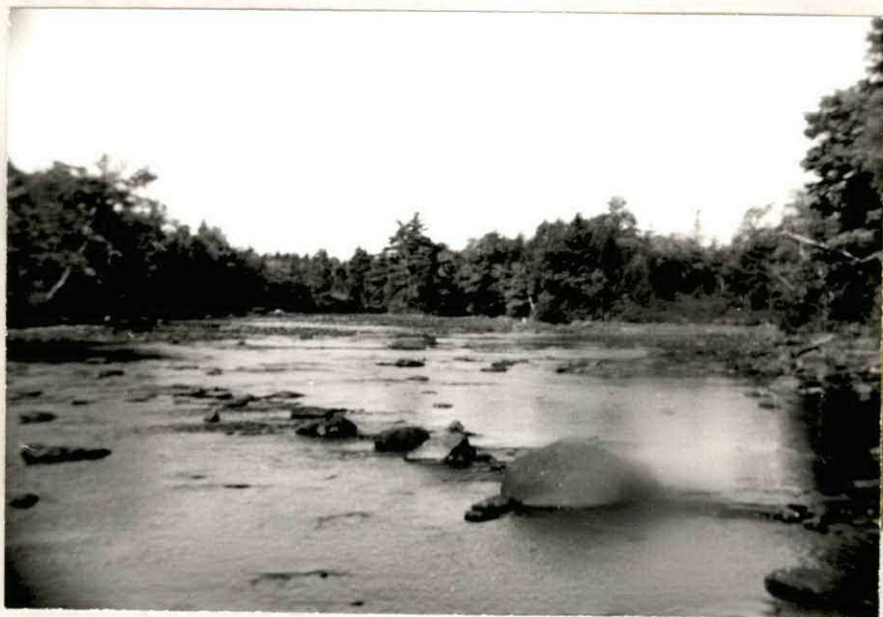
Photo 12. Nursery area below Mountain Falls, 16.3 miles from mouth, looking downstream. Stream width about 225 feet.

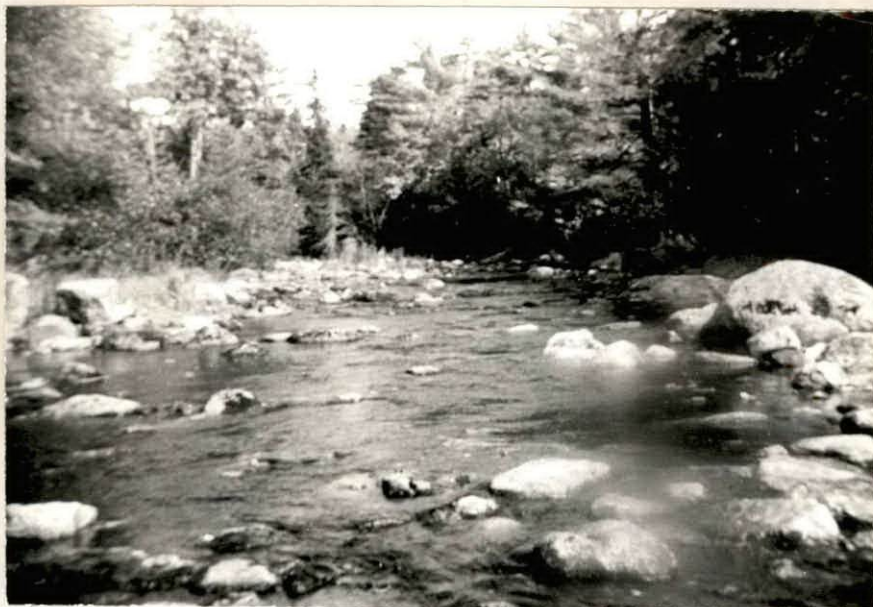
Photo 13. Below Medway Lake, 46.5 miles from mouth of main river, looking upstream. Rate of flow approximately 29 c.f.s. Abundant bottom fauna.

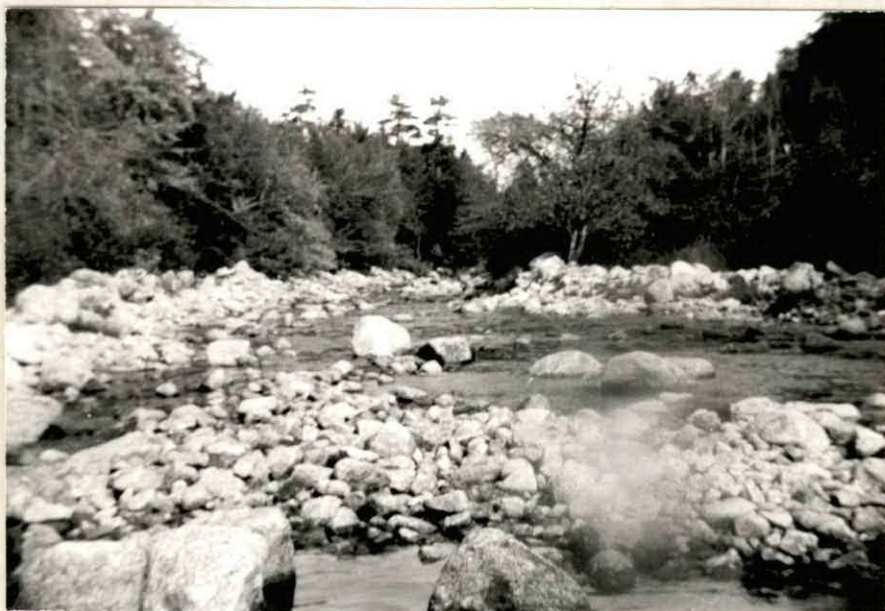
Photo 14. Below Medway Lake, 46.7 miles from mouth, looking upstream. Section of stream blasted and bulldozed to facilitate log-driving operation during the 1950's.

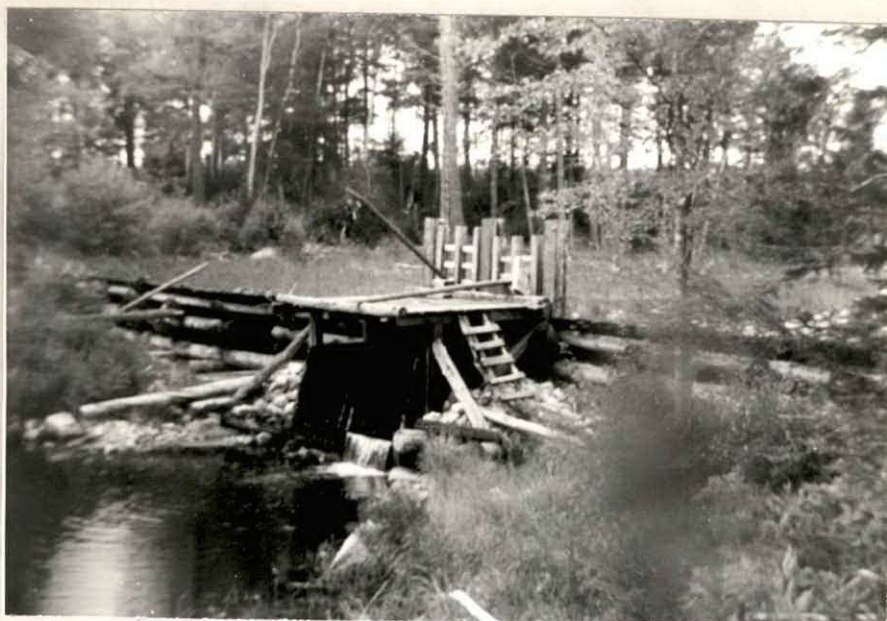
Photo 15. Former driving dam at Croker Lake
in the headwaters of the main river.

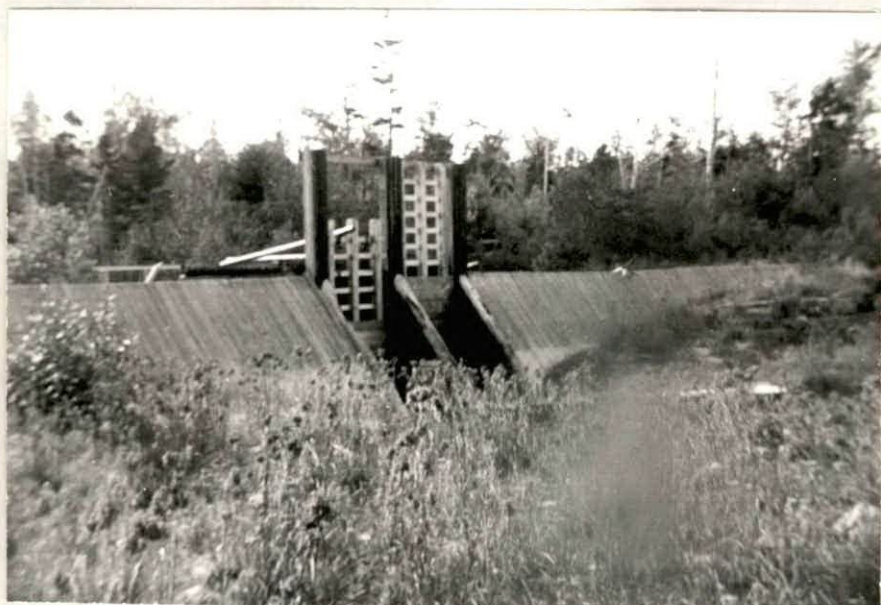
Photo 16. Former driving dam at Long Lake
in the headwaters of the main river.

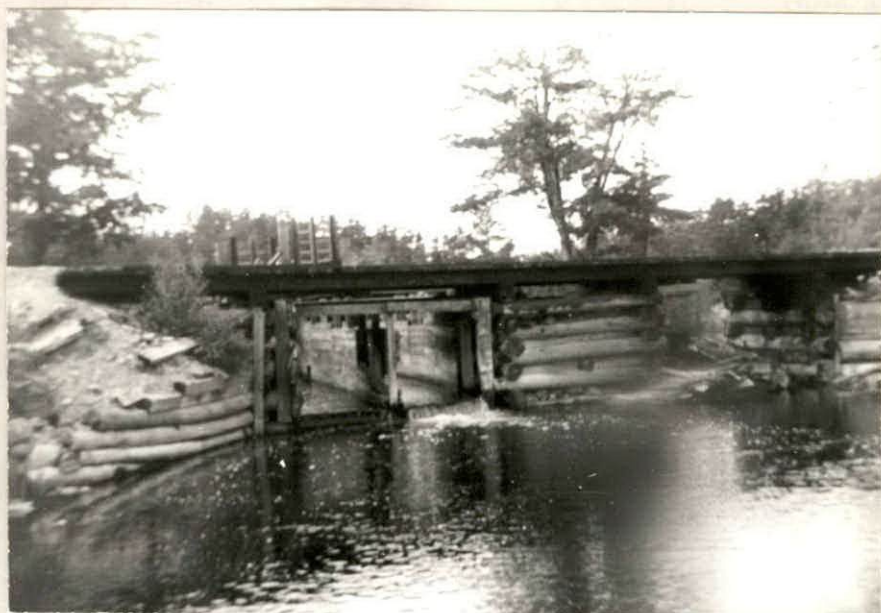
Photo 17. Former driving dam at Hendry Lake in the headwaters region on the West Medway River.

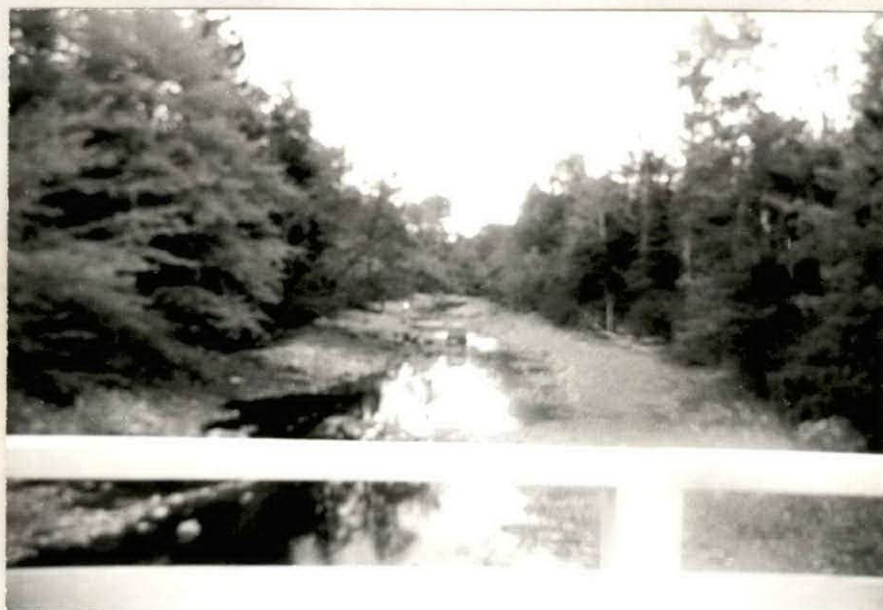
This river is three miles long, has a total drainage area of 60 acres, and an average width of 60 feet. It enters the main Medway River directly at a point 30.5 miles above tidewater. At survey time there was no water flowing in it (Photos 18 and 19) due to dry weather conditions and the absence of a storage dam which was formerly located at Tupper Lake. This tributary has a little less than one-third of the total spawning gravel available on the entire Medway River system. The overall gradient is slight at 1.5 yards per 1000 yards while the pool to riffle ratio is 1:1. There are five tributaries draining eight lakes but no dams remain on this tributary system at the present time.

Photo 18. Westfield River tributary. Looking downstream at first highway bridge, 1.2 miles from mouth. No water flowing.

It is further recommended that a dam be constructed at Tupper Lake on Westfield River to provide water during dry periods for this valuable spawning and nursery area. There was no water flowing in this river at the time of survey.

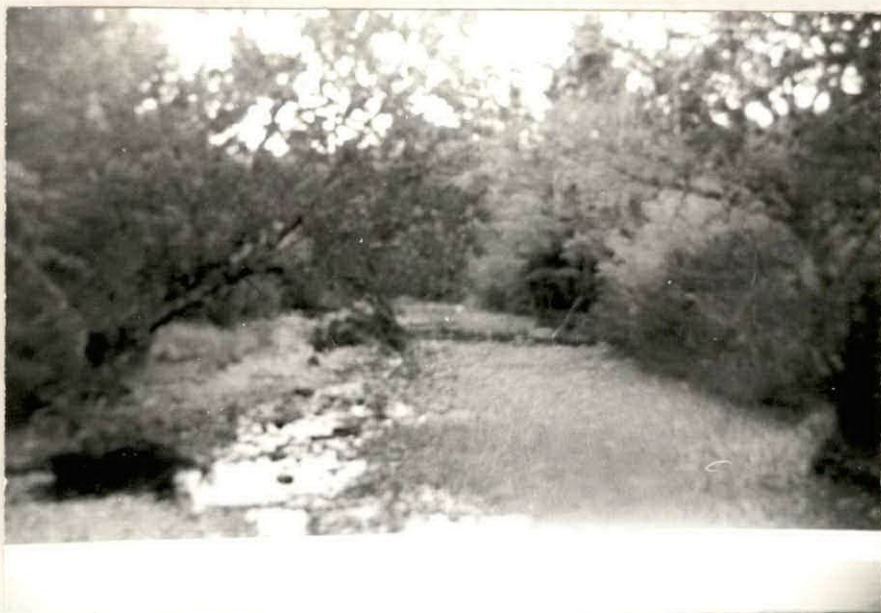
Photo 19. Westfield River tributary. Looking upstream from first highway bridge, 1.2 miles from mouth. No water flowing.

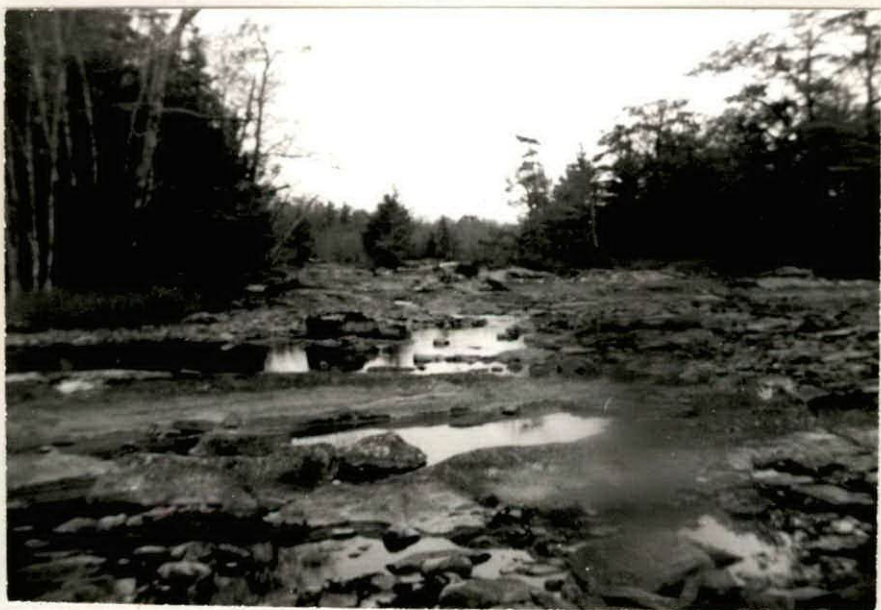
Photo 20. Pleasant River tributary. Looking upstream at a point 0.3 miles upstream. Coarse boulders and ledge rock. No salmon habitat on this section.

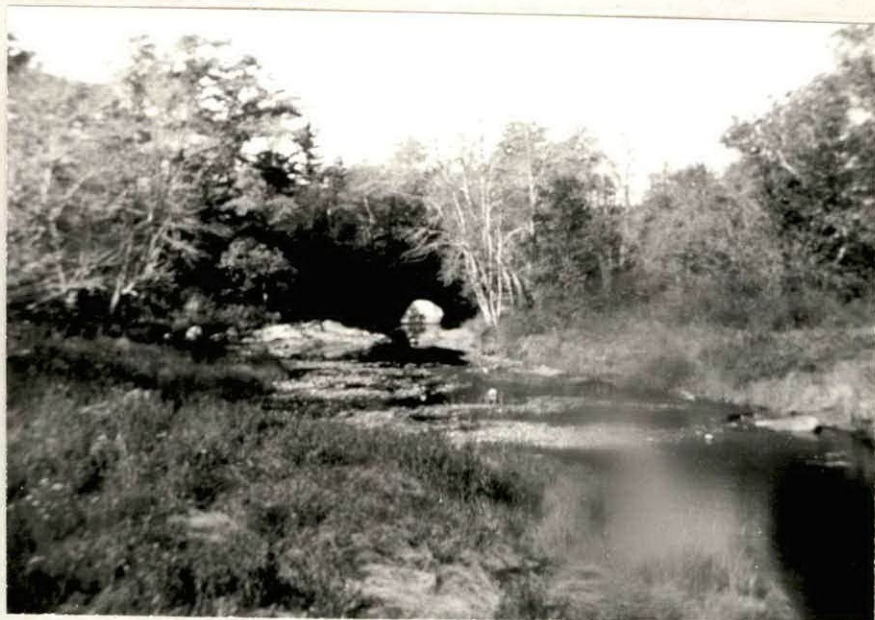
Photo 21. Pleasant River tributary. Looking upstream, 7.5 miles from mouth. Good spawning gravel. Little water flowing at survey time.
