MANUSCRIPT REPORT

No. 58-1

Obstruction Survey

East River, Chester, N. S.

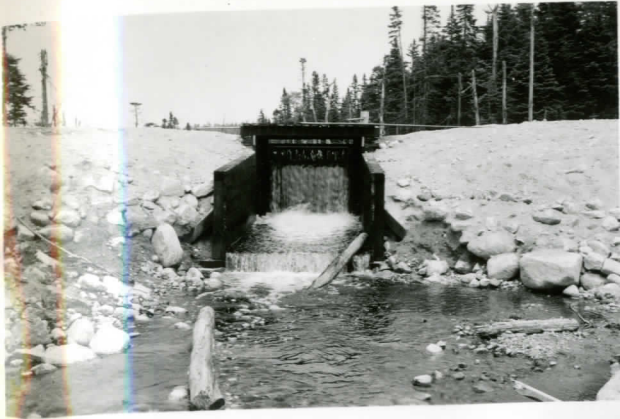
B-1. Little Whitford Lake Dam

The old wooden dam at the foot of Little Whitford Lake has been replaced by an earthen dam with a wooden centre section. The wooden section is 25 ft. long and 6 ft. high. It contains one sluiceway, 8 ft. wide and 20 ft. long. Stoplogs are used in the sluiceway, instead of a gate. This dam is required to hold a constant water level on the lake, which is used as a holding area for logs intended for the sawmill. The outlet from the lake has an average width of 10 ft., and would not be inhabited by adult salmon, trout or gaspereaux, except during freshet conditions. A hex should be installed at the mouth of the stream to prevent large fish moving into the stream during high-water conditions.

Little Whitford dam and the second Big Whitford dam (B-3) are not considered barriers, because they are located on a diversion of the main river. A hex should be installed at the mouth of Little Whitford Lake outlet to prevent adult fish from moving into this area during high-water conditions.

5. That a hex be installed at the mouth of Little Whitford Lake outlet to prevent adult fish from moving into the area during high water conditions.

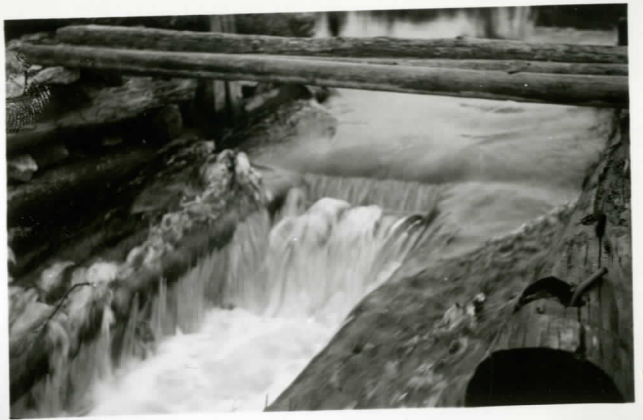
B-2. Whistler Lake Sluiceway

A rock roadway was built across the foot of Whistler Lake and a sluiceway was built in the centre of the road. The sluiceway is 15 ft. long, 10 ft. wide and 3 ft. deep.

There are no stop logs or gates in this sluiceway. The upper part of the floor is constructed of planks and the lower part of logs. The log section of the floor has been removed, but the spill flowing over the end of the plank section is obstructed by a cross log which formerly supported the log floor. The drop from the end of the plank floor to the tailwater is 1 to $1\frac{1}{2}$ ft. An inclined ramp from the end of the plank floor to the tailwater would allow gaspereaux to swim through this sluiceway.

By constructing a small inclined ramp on Whistler Lake sluiceway, even gaspereaux could move through this flume at all water levels.

3. That a small inclined ramp be installed on Whistler Lake sluiceway and on inclined plank floor replace the log floor on the main Big Whitford Lake sluiceway, so that fish can move through these sluiceways at all water levels when the gates are opened.

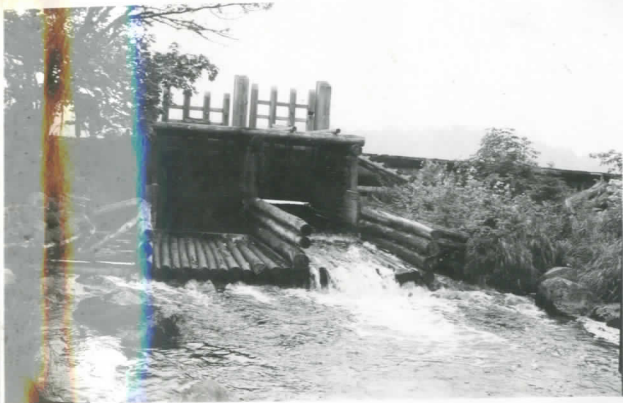
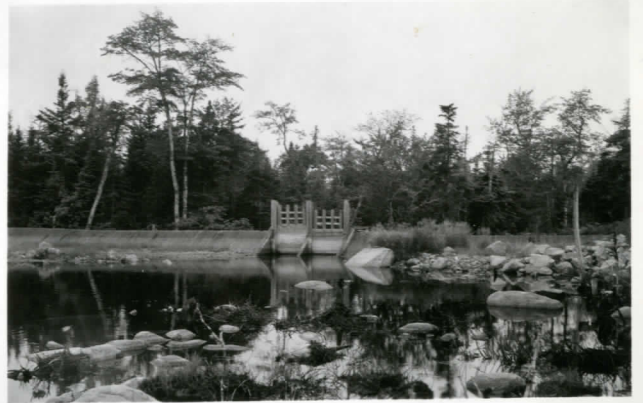
B-4. Big Whitford Lake Dam

B-4. This dam is located on the main outlet of the lake. It is approximately 200 ft. long and 6 ft. high. The dam has two sluiceways, each 27 ft. long and 6 ft. wide. The upper half of the sluiceway floor is built of planks and the lower part is built of logs spaced 1 to 2" apart. Water flowing through the sluiceway is lost before it reaches the end of the sluiceway. During very low water conditions, there is approximately a $1\frac{1}{2}$ ft. drop from the end of the sluiceway to the stream. At the time of the survey, one gate was open in the sluiceway.

Timber, Bad, Coolan and the main Big Whitford Lake dams are complete barriers to fish ascending the river when the gates are closed. Because these four dams are used only at certain periods of the year, it does not seem reasonable to recommend fishways on all these small dams. Minor repairs to the floor of the sluiceway at main Big Whitford Lake dam, by replacing the log floor with a plank floor inclined towards the tailrace, would allow gaspereaux, trout and salmon to ascend the sluiceway when the gates are open. With average water levels, fish can ascend Coolan and Bad Lake sluiceways when the gates are opened. A fishway would be required on Timber Lake dam because the area is used as an emergency storage and the gates are seldom opened. Even with the gates opened, it is doubtful if fish could ascend the sluiceway unless there was an extremely heavy flow of water.

1. That the Department of Fisheries obtain a written agreement from the Company to the effect that the gates in the main Big Whitford, Coolan and Bad Lake dams remain open except when the Company requires them for driving purposes in the spring of the year. This closed period in the spring should not extend beyond the end of May, so that the

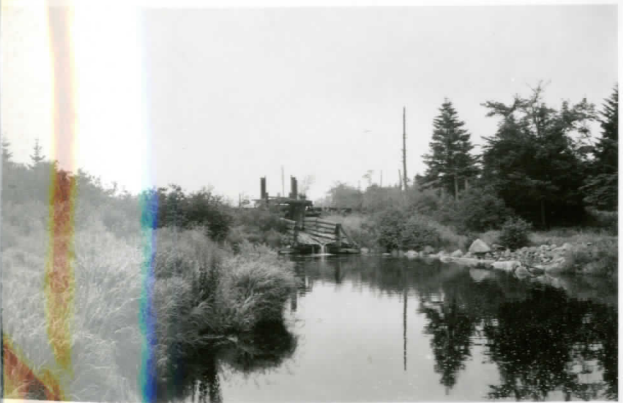
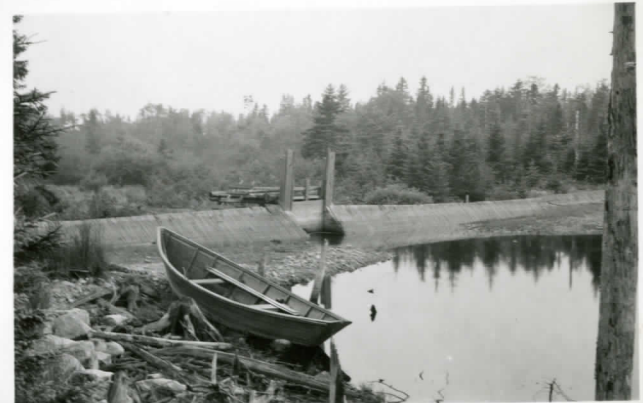
B-3. Big Whitford Lake Dam

B-3. The second dam is located on the south-eastern corner of the lake where a canal has been dug through to Little Whitford Lake. This is a wooden dam, 145 ft. long and 6 ft. high. The sluiceway in the dam is 50 ft. long and 6 ft. wide. The floor on this sluiceway is built of logs spaced 1 to 2" apart. The height of the end of the sluiceway above the water is approximately 2 ft. when water levels are very low. Sluiceway gate was closed when the dam was inspected.

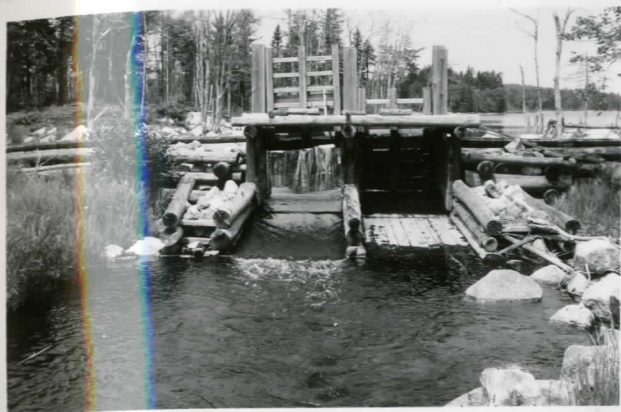
B-5. Bad Lake Dam

Bad Lake Dam is 130 ft. long and 6 ft. high. The dam contains two sluiceways, each 6 ft. wide and 21 ft. long. The floor of the sluiceway is inclined downwards to the tailrace and is constructed of planks, so that the water is confined to the sluiceway. The gate was open and approximately 2 to $2\frac{1}{2}$ " of water was flowing over the floor of the sluiceway on July 17th.

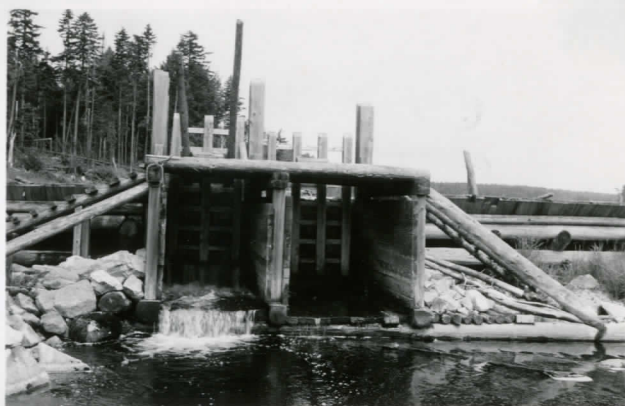
B-6. Coolan Lake Dam

Coolan Lake Dam is 185 ft. long and 6 ft. high. There are two sluiceways in the dam, both 12 ft. long; one is 5 ft. wide, and the other is 6 ft. wide. Both gates were closed, but mill officials claim that they had opened one gate and possibly a fisherman may have closed it. The floor of the sluiceway is constructed of planks and the height from the end of the sluiceway to the tailrace is approximately 1 ft.

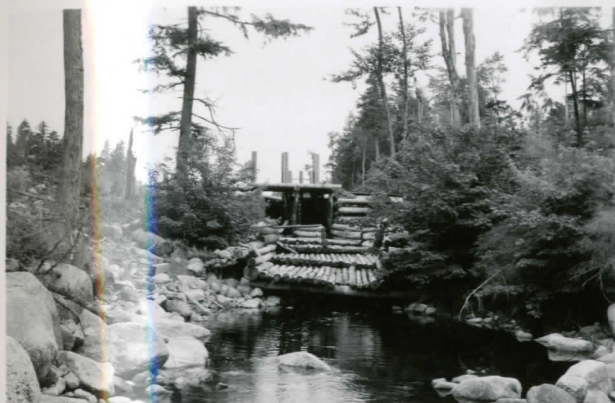
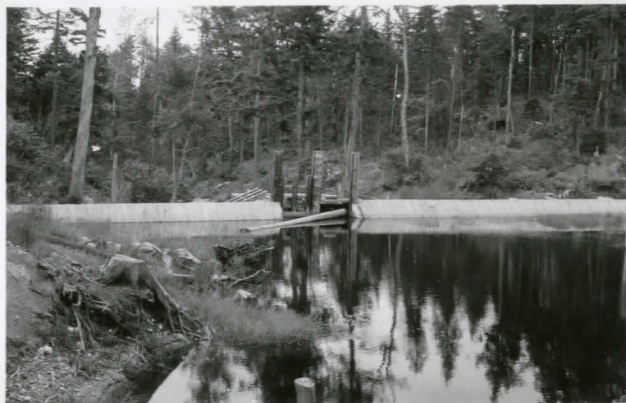
B-7. Timber Lake Dam

Timber Lake is situated on the headwaters of East River Chester. The dam at the foot of the lake is 130 ft. long and 10 ft. high. The sluiceway is 80 ft. long and divided on the upper half into two sections, each of which is 5 ft. wide. The floor of this sluiceway is constructed of logs spaced 1 - 3" apart. The end of the sluiceway is approximately $2\frac{1}{2}$ ft. above the water level of the tailrace. Water flowing through this sluiceway is lost between the openings in the floor before it reaches the end of the flume. Both gates were closed in the sluiceway, but there was considerable leakage around the gates. The lake is used as an emergency storage, and the dam is seldom opened after the spring run-off.

4. That a fishway be constructed on Timber Lake dam because it forms a barrier even when the gates are opened.

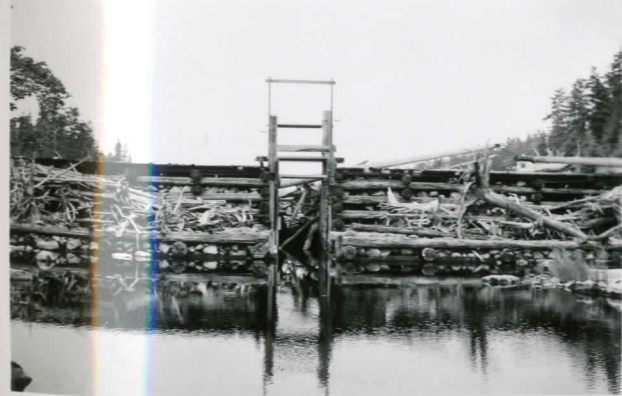
B-8. Connaught Lake Dam

Connaught Lake is situated on the Canaan River, and the dam at the foot of the lake is owned by the Nova Scotia Light and Power Company. This wooden dam, which is in a decaying condition, has been abandoned by the Company and the gate in the dam is always open. Water levels in front and in back of the dam are similar, but the opening has become plugged with old dead trees, logs and debris. This accumulation of logs and trees should be removed so that fish can pass freely through this opening.

The dams on Canaan River are not considered as barriers except for the trash and debris collected in the opening of Connaught Lake dam.

It is also recommended that the trash and debris be removed from the opening in Connaught Lake dam.

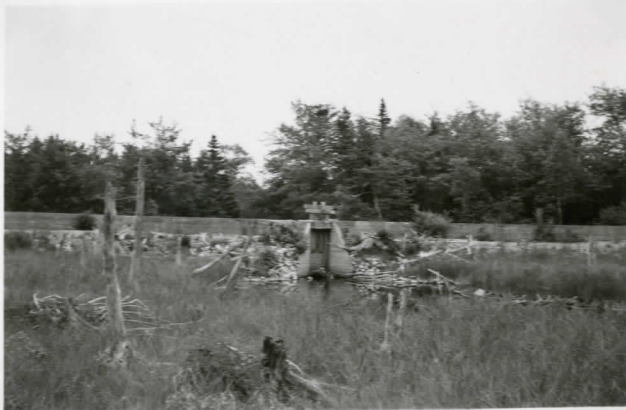
B-9. Newton Lake Dam

Newton Lake, also located on the Canaan River, has a concrete dam at the foot of the lake. This dam is owned by the Nova Scotia Light & Power Company but is not used by them, so the gate is always open. This dam is not considered a barrier as fish can move from the brook to the lake if water conditions are not extremely low.
