Development of a Manual for the Design of Floating Breakwaters

Western Canada Hydraulic Laboratories Ltd.

Department of Fisheries and Oceans
Small Craft Harbours Branch
Ottawa, Ontario K1A 0E6

November 1981

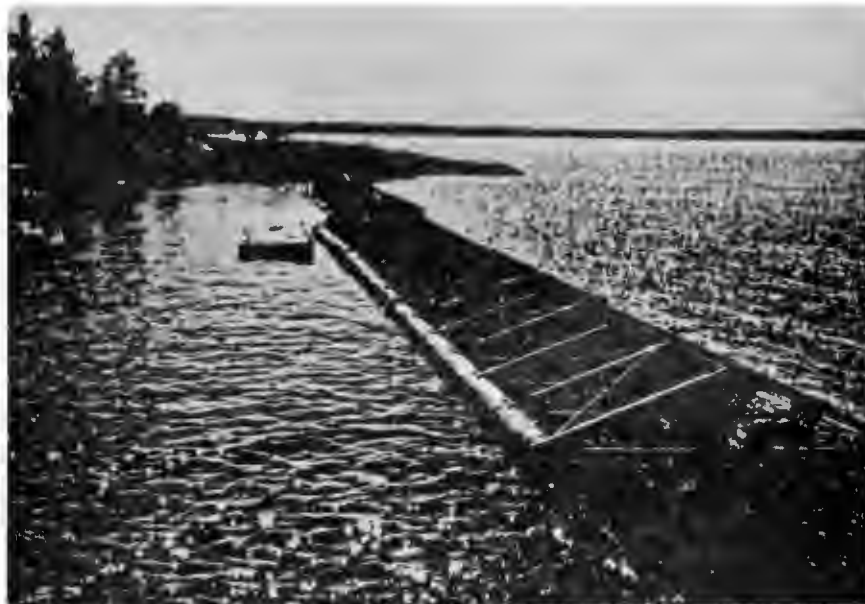
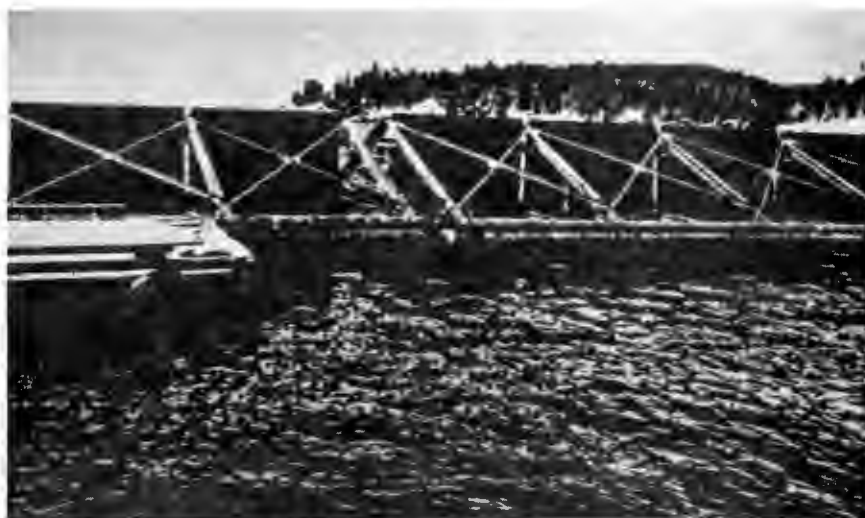
A. Breakwater at Lund, B.C., with centreboard support frames above water level

B. Lund A-Frame breakwater construction

A-FRAME BREAKWATERS - SUPPORT FRAME ABOVE WATER

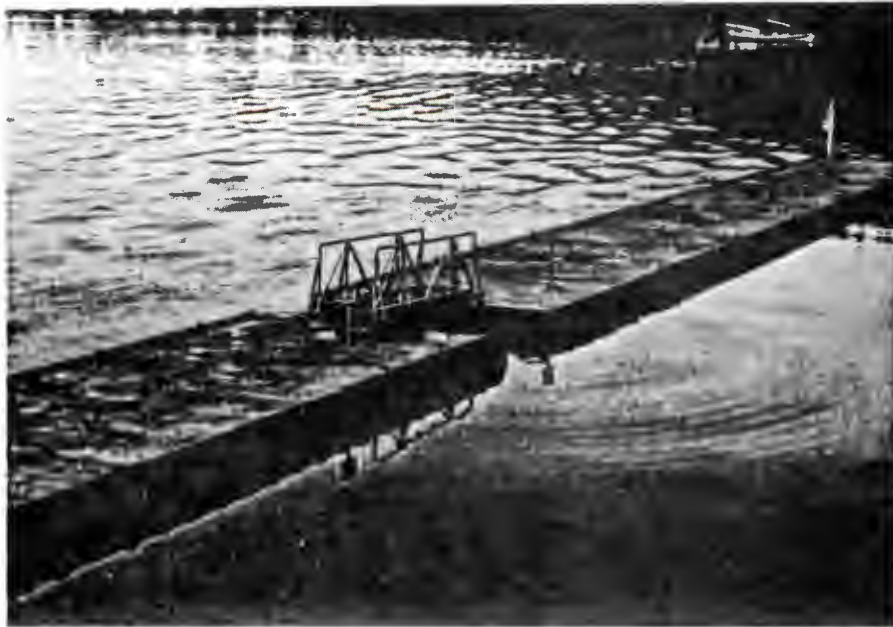
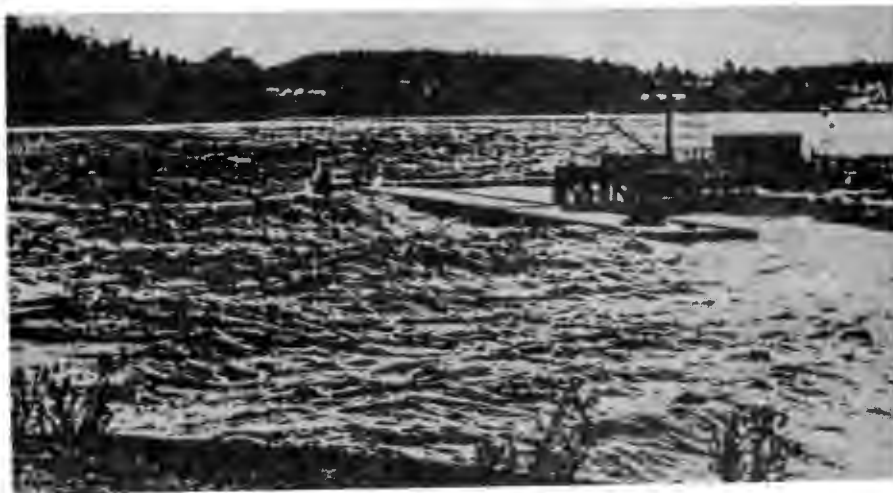
A. Floating Caisson breakwater of 4.6 m width and 1.1 m draft at Friday Harbour

B. Friday Harbour breakwater in 2.8 sec. waves

CAISSON BREAKWATERS

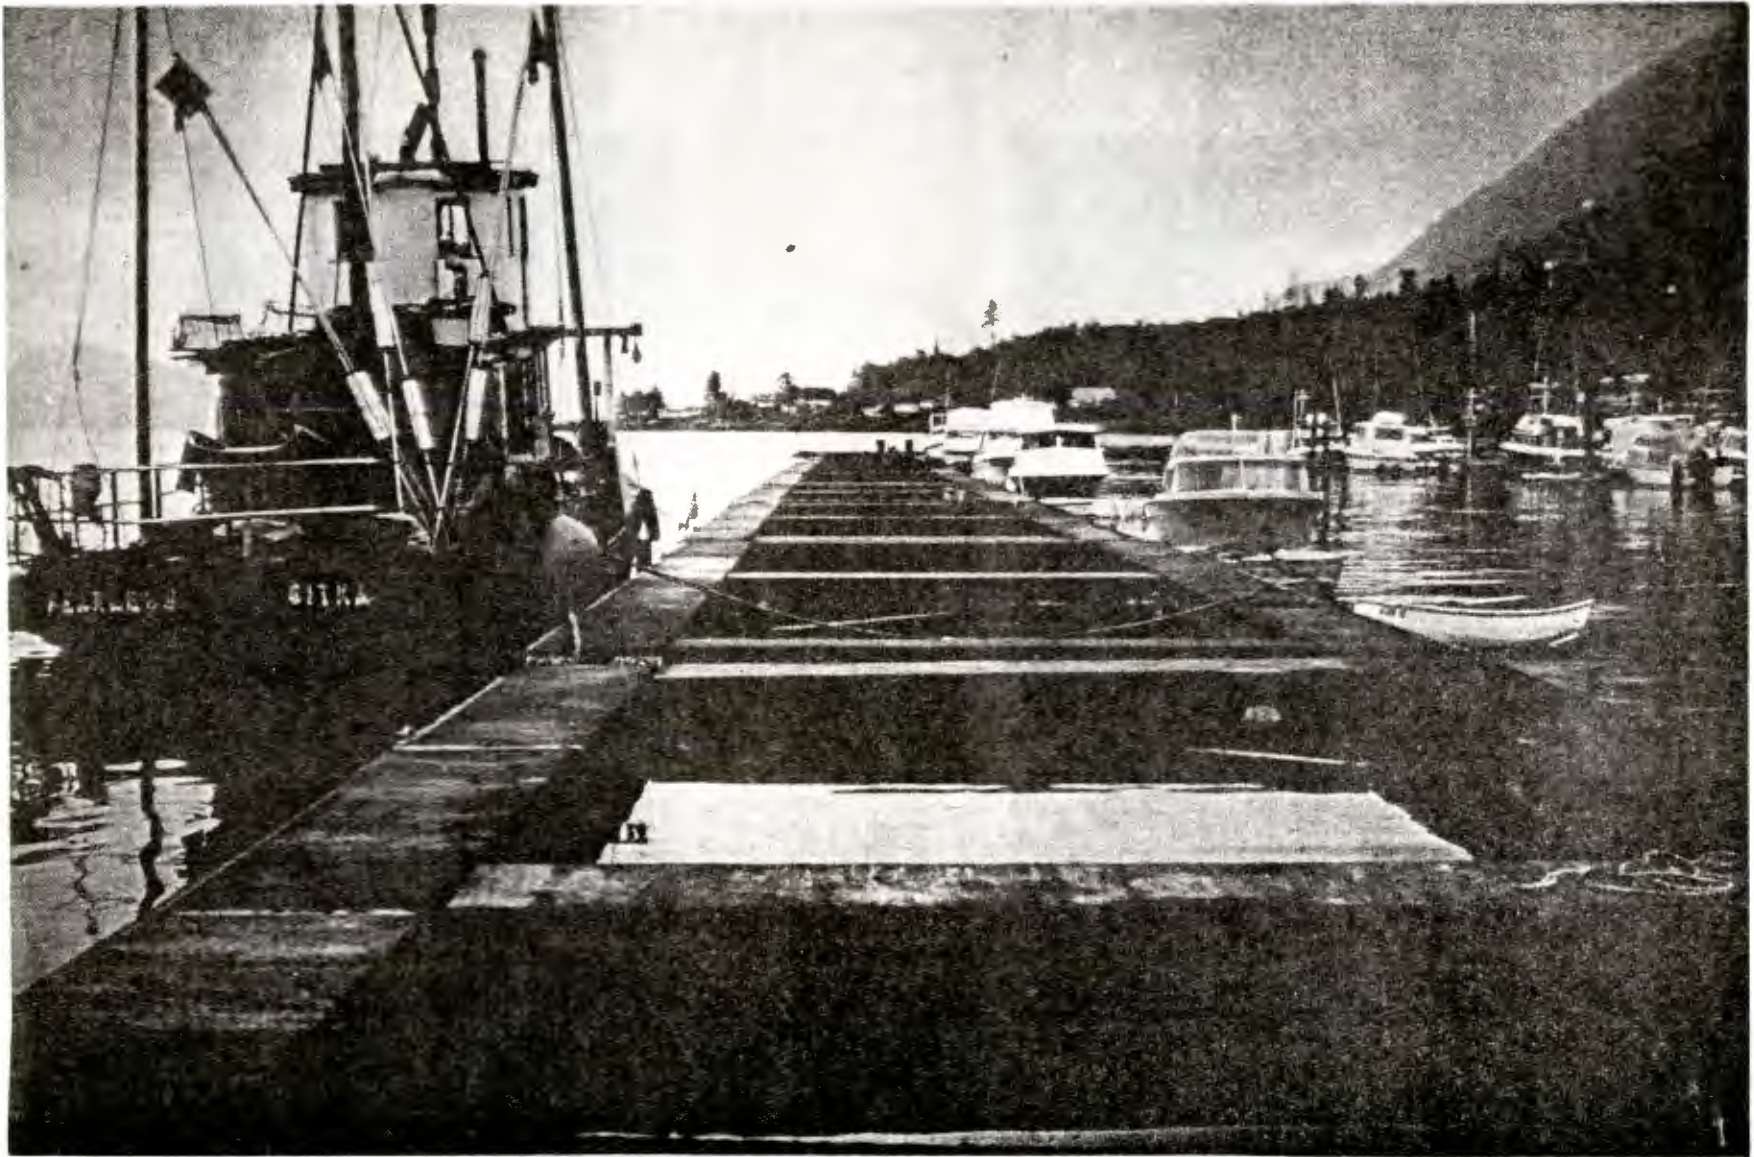
PONTOON BREAKWATER AT SITKA, ALASKA

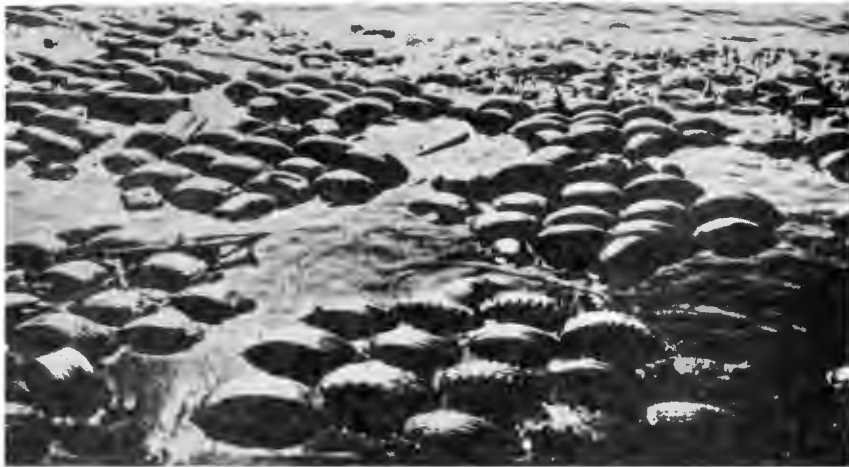
A. 3 module Goodyear design breakwater at Pickering Beach
- photo by U.S. Army Corps of Engineers

B. Goodyear module design breakwater at North Vancouver, B.C.

C. Wave Breaking action induced by Wave Maze Breakwater
FLOATING TIRE BREAKWATER

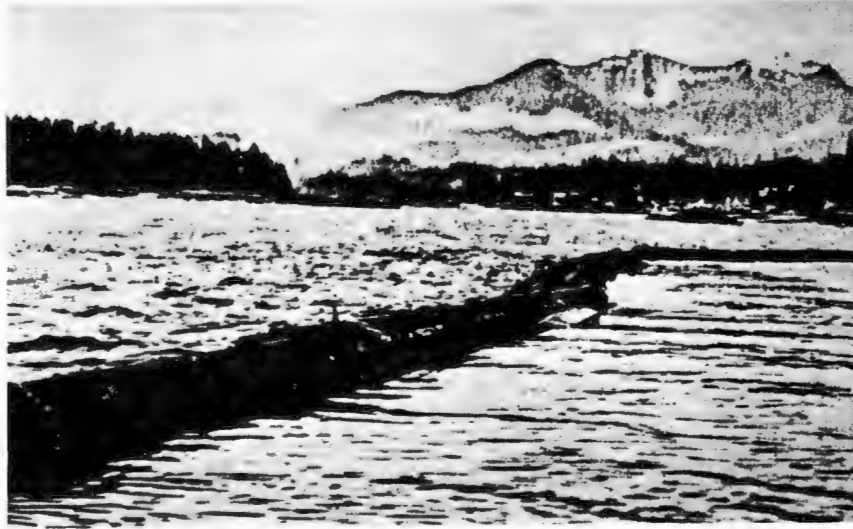
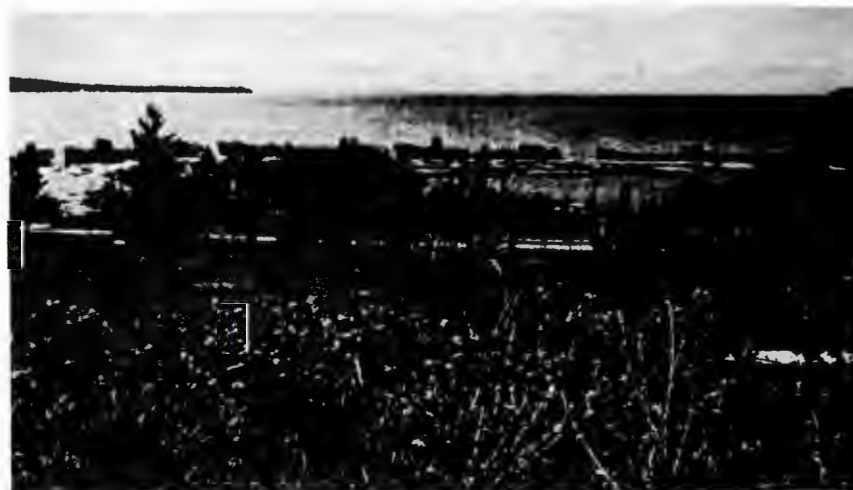
A. Floating log bundle breakwater

B. Breakwater at Powell River B.C. of Scrapped Ship Hulls

BREAKWATERS FROM AVAILABLE MATERIALS

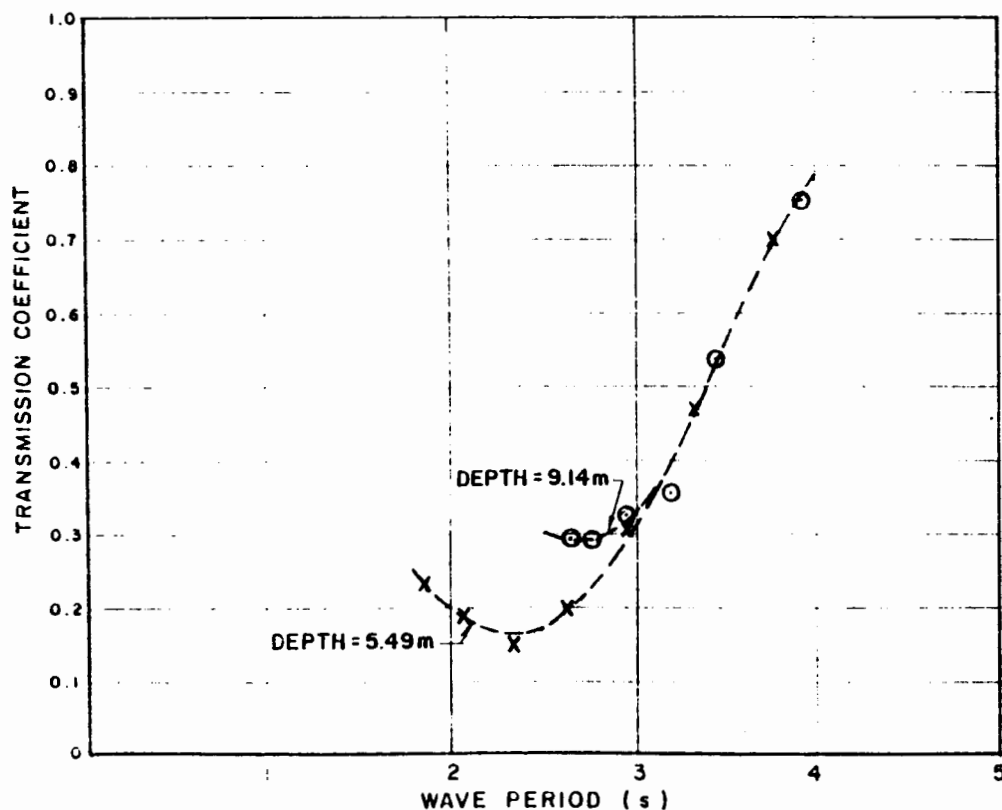
FIGURE C 1

SCALE 1:12
REGULAR WAVES

Moored with 1.5 mm (model) stainless steel cable. A spring with a linear spring constant connected the cable to a force meter. Stiffness not available.

Initial tension = 0. Scope not available.

OFUYA, 1968, A-FRAME
