Low Flows in High Value Fish Streams – Thompson Basin, 2003

Prepared for :
Fisheries and Oceans Canada
Kamloops, BC

Prepared by:
Dave Pehl, BSc.
Fraser Basin Council
Kamloops B.C.

April 2004

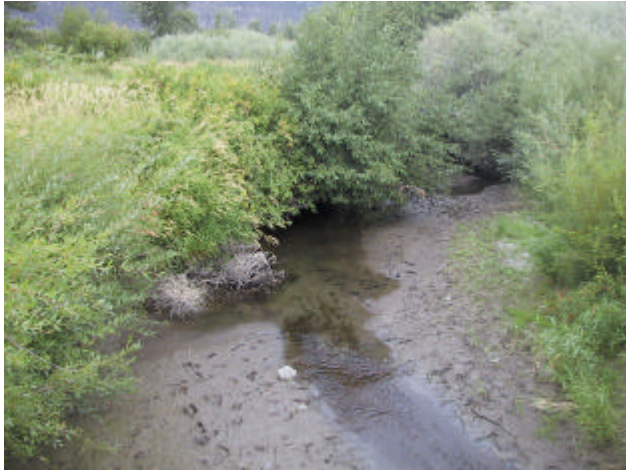
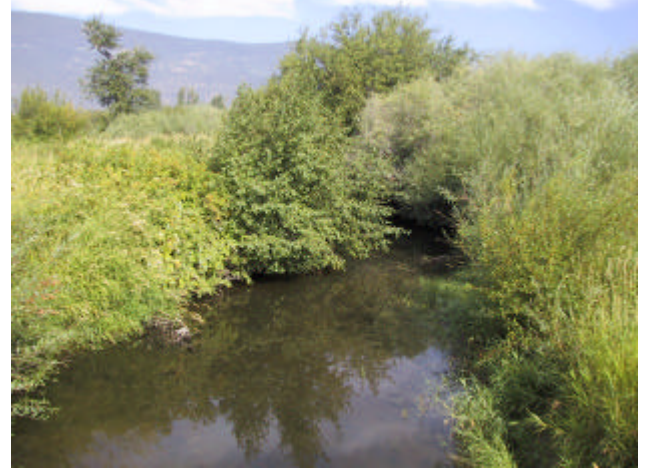
Figure 1. Flow levels and changes to habitat as a result of beaver activity in August (left) and September (right) at Quilchena Creek.

Photographs taken at the highway 5 bridge show variability in juvenile rearing habitat availability throughout August (Figure 1). Changes to the channel were a result of beaver activity in the section of creek downstream of the highway bridge. Pools created by this activity may have provided habitat for juvenile salmonids.

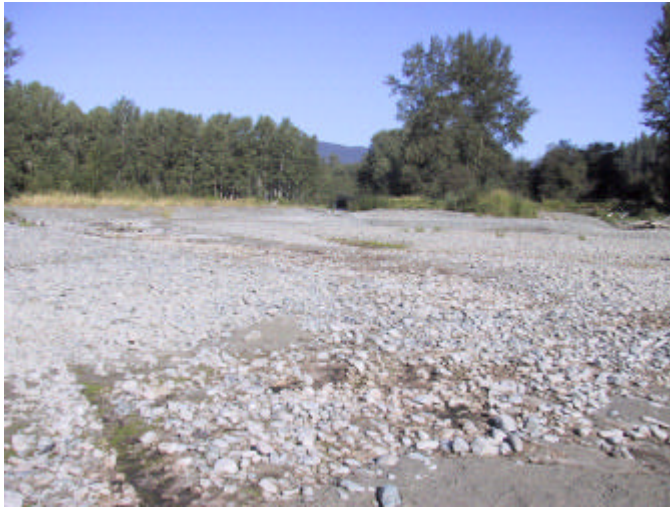
Figure 2. Low flow impacts at the mouth of Lemieux

Access for migration chinook was an obvious impact to the fisheries resource throughout the monitoring period. Chinook migration usually begins in early to mid August and continues through to early October. Throughout the low flow period a section 75-150m at the confluence of Lemieux and the North Thompson River was dry or contained minimal flows, insufficient of providing fish passage (Figure 2).
