Study of Flood Proofing Barriers in Lower Mainland Fish Bearing Streams

May 1999

**Department of Fisheries and Oceans
Habitat and Enhancement Branch
Pacific Region**

**Alan R. Thomson and Associates
Vancouver, B.C.**

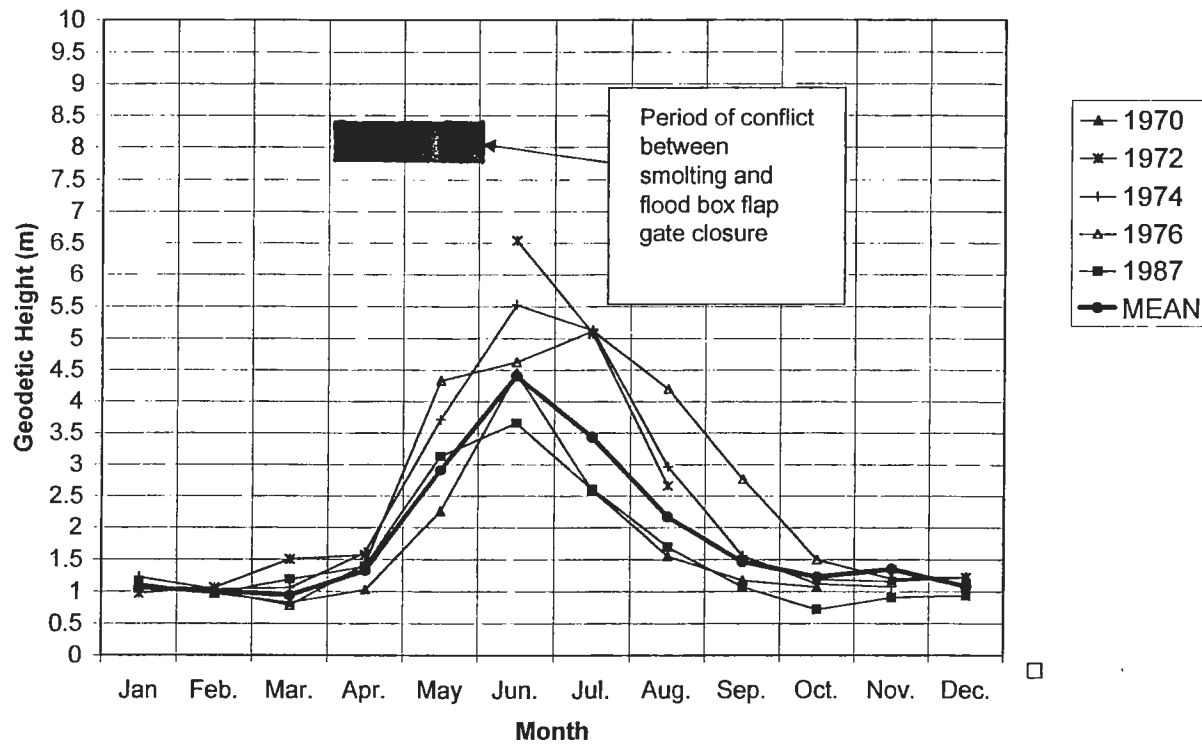
Figure 2: Monthly water levels of the Fraser R. at Mission for selected years between 1969 – 1992.

Note: Years represented in the figure are included to indicate extreme values (both high and low discharge years) and the mean discharge over the time period. Source for hydrometric data: Environment Canada

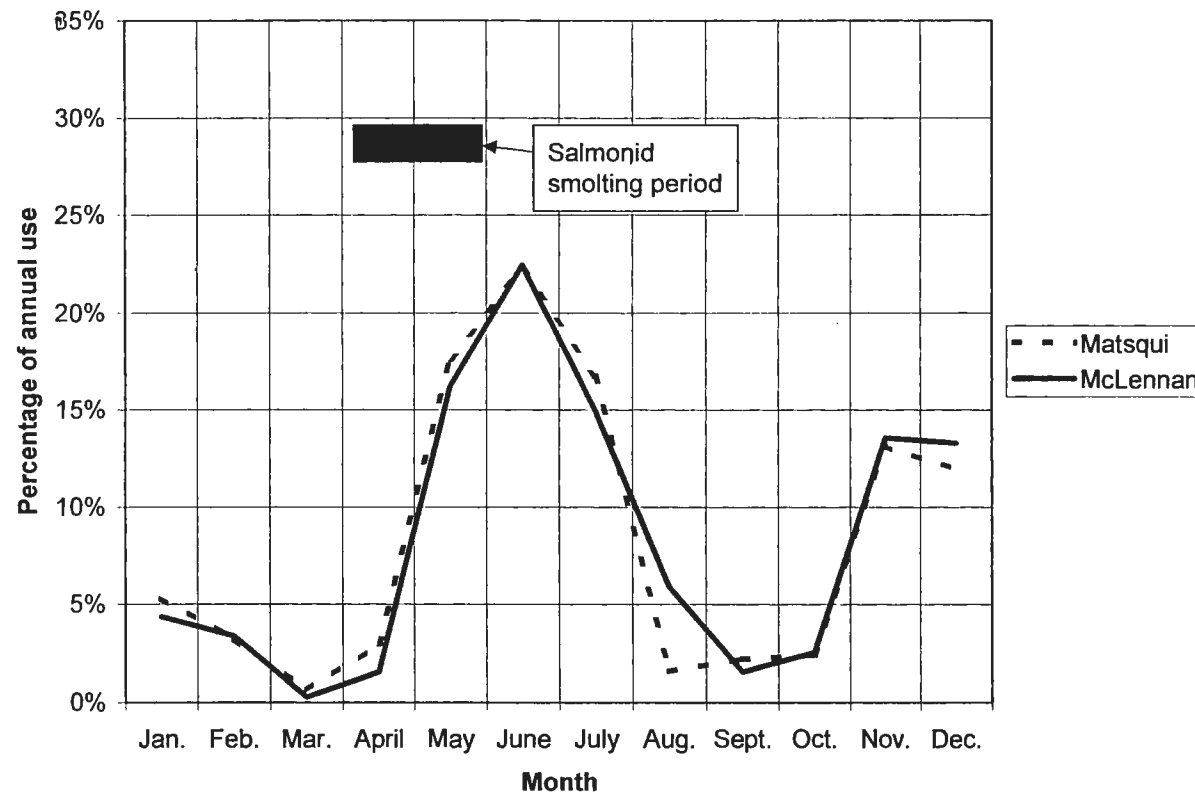
Figure 3: Average monthly pump station operating hours expressed as percentage of total annual hours for Matsqui Slough and McLennan Creek stations from 1974- 1987.

is required for continued drainage to the mainstem. Flood boxes located near the mouths of tributaries and sloughs along the lower Fraser River are often closed for long periods during late spring and early summer when the mainstem freshet occurs. As a result, the flap gate closure period and the migration period always overlap. The duration of overlap is largely dependent upon when the freshet arrives and when the salmonids start smolting (See Figure 2). In some years when the freshet arrives late, it is likely that the majority of smolts leave their natal stream unimpeded through the flood boxes. In other years when the freshet arrives early, the pumps likely entrain the majority of smolts (see Figure 3).

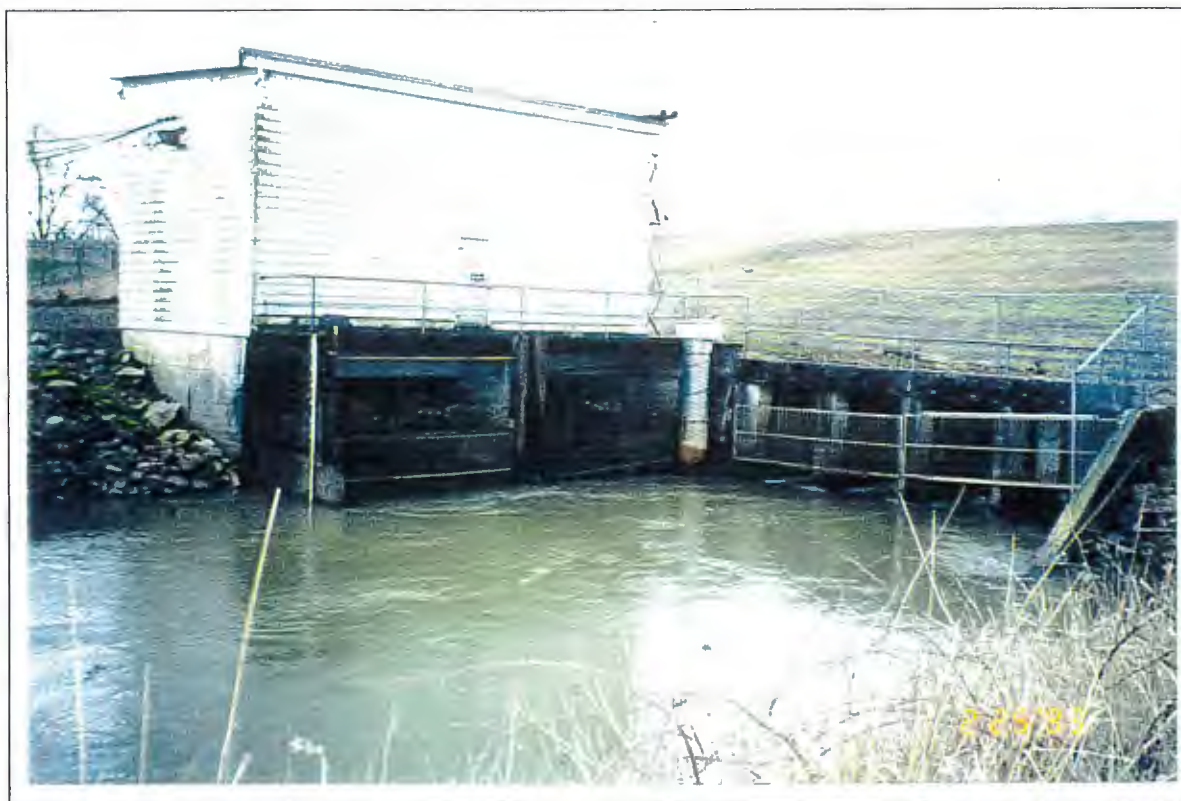
Photo 1: Hatzic Slough station: pump intakes (L), flood box (R).

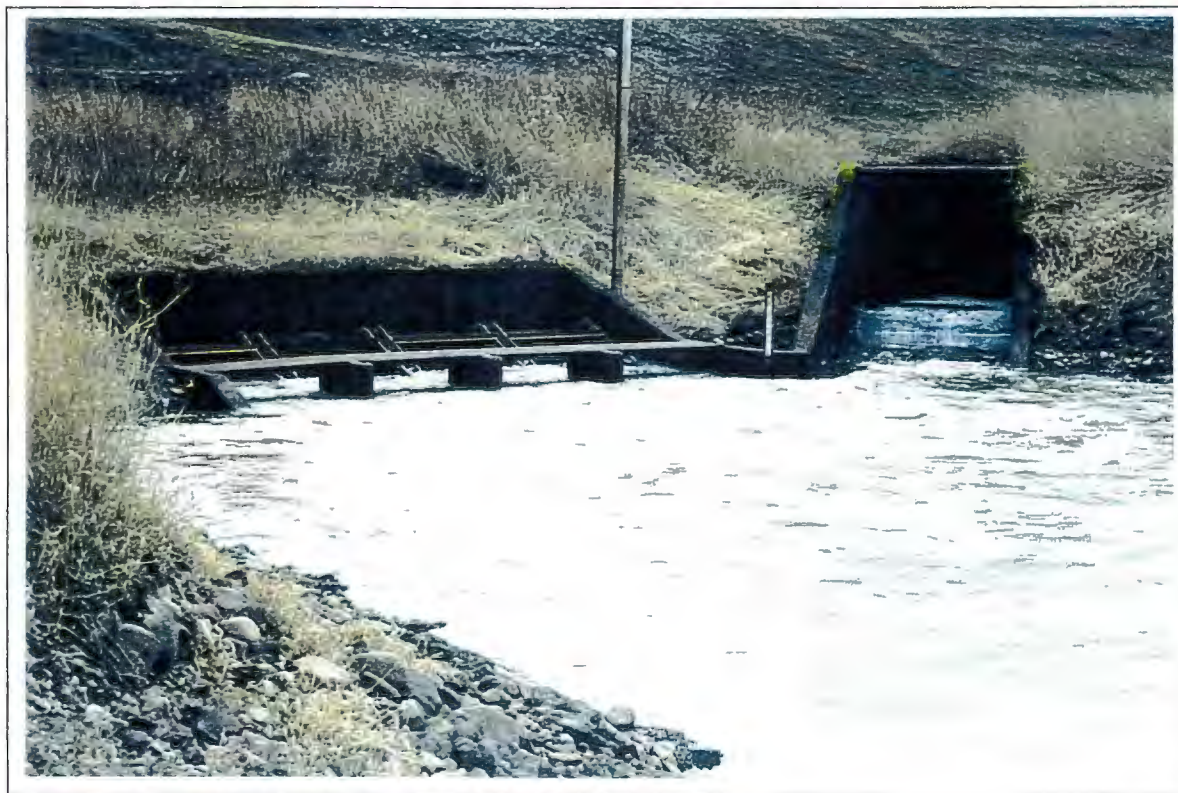
Photo 2: Hatzic Slough station: flood box (L) and pump (R) discharge.

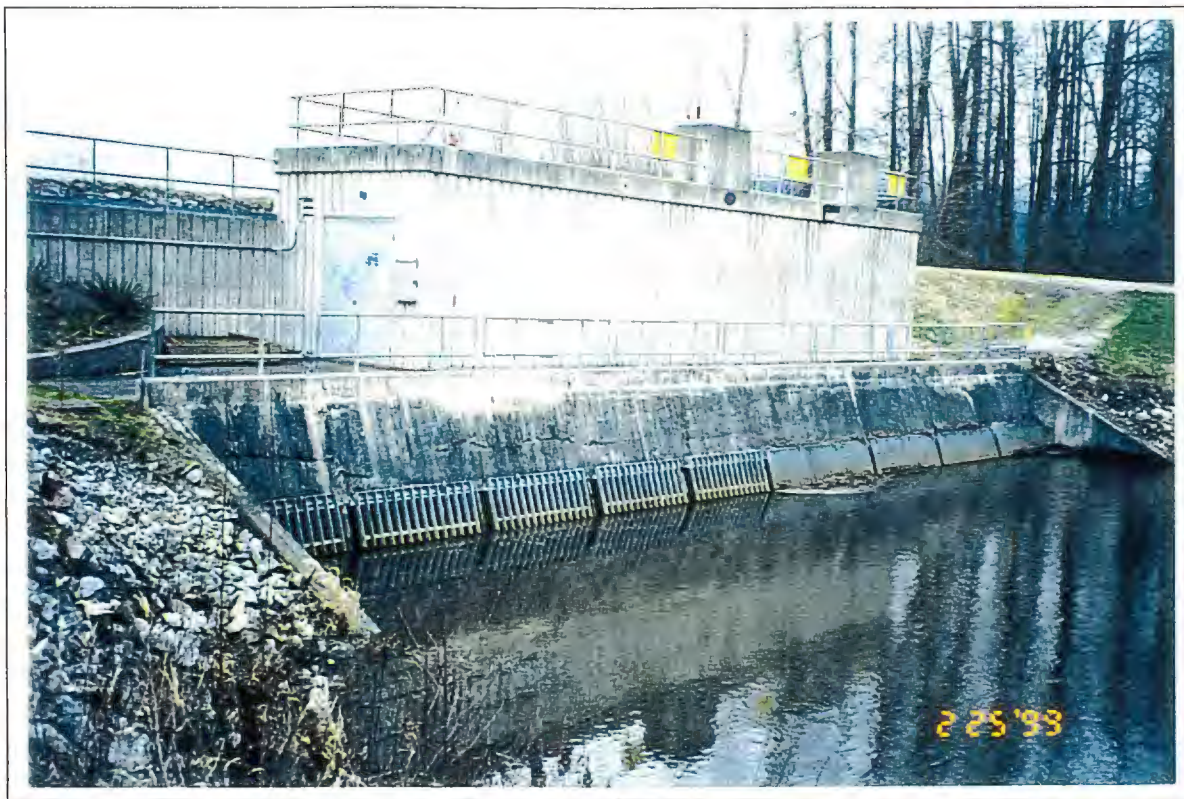
Photo 3: Katzie Slough station: pump intakes (R), flood box entrance (L).

The pumping station is located approximately 30 m upstream of the confluence of the Slough with the Pitt River (see Photos 3 and 4). The existing pumping station, known as the Kennedy Pumping Station, was constructed in 1983 under the auspices of the Canada – British Columbia Fraser River Flood Control 1968 Agreement. It replaced a smaller pump house and flood box structure. The present pumping station consists of four flood boxes with side mounted flood gates and four pumps with the following characteristics:

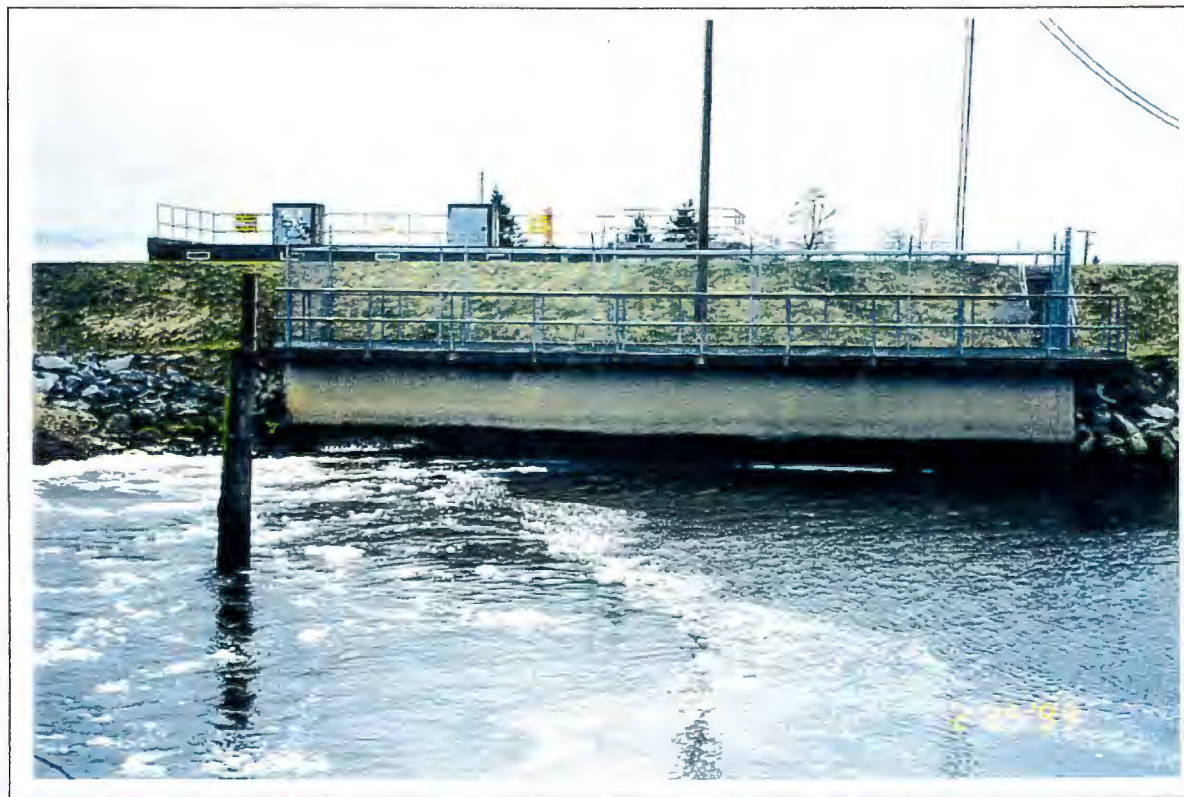
Photo 4: Katzie Slough station: pump and flood box outfall.

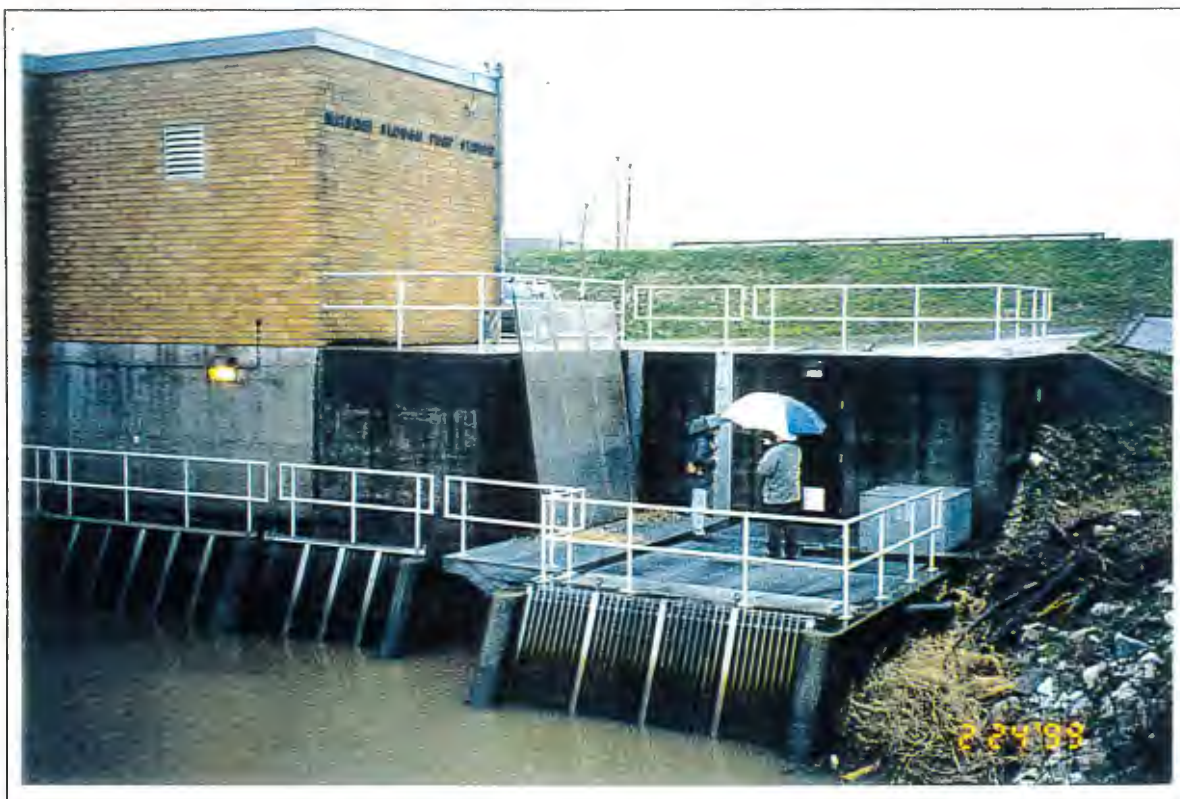
Photo 5: Matsqui Slough station: fish pump and screen located in right forebay.

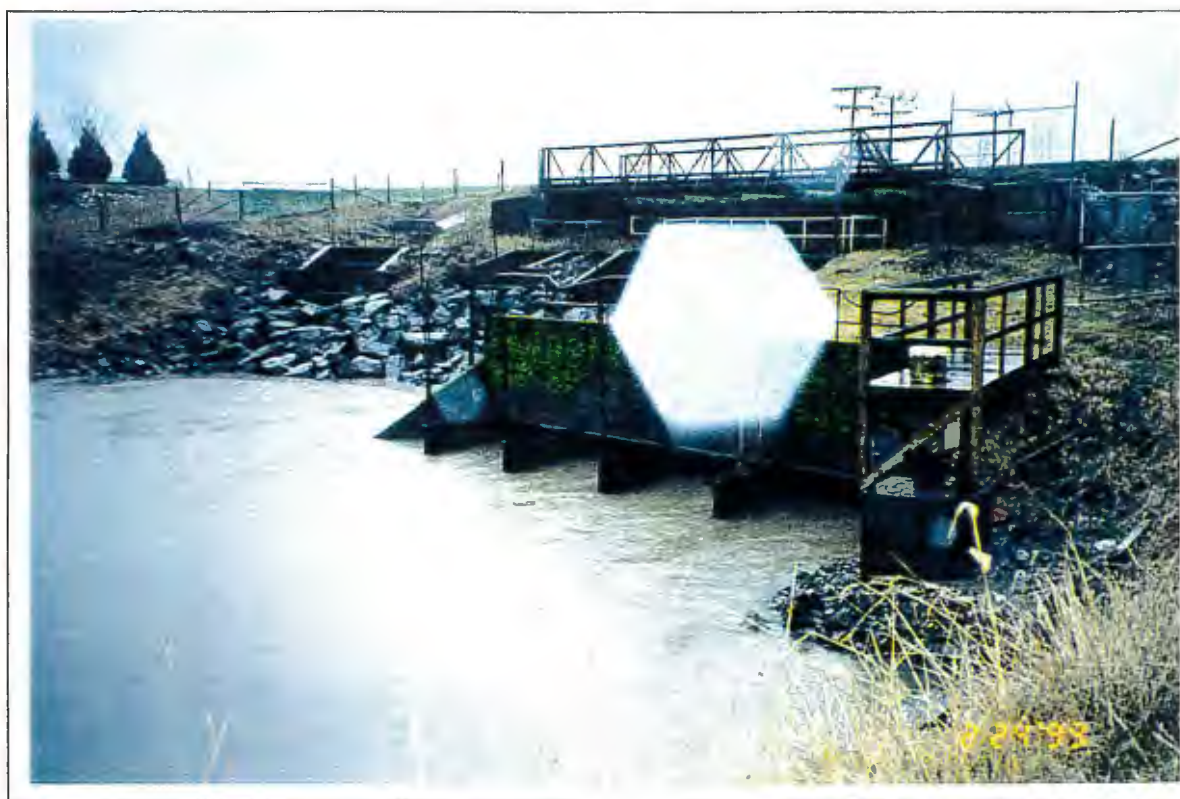
Photo 6: Matsqui Slough station: flood box outfall (R), pump outfall (L).

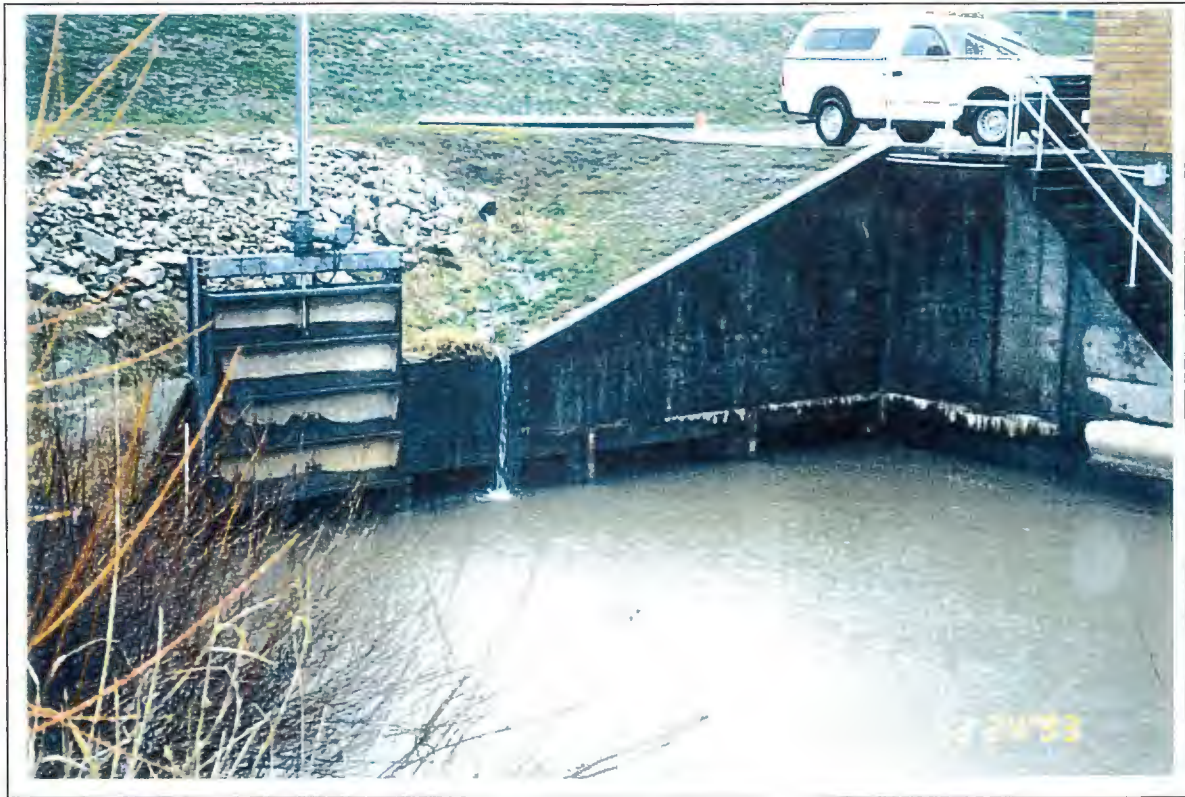
Photo 7: Matsqui Slough station: entrance to flood boxes. Note hydraulic gate and slots for stop logs.

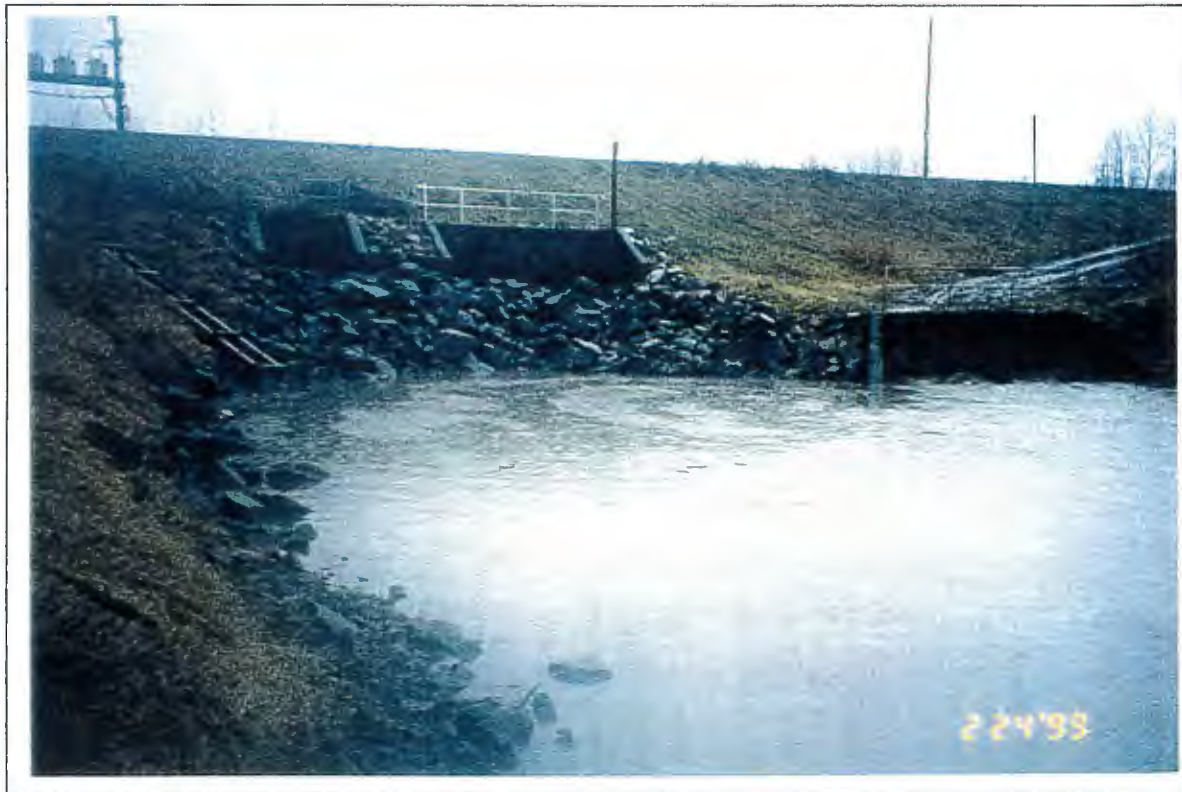
Photo 9: McLennan Creek station: pump (left) and flood box (right) outfalls.

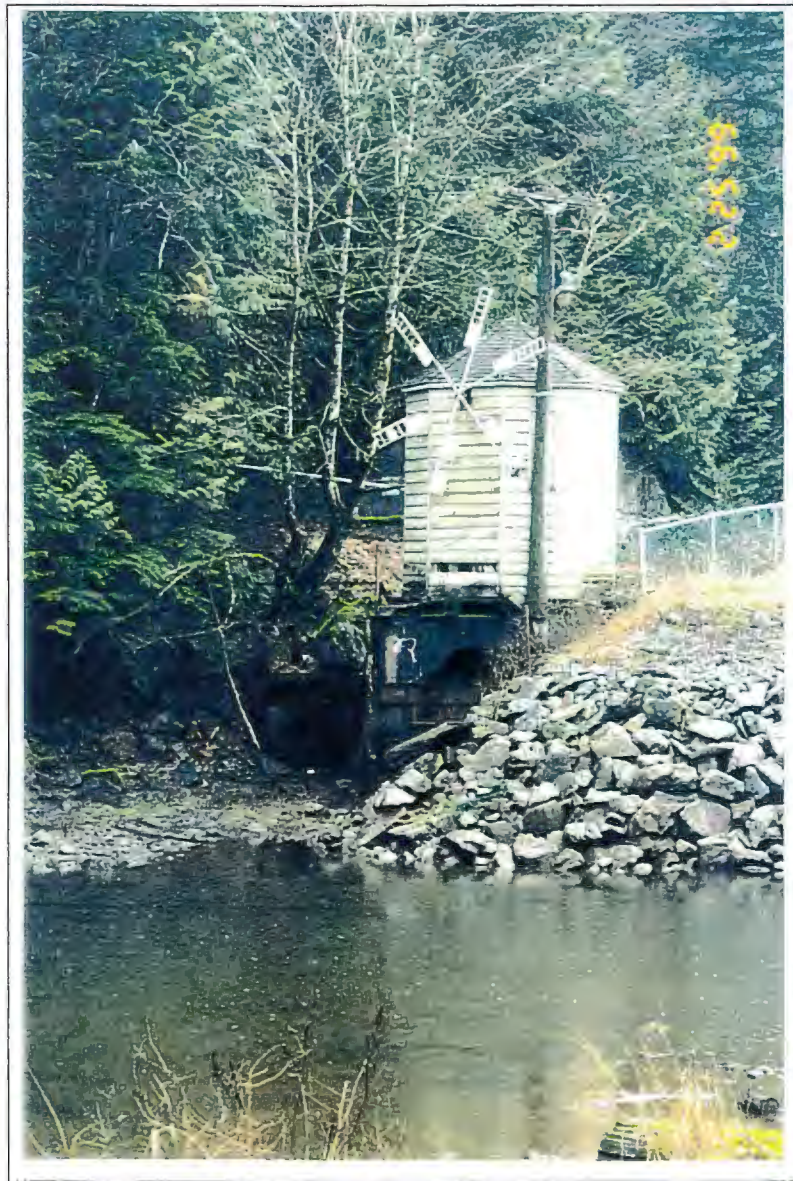
Photo 10: Miami Creek pumping station: old flood boxes under station. Also note the aged screen in front of the sump.

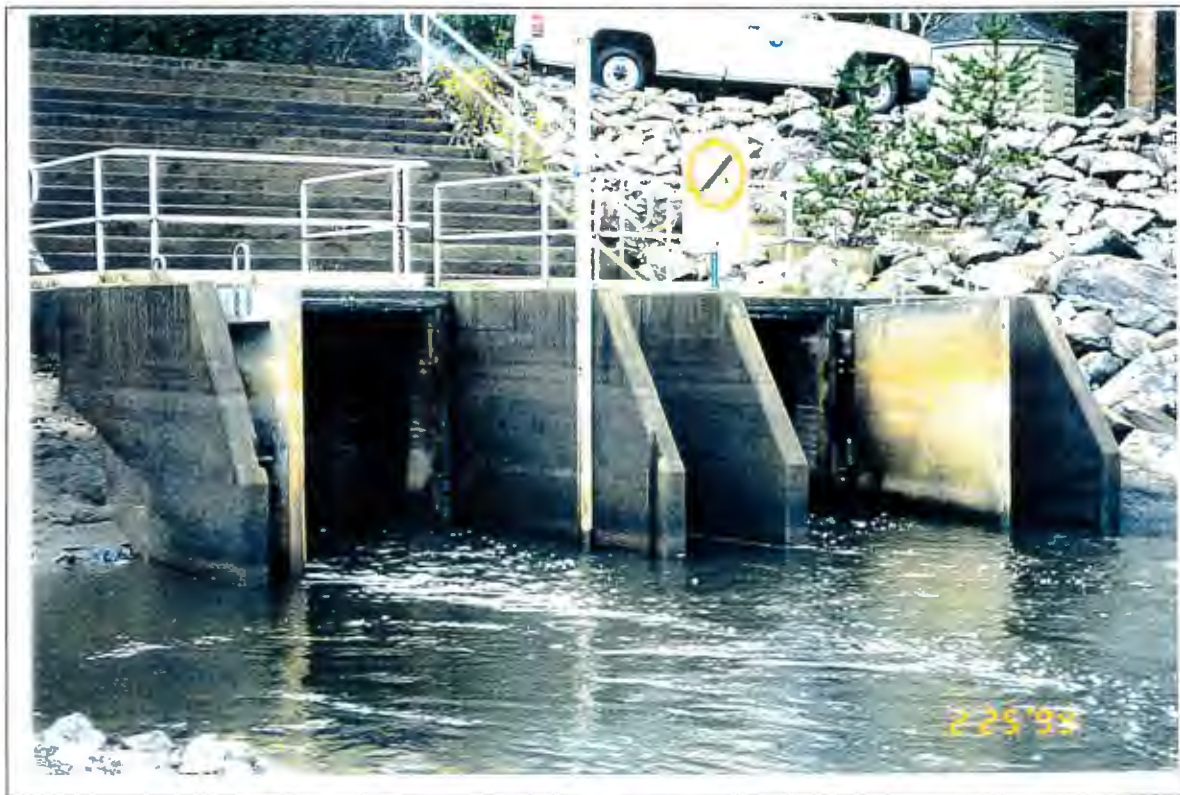
Photo 12: Miami Creek station: flood box outfall. Note that gates are wide open with little flow.

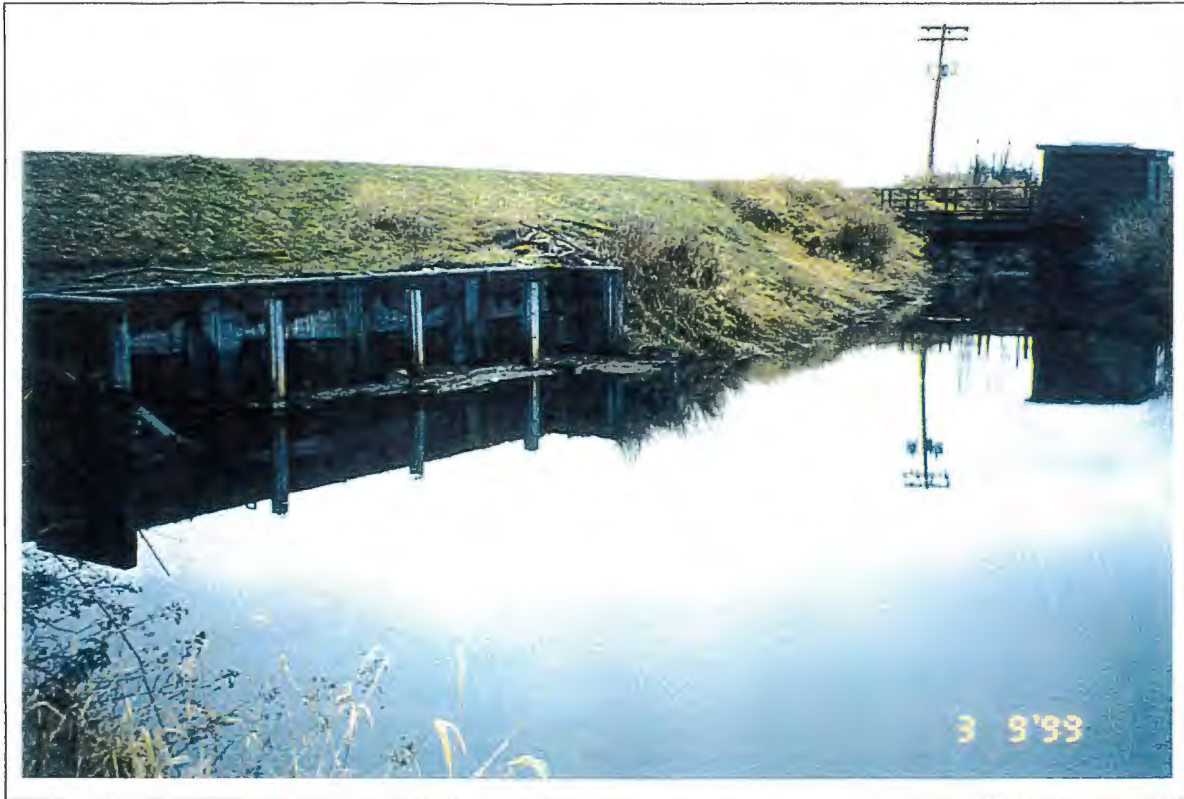
Photo 13: McLean Creek station: flood box entrance (L), pump house (R).

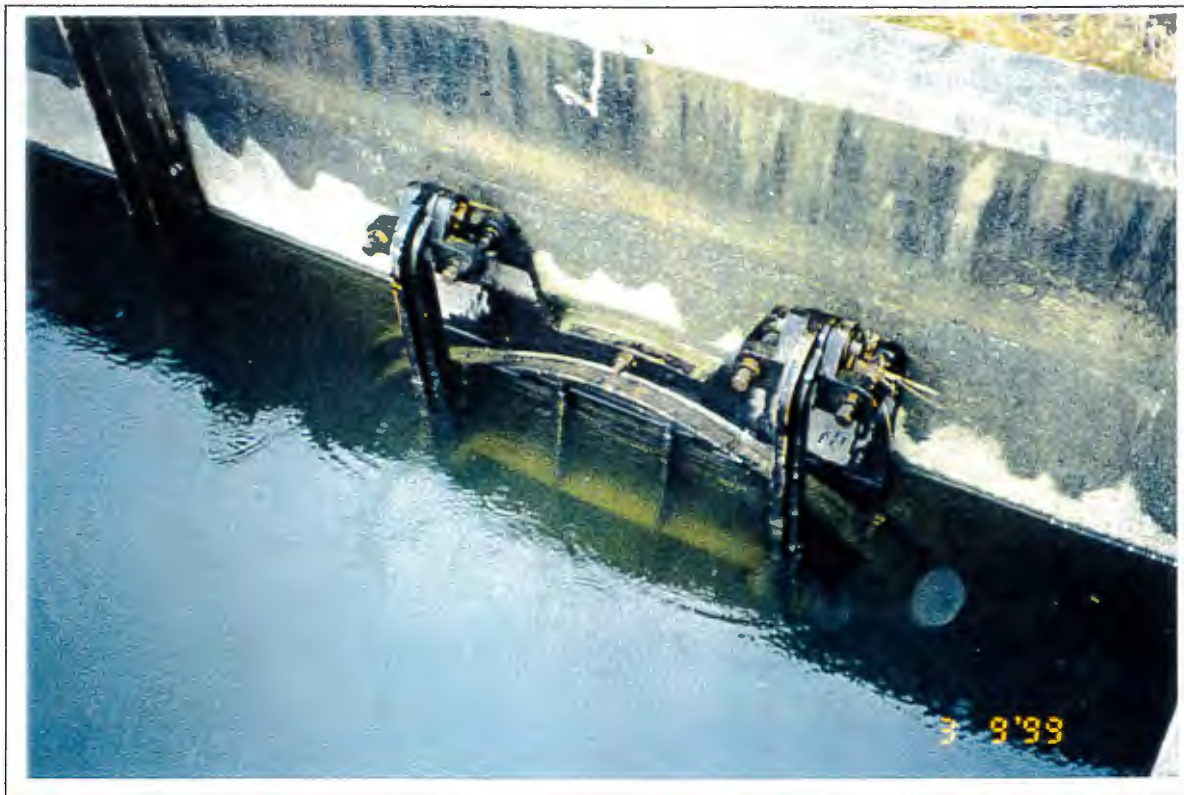
Photo 14: McLean Creek station: cast iron top-mounted flap gate on flood box outfall.

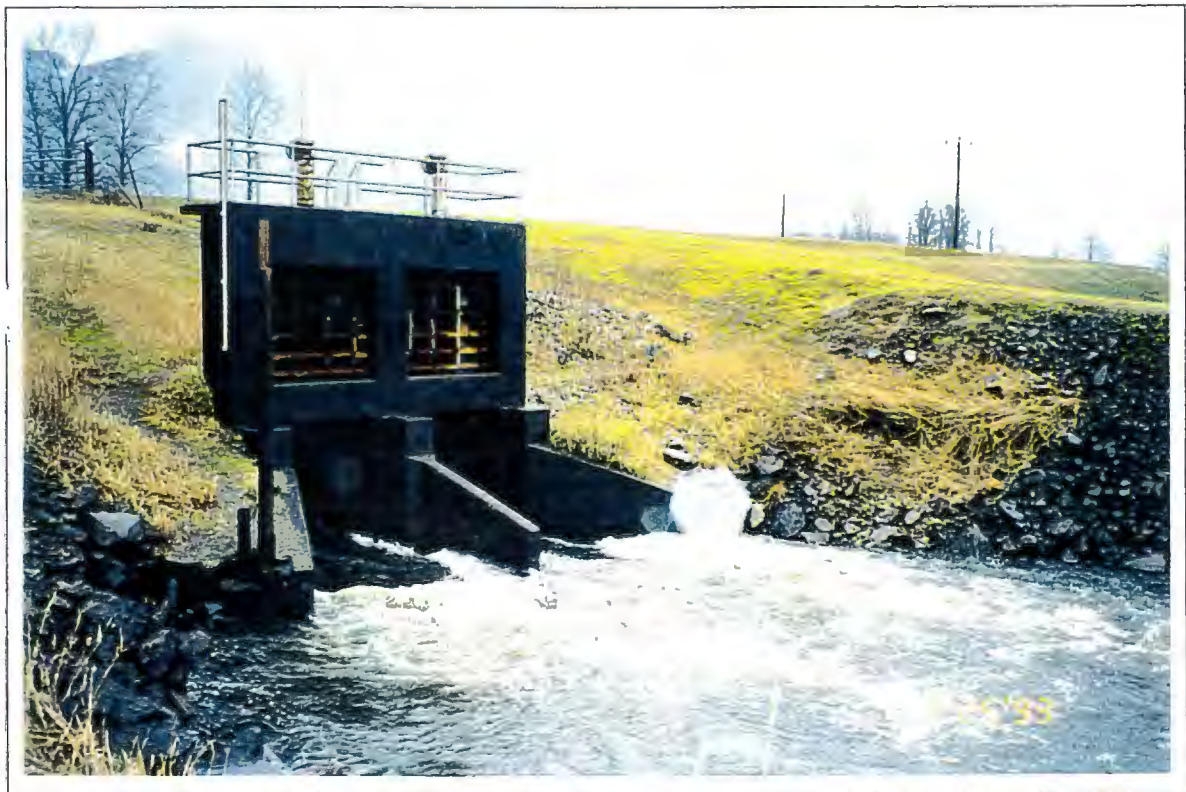
Photo 16: Hammersley pump station: flood box outfall. Note hydraulic jump – possible barrier.

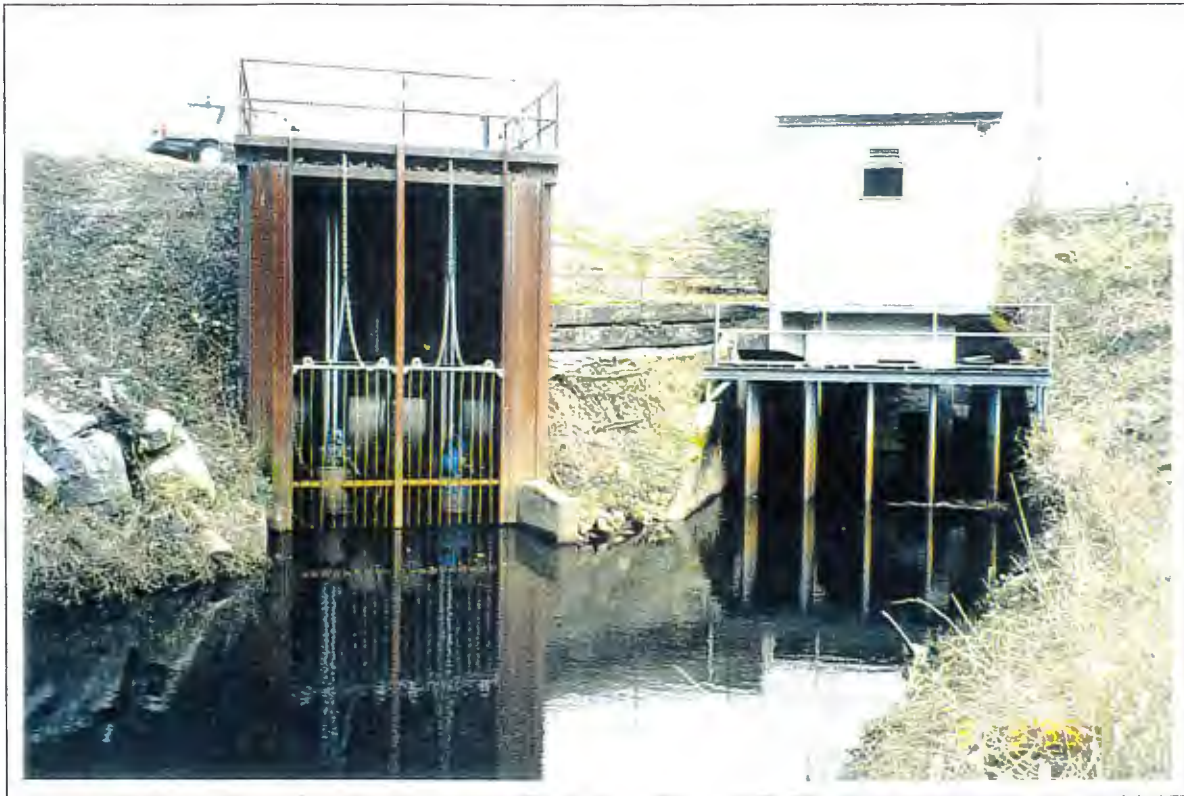
Photo 17: Nathan Slough station: older station (R), new station (L) with submersible pumps.

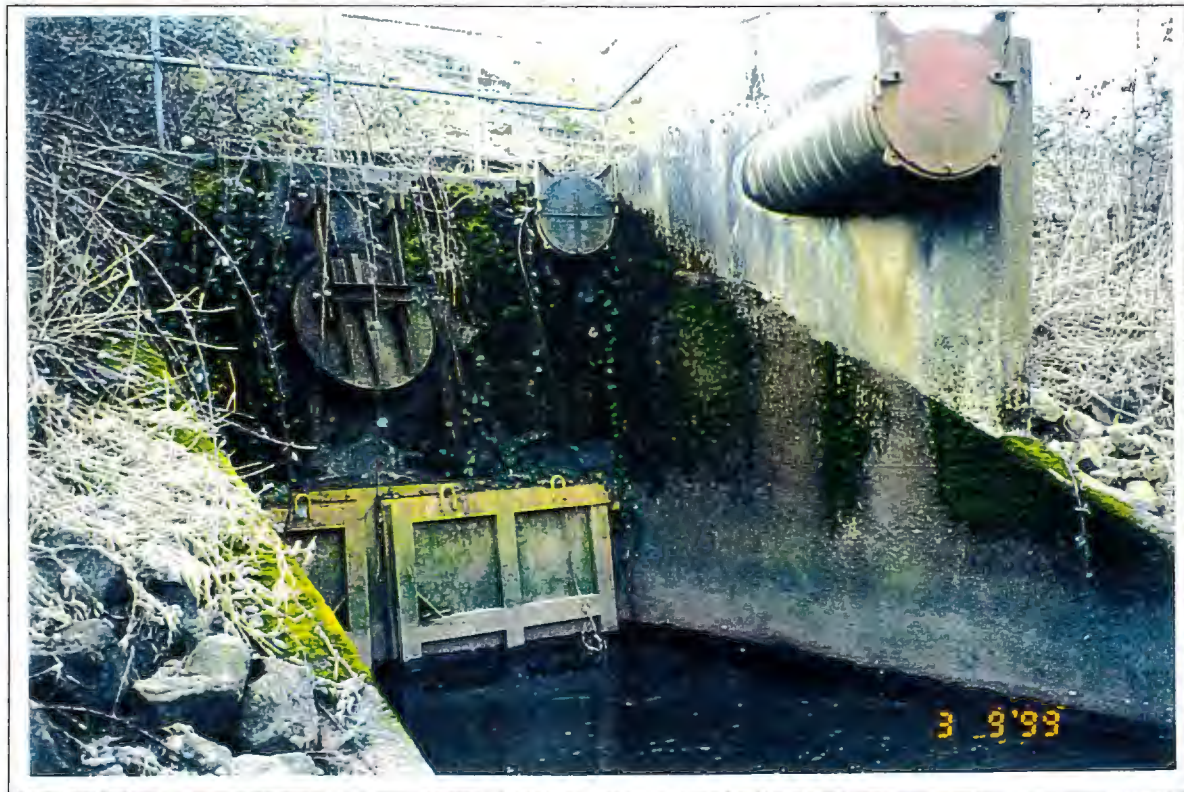
Photo 18: Nathan Slough station: flood box and pump outfalls.

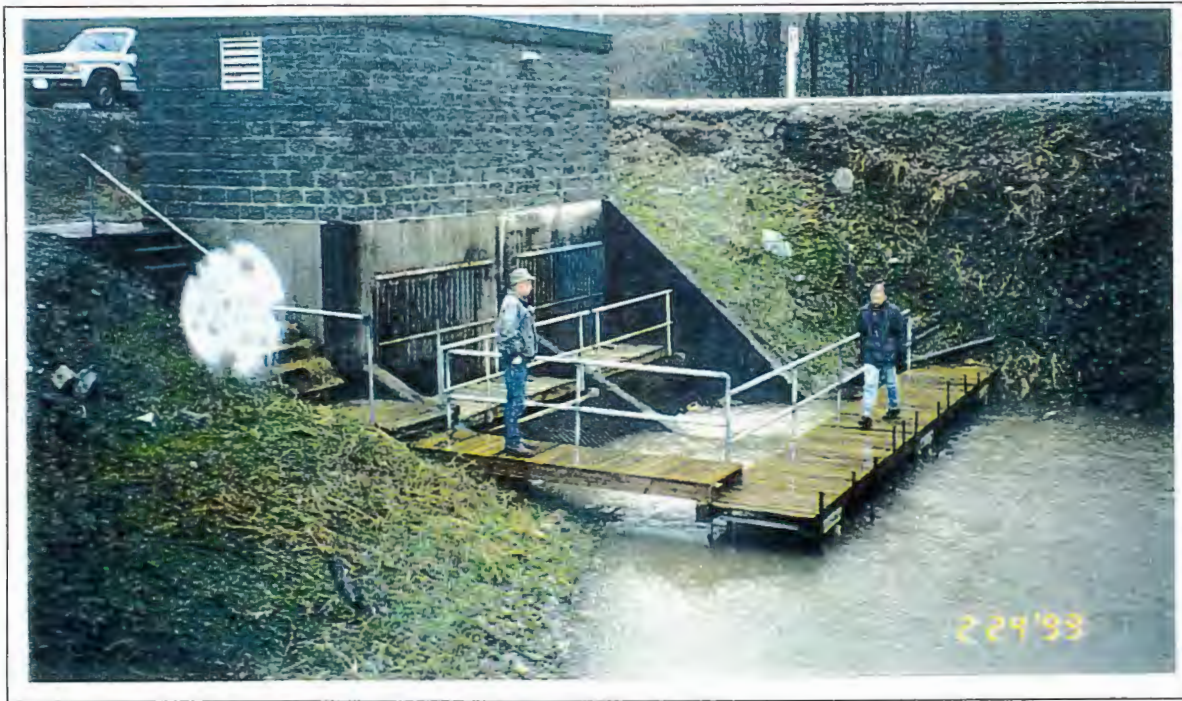
Photo 19: Silverdale station (Chester Creek): walkway to facilitate fish salvage during freshet.

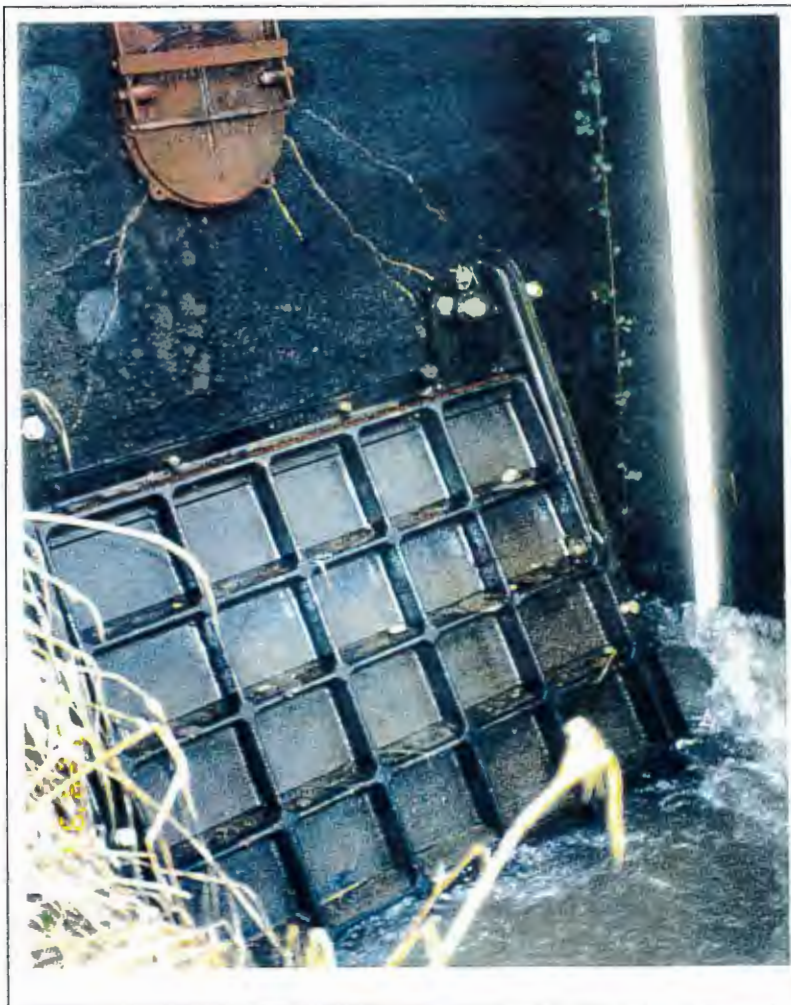
Photo 20:
Silverdale
station (Chester
Creek): new top
mounted steel flap
gate on flood box
outfall.

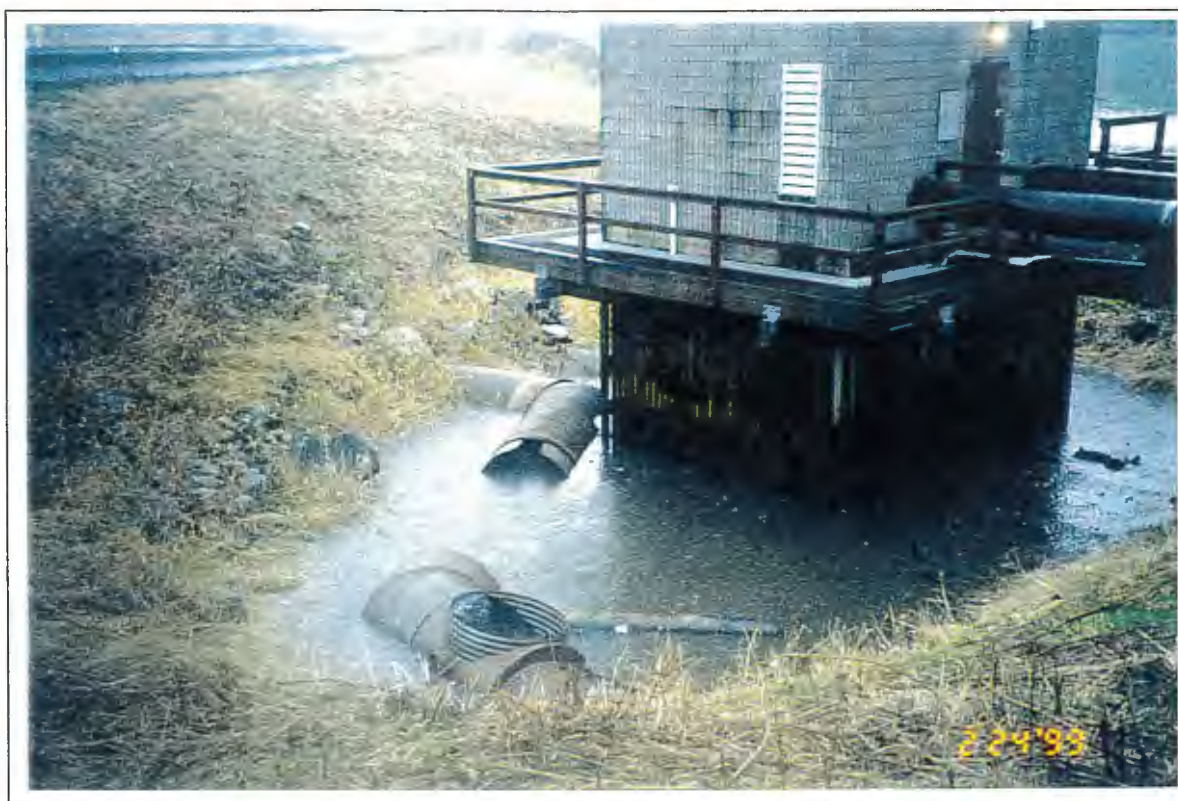
Photo 21: Lane Creek station: Lane creek enters through culvert in center of pic.

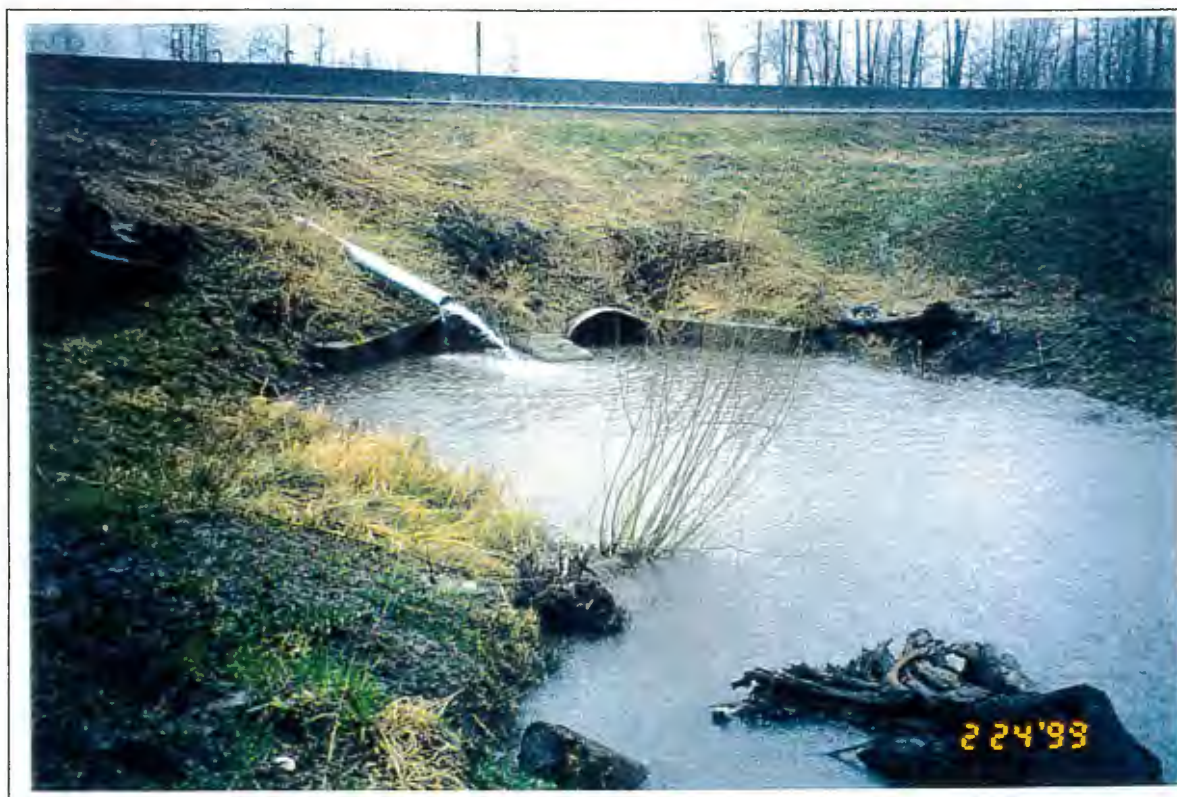
Photo 22: Lane Creek station: culverts lead to pump station behind embankment.

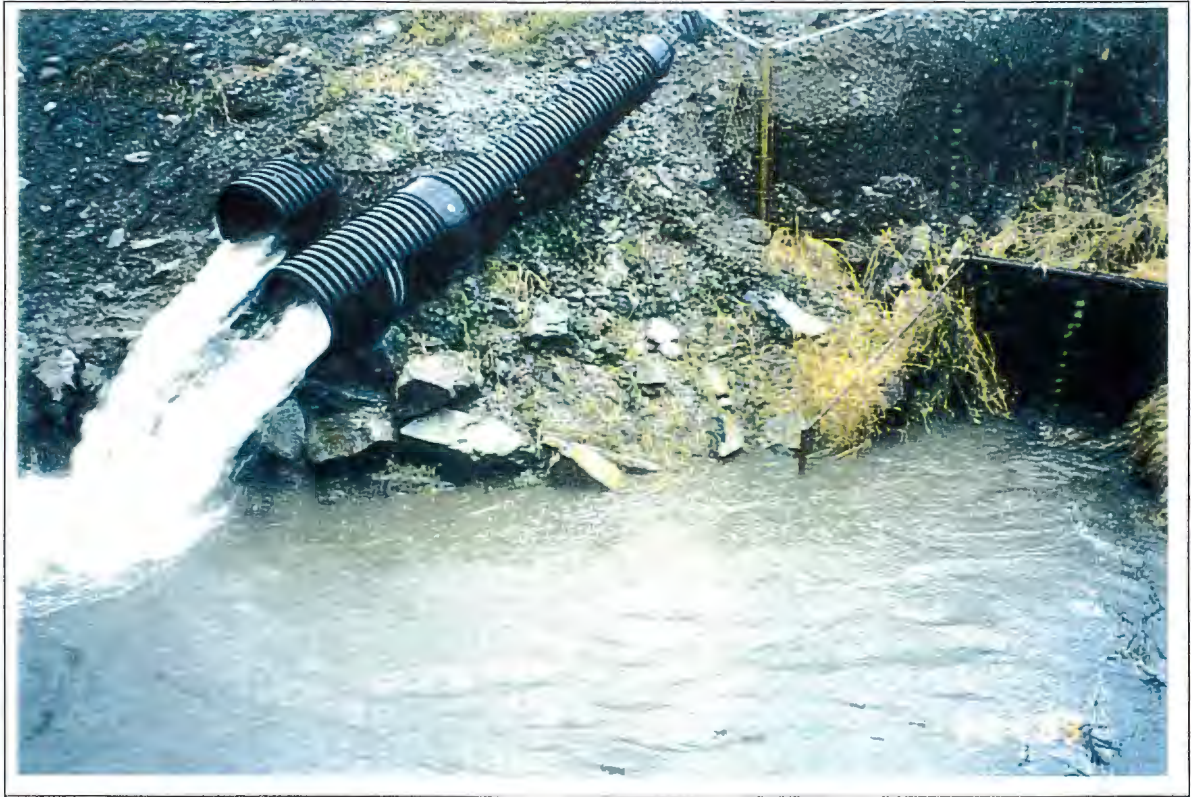
Photo 23: Lane Creek station: pump (L) and flood box (R) outfalls.
